THE OPTIMIZATION OF BUILDING DECONSTRUCTION FOR DEPARTMENT OF DEFENSE FACILITIES: FT. MCCLELLAN DECONSTRUCTION PROJECT

FT. MCCLELLAN DECONSTRUCTION PROJECT

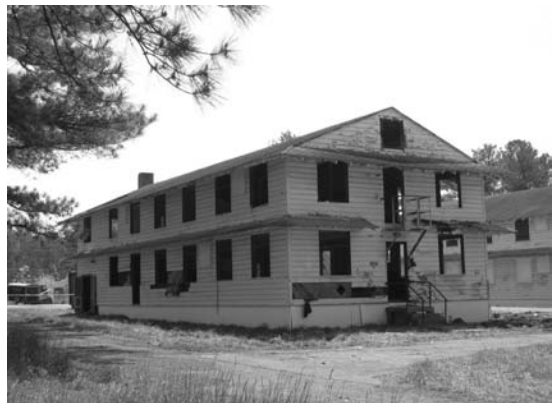
PHOTOGRAPH 1. Typical case study building at Ft. McClellan Army Base

The buildings used in this study were comprised of raised floor system, balloon-framing, and roof rafters with joists, and were approximately 30' wide x 73' long. At one end was a slab-on-grade boiler room and common bathroom facilities at each floor. The other three-quarters length of the building was a single open room on each floor, with partial height partitions to form cubicles.

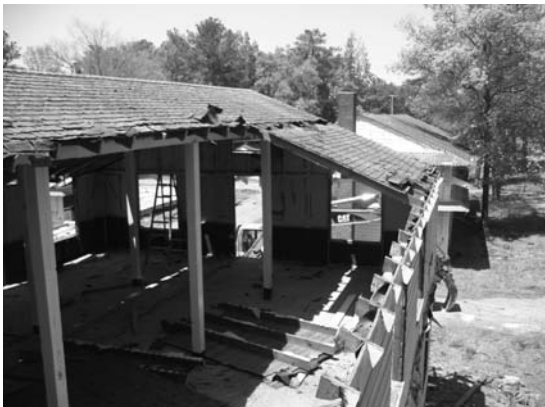
PHOTOGRAPH 2. Roof panelization

Lift (HS) was a technique uniquely applied to the roof structure using a crane to lower a section of roof to the ground where its constituent materials were separated by hand.

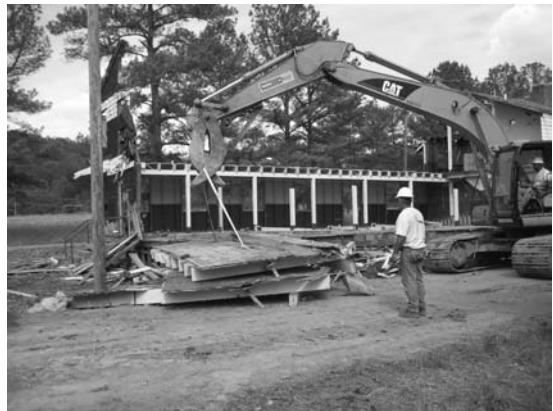
PHOTOGRAPH 3. Second floor panelization and lay-down for hand disassembly

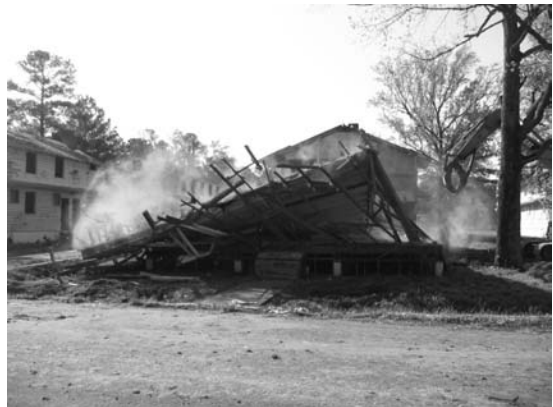
PHOTOGRAPH 4. “Dropping” second floor by collapsing onto first floor

Drop (HS) was a technique applied to the second floor structure in which a controlled collapse of

the second floor was used to facilitate the hand separation of its constituent materials.

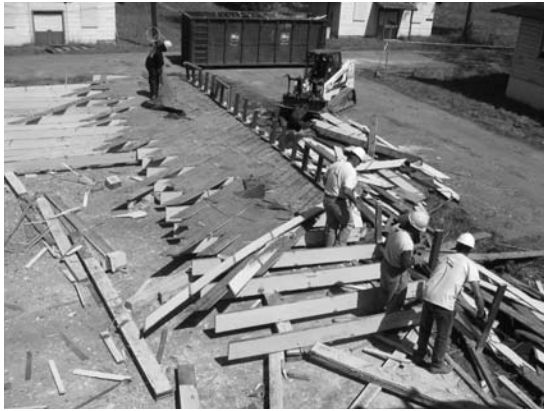
PHOTOGRAPH 5. Hand disassembly of dropped second floor
