# A comprehensive review on the challenges of cured-in-place pipe (CIPP) installations

This paper outlines the issues and challenges associated with cured-in-place pipe (CIPP) rehabilitation projects of sewer mains, water mains, and service laterals. Common problems and challenges are first reviewed from the available literature and CIPP installation site visits. These obstacles and risks are classified into five different categories: pipe condition and configuration, pre-installation, challenges during installation, post-installation, and environmental challenges. In addition, this paper discusses relevant measures adopted in the current practices to mitigate these challenges. The main purpose of this paper is to provide a concise but comprehensive summary of all information needed by researchers and engineers to understand the obstacles and challenges that may arise during CIPP rehabilitation work. Meanwhile, much effort is made to identify future research needed to better understand how the current practice deals with such issues and to find better solutions to current challenges.

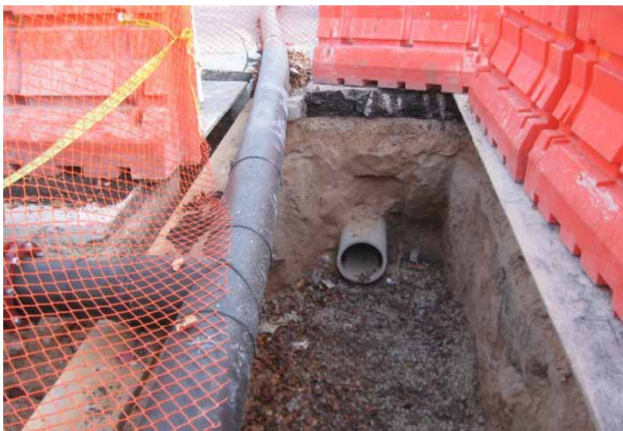
**Figure 2** | Access pit with pipe removed (right) and bypass (left) (with permission from Matthews *et al.* 2015).

Installation of CIPP liners in water mains is more complex compared to sewer mains due to access problems of pressure mains (Matthews *et al.* 2015) and the requirement for the flow to be shut down or bypassed, whereas gravity sewer flows can be diverted more easily (Hu *et al.* 2009). In order to gain access to the water main, access pits must be created (Figure 2). This requires digging and shoring, removal of the asphalt and concrete structure, and cutting 6–8 feet of the exposed host pipe (Lueke *et al.* 2015; Rosenberg & Anderson 2015). While the rehabilitation work itself is trenchless, it still requires a fair amount of digging and other open-cut activities during procedures like the installation of isolation valves and associated piping, the digging and shoring of pits, disposal of the cut away sections and the reinstatement of service pipe connections to water mains (Leitch *et al.* 2015). As CIPP liners are not compatible with the operation of valves, valves must be replaced using open-cut (Wong *et al.* 2015). As a result, the locations of installation access pits are normally selected at existing valve boxes that will require replacement. For the case of

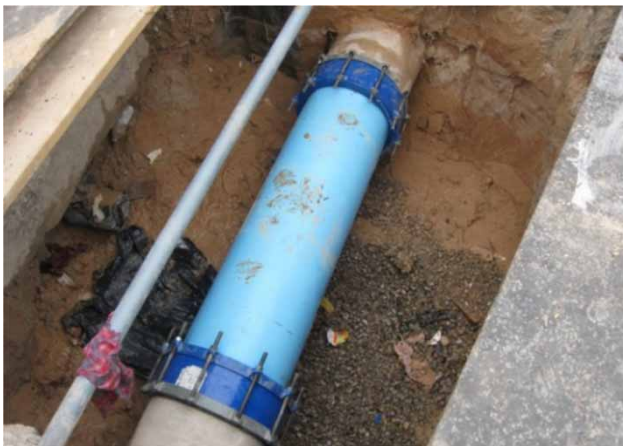
**Figure 5** | Lined pipe sections connected by PVC pipe (with permission from Matthews *et al.* 2015).

A particular challenge for water mains is site restoration after CIPP installation, which is achieved by backfilling the access pits, concrete repair/replacement, asphalt paving of the roadway, and restoration of any green space that was disturbed. As shown in Figure 5, after successful CIPP installation, lined pipe sections have been connected by PVC pipe (Matthews *et al.* 2015).
