A comprehensive review on the challenges of cured-in-place pipe (CIPP) installations

ABSTRACT

Key words | CIPP, issues and challenges, service laterals, sewer main, trenchless, water main

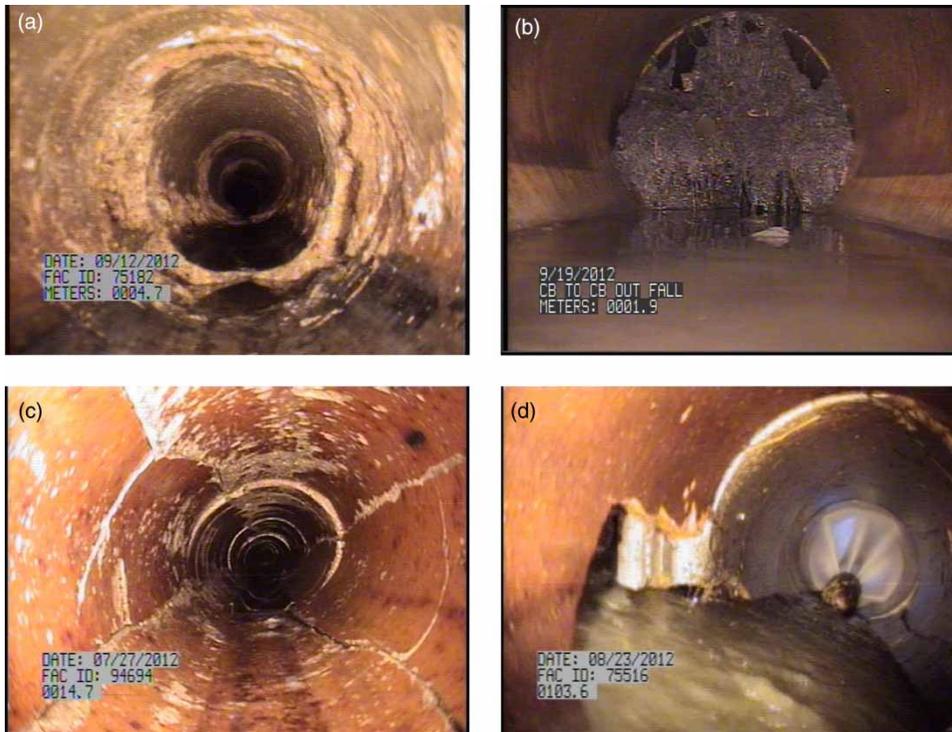
Figure 1 | Pipe defects inside a sewer mainline: (a) hole in pipe; (b) roots mass; (c) deformed pipe, multiple fractures, surface damage; (d) broken pipe with pieces missing (with permission from Navab 2014).

It is estimated that 25% of the gravity sewer network is more than 40 years old, whereas only 2% of the force main network is over 50 years old and 68% is less than 25 years old (Selvakumar & Tafuri 2012). For sewer infrastructures, challenges can typically be related to cracks, severe internal corrosion (especially for concrete sewers), root intrusion, grease build-up together with sediment and debris, joint misalignment, excessive pipe deflection, separation and/or leakage, lateral connection leakage, and grade and alignment (Murray 2009; Selvakumar & Tafuri 2012). Pipe preparation or cleaning is the preliminary step for CIPP installation. Figure 1 shows some examples of pipe defects inside a sewer mainline.

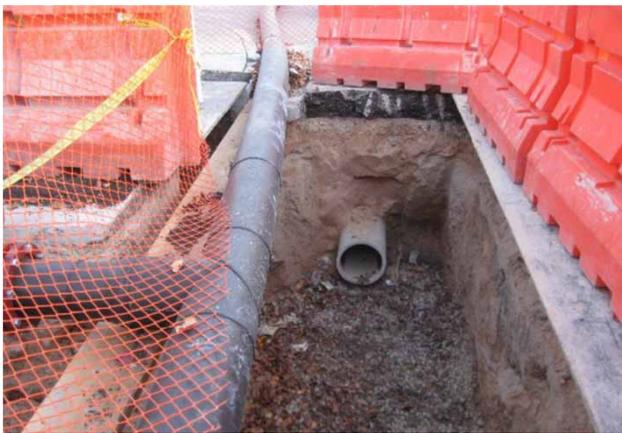
Figure 2 | Access pit with pipe removed (right) and bypass (left) (with permission from Matthews *et al.* 2015).

Installation of CIPP liners in water mains is more complex compared to sewer mains due to access problems of pressure mains (Matthews *et al.* 2015) and the requirement for the flow to be shut down or bypassed, whereas gravity sewer flows can be diverted more easily (Hu *et al.* 2009). In order to gain access to the water main, access pits must be created (Figure 2). This requires digging and shoring, removal of the asphalt and concrete structure, and cutting 6–8 feet of the exposed host pipe (Lueke *et al.* 2015; Rosenberg & Anderson 2015). While the rehabilitation work itself is trenchless, it still requires a fair amount of digging and other open-cut activities during procedures like the installation of isolation valves and associated piping, the digging and shoring of pits, disposal of the cut away sections and the reinstatement of service pipe connections to water mains (Leitch *et al.* 2015). As CIPP liners are not compatible with the operation of valves, valves must be replaced using open-cut (Wong *et al.* 2015). As a result, the locations of installation access pits are normally selected at existing valve boxes that will require replacement. For the case of

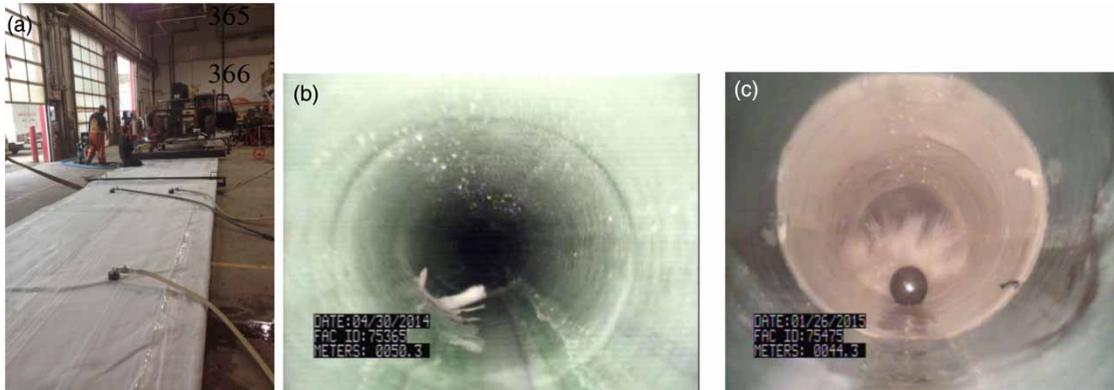
Figure 3 | (a) Vacuum impregnation and sealing, (b) liner peeling, and (c) spot repair.

The literature review shows a significant number of deficiency incidences following CIPP installation. Downey & Koo (2015) suggested that after CIPP installation, some fundamental issues require close attention, such as variable impregnation and curing, shrinkage due to polymerization, and wrinkling and folding, which may occur in CIPP at bends and at irregularities in the host pipe. In a CIPP project in the province of Quebec, problems with matching the manufactured liner with the existing pipe was a common issue found (Alzraiee et al. 2014). Liner thickness can change as a result of varying fabric thickness, inadequate resin, erroneous calibration of rollers during impregnation, higher than intended pressures during installation, and/or stretching of the fabric at steep downhill sections of the host pipe. A site visit to a CIPP project in Edmonton, Alberta, found evidence of liner peeling after the CCTV inspection, and a further study verified that liner peeling occurred exactly at a vacuum impregnation sealing spot. This problem may arise due to improper sealing after vacuum impregnation and poor workmanship. Addressing this liner peeling required a costly spot repair. Figure 3 depicts vacuum impregnation inside a wet out shop, peeling of liner after installation, and spot repair to resolve the liner deficiency.

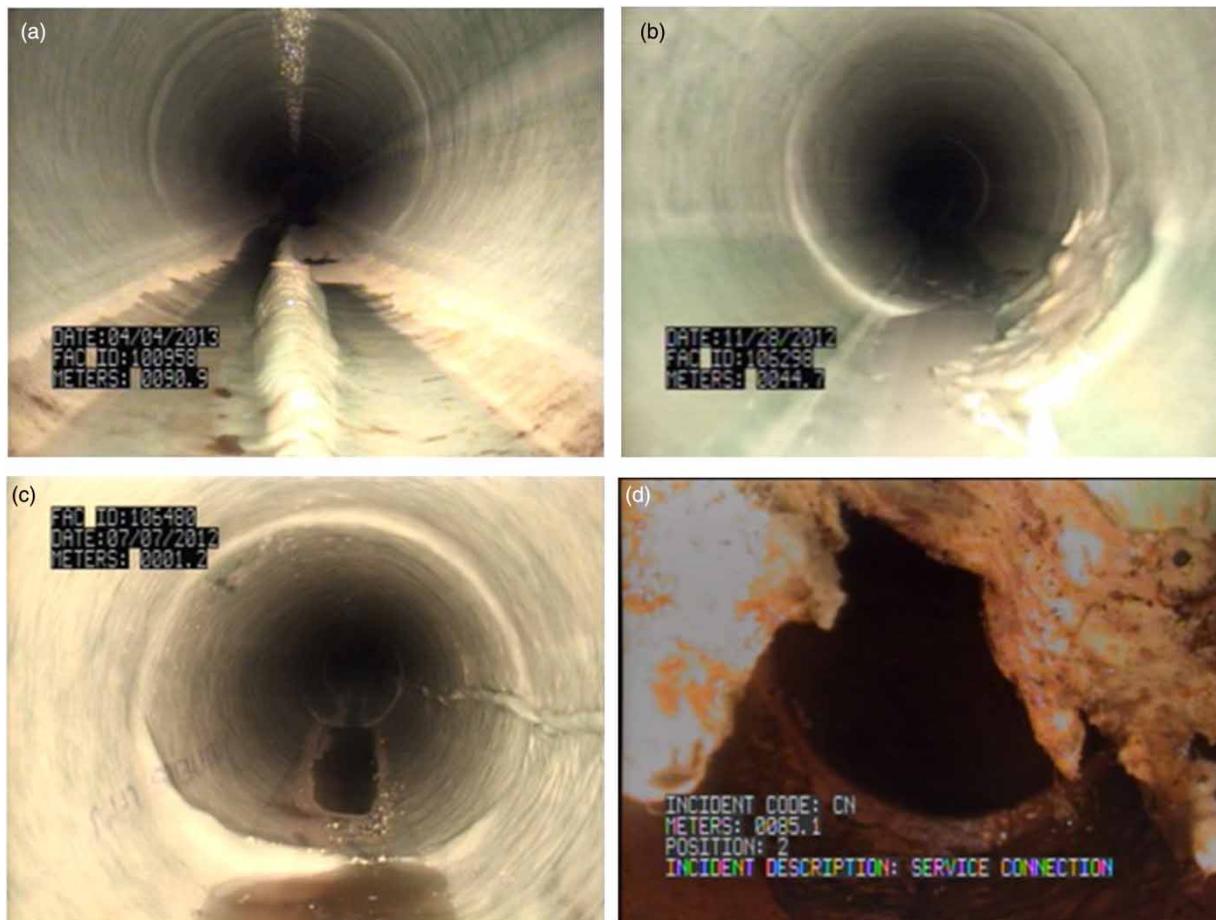
Figure 4 | Different liner deficiencies of sewer main CIPP: (a) fold in liner, (b) liner peeling, (c) wrinkles or bubbles, and (d) service undercut.

Figure 4 shows different examples of post-installation liner deficiencies collected from sewer main CIPP installation projects in Edmonton, Alberta. There is evidence of water re-entering the system post-main line rehabilitation

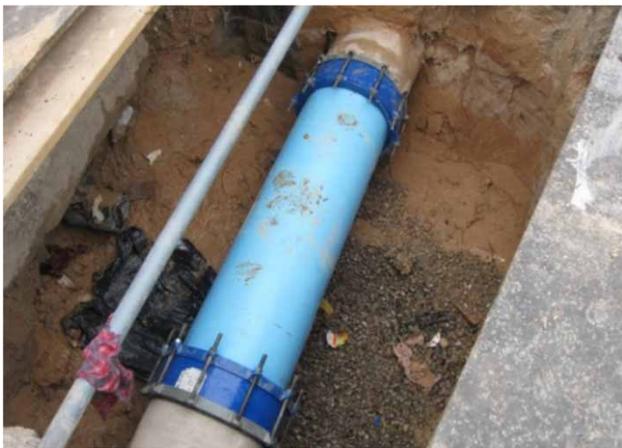
Figure 5 | Lined pipe sections connected by PVC pipe (with permission from Matthews *et al.* 2015).

A particular challenge for water mains is site restoration after CIPP installation, which is achieved by backfilling the access pits, concrete repair/replacement, asphalt paving of the roadway, and restoration of any green space that was disturbed. As shown in Figure 5, after successful CIPP installation, lined pipe sections have been connected by PVC pipe (Matthews *et al.* 2015).

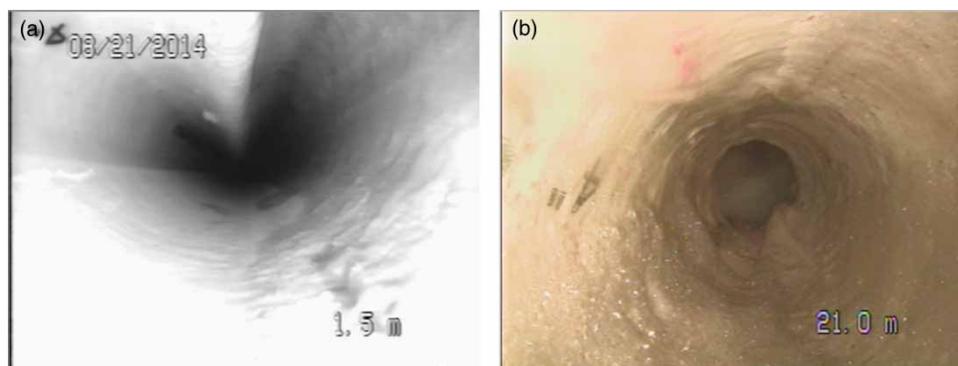
Figure 6 | Post-installation deficiencies in lateral: (a) fold in liner, (b) liner peeling.

Several post-installation deficiencies, such as liner fold, lift, peeling and wrinkles, are significant issues for lateral CIPP installation projects. These kinds of deficiencies need spot repairs with significant cost. Figure 6 illustrates deficiencies in lateral liners (liner fold and peeling) found from CCTV inspection after CIPP installation in Edmonton city lateral rehabilitation projects.
