## Time-lapse photography for monitoring reservoir leakages (Montejaque dam, Andalusia, southern Spain)

A methodology based on the use of time-lapse photographs is presented to evaluate the leakages over time of a reservoir (Montejaque dam, Málaga Province, Spain) that feeds a karstic aquifer. In particular, photographic control allows the evolution of water levels in the dam and the river that feeds it to be monitored. Through changes in water volume, which are calculated from the level differences, daily leakages are evaluated, and the relationship between leakages and the water level of the reservoir is established. The proposed method includes adjusting the hydric balance and the use of digital terrain model and climate data. The inputs (river flow and direct precipitation) and other outputs (direct evaporation) are also evaluated. Values between  $4 \text{ m}^3/\text{s}$  and  $0.35 \text{ m}^3/\text{s}$  are obtained for the reservoir infiltration, clearly superior to the values obtained at the time of the construction of the dam in the 1920s. Mobilisation of the filling of fractures and conduits in karstic massif and calcite dissolution are processes that can influence this

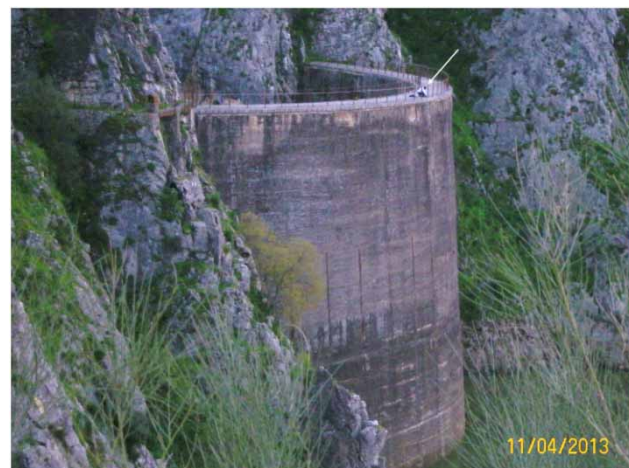
Figure 2 | Current view of the Montejaque dam.

The dam was completed in 1924 and was a pioneer in its time in terms of size (84 m from the foundation) and

construction techniques (double curvature arch concrete dam) (Figure 2).

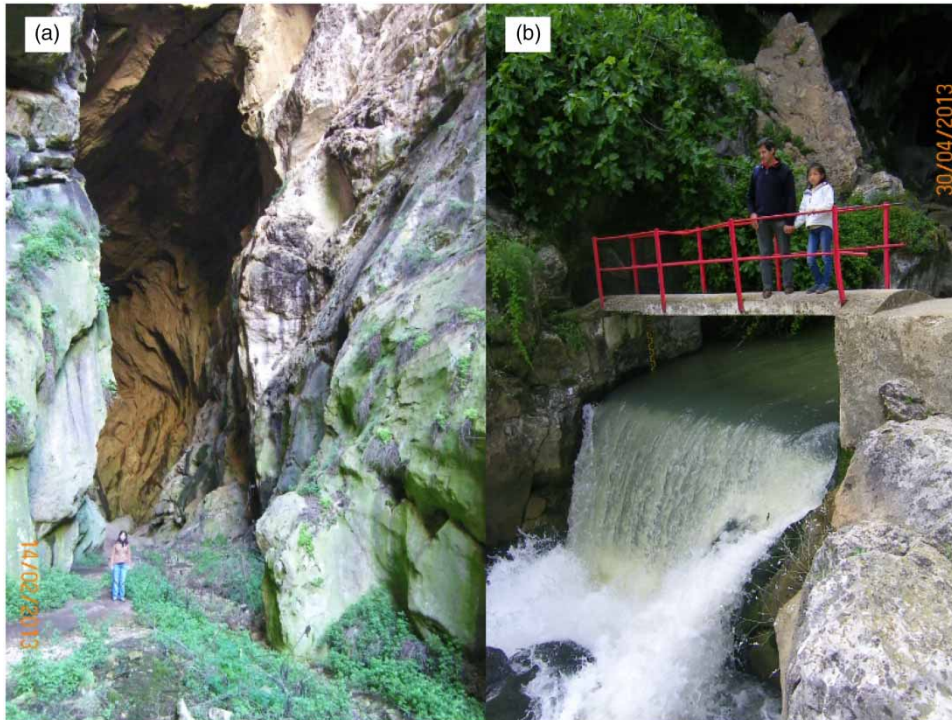
**Figure 4** | Hundidero-Gato underground complex: (a) Hundidero Cave, (b) Cueva del Gato spring.

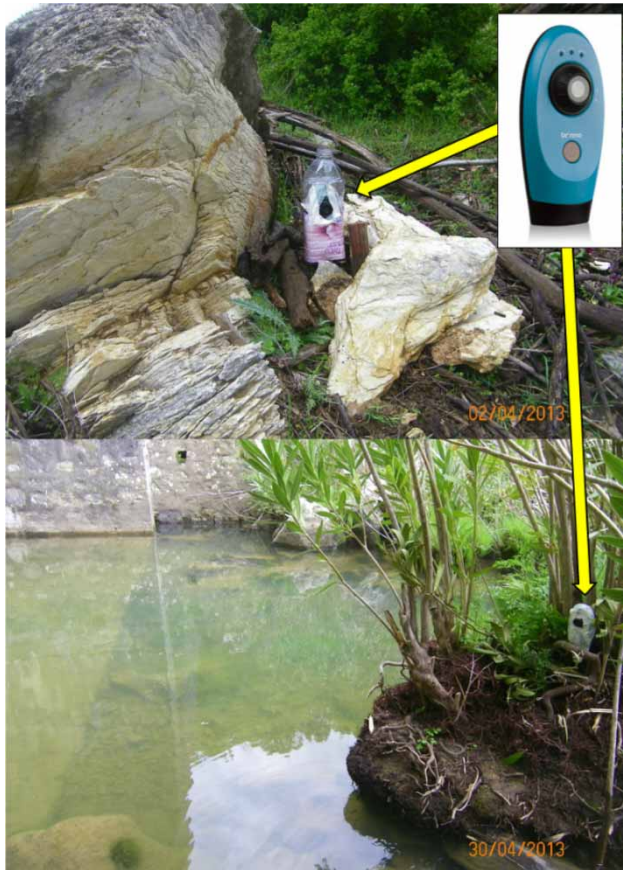
**Figure 5** | Brinno-TLC100 camera hidden in the ground at a location near the dam (above) and near the river, where it flows into the reservoir (bottom).

The proposed application is based on the use of photographs taken with a Brinno TLC-100 camera (Figure 5). This instrument is a low-cost, time-lapse camera that is capable of outdoor operation, with an opening angle of  $49.5^\circ$ , a video resolution of  $1,280 \times 1,024$  and a storage capacity of 8 GB. It allows exposure programming at intervals between 5 seconds and 24 hours. The functioning is autonomous: the camera is powered by disposable batteries and has a variable duration of operation, with a shooting interval of up to 200 days in the case of daily photographs.

In this study, two cameras were installed. They were hidden in the ground to prevent acts of vandalism. The first (location 1) was installed near the dam to record the

variation in the reservoir water level. It was placed in the left margin, at a distance of around 100 m from the dam, with the optical axis approximately horizontal and oblique to the construction. The second camera (location 2) was placed in the Guadares riverside, at the entrance of the reservoir, to record the water level of the river in a section regularised under a bridge, which had previously been used as a gauging station. The camera-channel section distance is less than 10 m. In this case, the objective is to reconstruct the hydrograph in the study period.

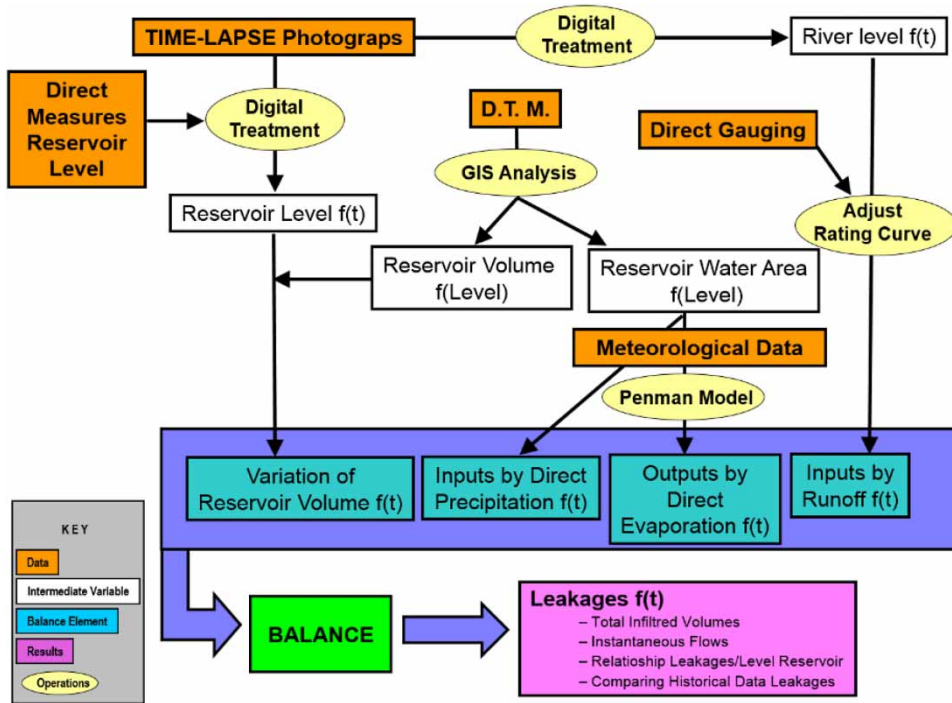
Figure 6 | General outline of the method.

The working scheme is shown in Figure 6. To determine the leakages, a balance method was considered. The changes in water level in the reservoir are due to the differences between the inputs and the outputs, for a given time interval (in the present study it has been considered a day). The entries refer mainly to the contribution of the main water course that feeds the reservoir, which has been monitored with time-lapse photographs. Inputs derived from direct precipitation on the water sheet have been taken into account. The contributions of the surface slope to the reservoir

outside the main channel have been considered to be insignificant and have not been regarded. As for the outlets, only two types have been identified: the infiltration into the permeable materials that make up the reservoir vessel and the losses by direct evaporation from the water sheet of the reservoir. The infiltration into the permeable materials depends basically on two factors: the flooded surface of permeable rocks and the hydraulic load, both of which are determined by the reservoir level. The infiltration is the unknown variable that is deduced after the estimation of the rest of the variables of the water balance. Finally, direct evaporation depends on the temperature, humidity, solar radiation, wind factors and the surface exposed to evaporation; the latter also depends on the reservoir level. Thus, inputs, outputs and storage variations were estimated.

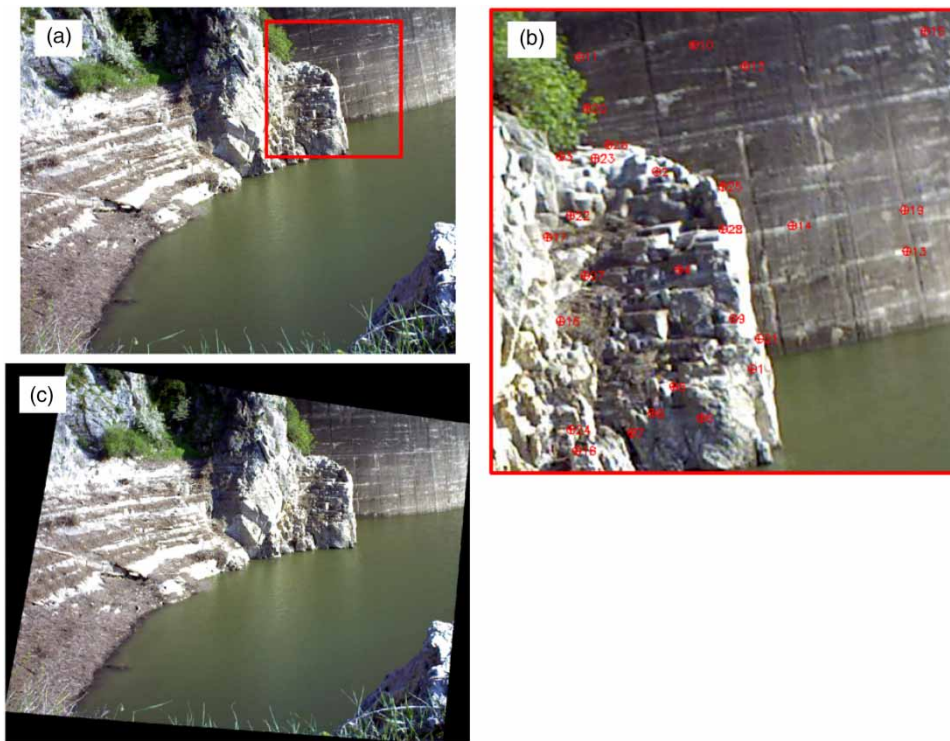
Figure 7 | Example of processed time-lapse photography: photo taken on 24/04/2013 in location 1 (near the dam): (a) original image, indicating the area geometrically adjusted by control points, (b) detail of control points considered, (c) geometrically transformed image.

The digital treatment performed has been basically oriented to achieve a very good geometric coincidence among all of the photographs of each set. For this purpose, we used the method of control points with transformation functions (Wolf 1983). For both the set of photographs obtained in the reservoir and the set obtained in the river, a photo was selected as reference, and the rest were adjusted to it. The adjustment was performed by applying first- and second-degree polynomial transformation functions, which were defined by a number of control points between 15 and 50. Control points were preferentially selected in the area of the frame where distance measurements were to be performed thereafter (Figure 7). The imposed condition was that the root-mean square error between the positions in the reference image and the positions in the transformed image should be less than 0.5 pixels and that the single residue for each point was a maximum of 1 pixel.

Without the geometric transformation it would not have been possible to make precise dimensional measurements between photographs. It should be noted that although all of the photographs were taken from the same point, the camera orientation suffered slight alterations as a result of the camera's own dimensional instability and because of variables and environmental conditions. After adjusting the images, we proceeded to determine the displacement of the water surface between successive photographs, expressed in image units (pixels). This displacement was measured in every image using the following routine: the mean of five measurements was considered after removing values that differed by more than 1 pixel from the mean.

For photographs of the dam (location 1), the image units were transformed into terrain units from the consideration of water sheet measurements made with an electric water level meter with respect to the crown of the dam. In this way, the sizes of the pixels on the ground in the measurement area image were determined (between 4.2 cm and 4.4 cm). The accuracy obtained by repetition of measures was estimated to be on the order of half a pixel (2.2 cm).

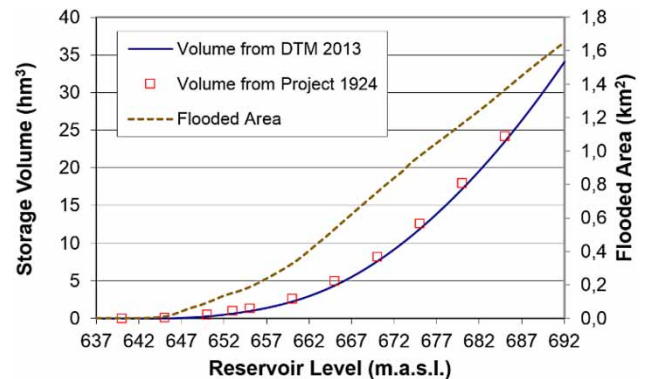
**Figure 8** | Results obtained from the DTM analysis of the reservoir basin: graphs of flooded area and stored volume versus reservoir water level and comparison with historical data.

First, the analysis of the DTM led to defining the characteristic curves of the reservoir (Figure 8). In the graph ‘flooded area versus reservoir level’, we can observe a clear change in

the slope starting at the value 660 m asl. This change is a consequence of the transition from the alluvial plain of the bottom of the reservoir towards the steepest slopes. The graph ‘storage volume versus reservoir level’ shows remarkable similarities with respect to the curve obtained using the data from the original project (year 1924). However, at present, there is a lower storage capacity (between 0.3 and 0.6 hm<sup>3</sup> less). This difference is explained by the sedimentation of fine materials (silt, clay and fine sand) at the bottom of the reservoir since the construction of the dam, indicating a relatively small degree of sedimentary fill (between 1 and 2 cm/year at the bottom of the reservoir).

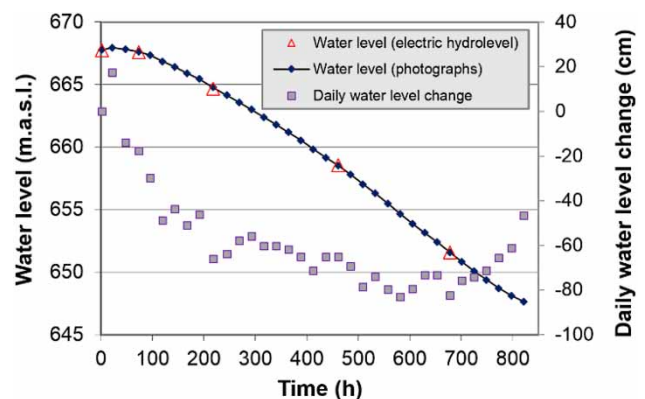
**Figure 9** | Evolution of reservoir water level obtained from measurements in photos and daily descents, obtained by difference of each day with respect to the previous day.

The photographic monitoring of the dam, along with direct measures, has helped define the evolution of the reservoir level and its daily variations. Daily water level change is obtained by calculating the difference between reservoir levels of 2 consecutive days (Figure 9).

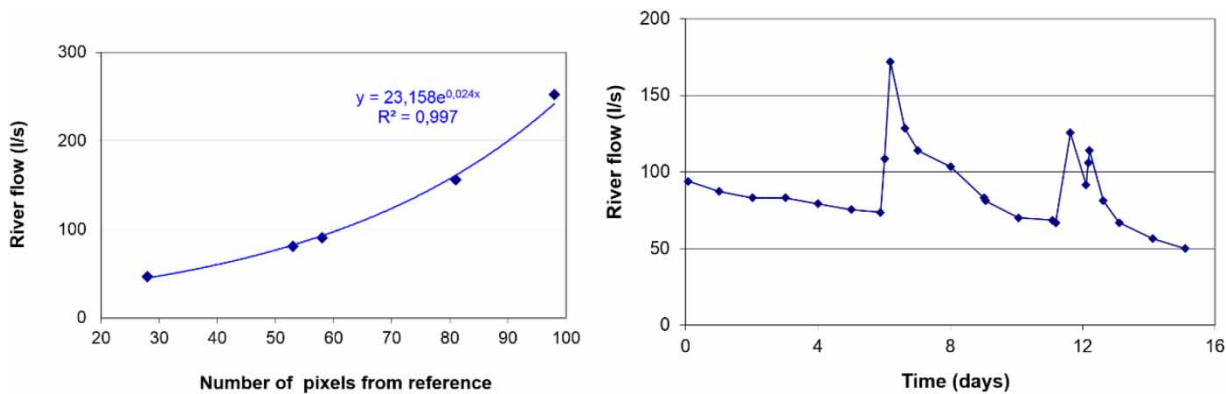
Figure 10 | Left: Rating curve obtained by direct gauging (level is expressed in units-photography). Right: Hydrograph of the Guadares river, obtained from the treatment of photographs taken at location 2.

Processing the images obtained in the river (location 2) was similar, but it was necessary to establish a rating curve from the position of the sheet water in the photographs and the flow determinations that were obtained using the micro current meter. The control points used to adjust the set of photographs were taken on one of the walls of the artificial river channel. In this case, the sensitivity in the determination of distances on the photograph was better because of the lower camera-object distance.

The photographic monitoring of the river and direct gauging have helped define the rating curve in relative terms. From this information, a hydrograph of flow rates during the monitoring period was generated (Figure 10).
