Time-lapse photography for monitoring reservoir leakages (Montejaque dam, Andalusia, southern Spain)

ABSTRACT

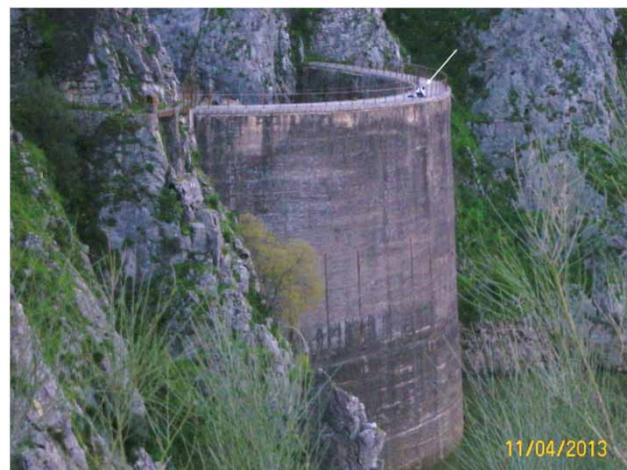
Figure 2 | Current view of the Montejaque dam.

The dam was completed in 1924 and was a pioneer in its time in terms of size (84 m from the foundation) and

construction techniques (double curvature arch concrete dam) (Figure 2).

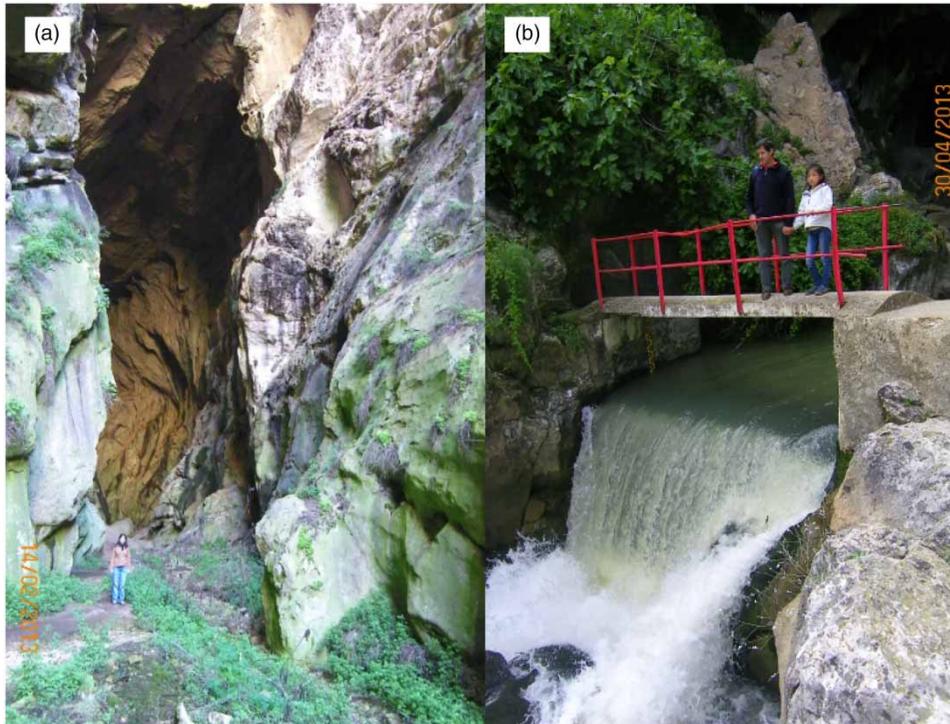
Figure 4 | Hundidero-Gato underground complex: (a) Hundidero Cave, (b) Cueva del Gato spring.

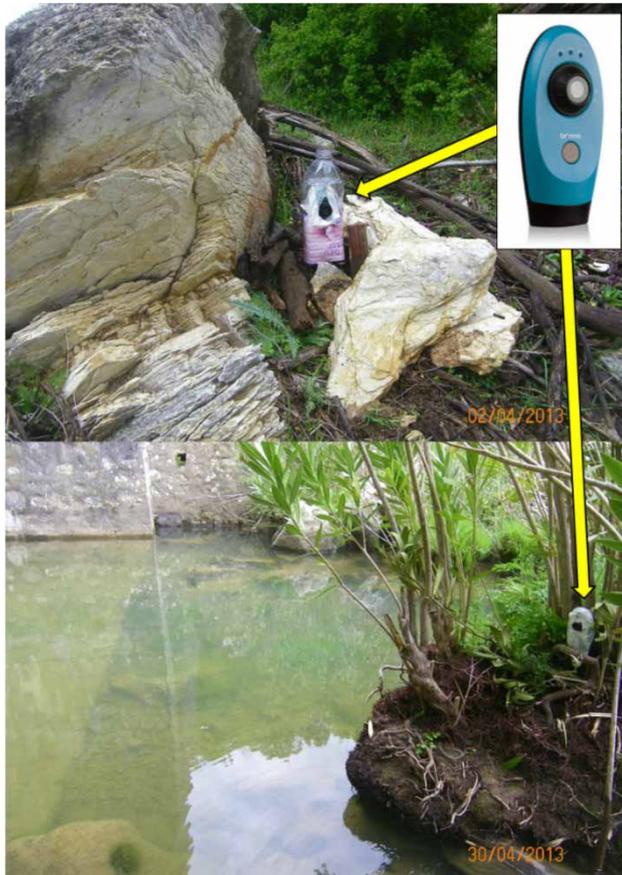
Figure 5 | Brinno-TLC100 camera hidden in the ground at a location near the dam (above) and near the river, where it flows into the reservoir (bottom).

The proposed application is based on the use of photographs taken with a Brinno TLC-100 camera (Figure 5). This instrument is a low-cost, time-lapse camera that is capable of outdoor operation, with an opening angle of 49.5° , a video resolution of $1,280 \times 1,024$ and a storage capacity of 8 GB. It allows exposure programming at intervals between 5 seconds and 24 hours. The functioning is autonomous: the camera is powered by disposable batteries and has a variable duration of operation, with a shooting interval of up to 200 days in the case of daily photographs.

In this study, two cameras were installed. They were hidden in the ground to prevent acts of vandalism. The first (location 1) was installed near the dam to record the

variation in the reservoir water level. It was placed in the left margin, at a distance of around 100 m from the dam, with the optical axis approximately horizontal and oblique to the construction. The second camera (location 2) was placed in the Guadares riverside, at the entrance of the reservoir, to record the water level of the river in a section regularised under a bridge, which had previously been used as a gauging station. The camera-channel section distance is less than 10 m. In this case, the objective is to reconstruct the hydrograph in the study period.

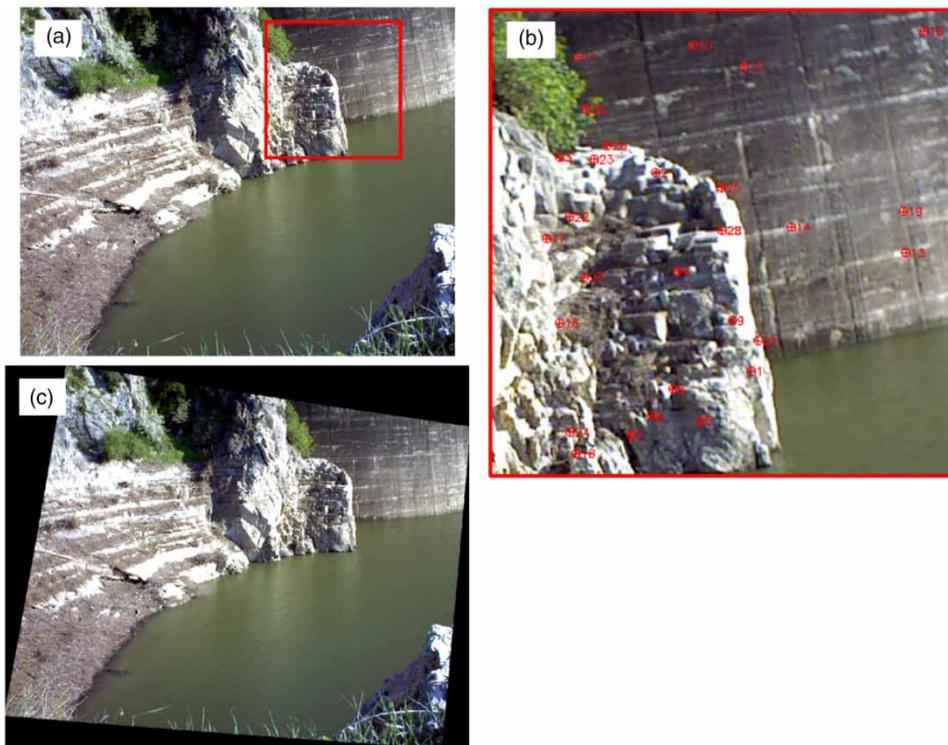
Figure 7 | Example of processed time-lapse photography: photo taken on 24/04/2013 in location 1 (near the dam): (a) original image, indicating the area geometrically adjusted by control points, (b) detail of control points considered, (c) geometrically transformed image.

The digital treatment performed has been basically oriented to achieve a very good geometric coincidence among all of the photographs of each set. For this purpose, we used the method of control points with transformation functions (Wolf 1983). For both the set of photographs obtained in the reservoir and the set obtained in the river, a photo was selected as reference, and the rest were adjusted to it. The adjustment was performed by applying first- and second-degree polynomial transformation functions, which were defined by a number of control points between 15 and 50. Control points were preferentially selected in the area of the frame where distance measurements were to be performed thereafter (Figure 7). The imposed condition was that the root-mean square error between the positions in the reference image and the positions in the transformed image should be less than 0.5 pixels and that the single residue for each point was a maximum of 1 pixel.

Without the geometric transformation it would not have been possible to make precise dimensional measurements between photographs. It should be noted that although all of the photographs were taken from the same point, the camera orientation suffered slight alterations as a result of the camera's own dimensional instability and because of variables and environmental conditions. After adjusting the images, we proceeded to determine the displacement of the water surface between successive photographs, expressed in image units (pixels). This displacement was measured in every image using the following routine: the mean of five measurements was considered after removing values that differed by more than 1 pixel from the mean.
