Time-lapse photography for monitoring reservoir leakages (Montejaque dam, Andalusia, southern Spain)

ABSTRACT

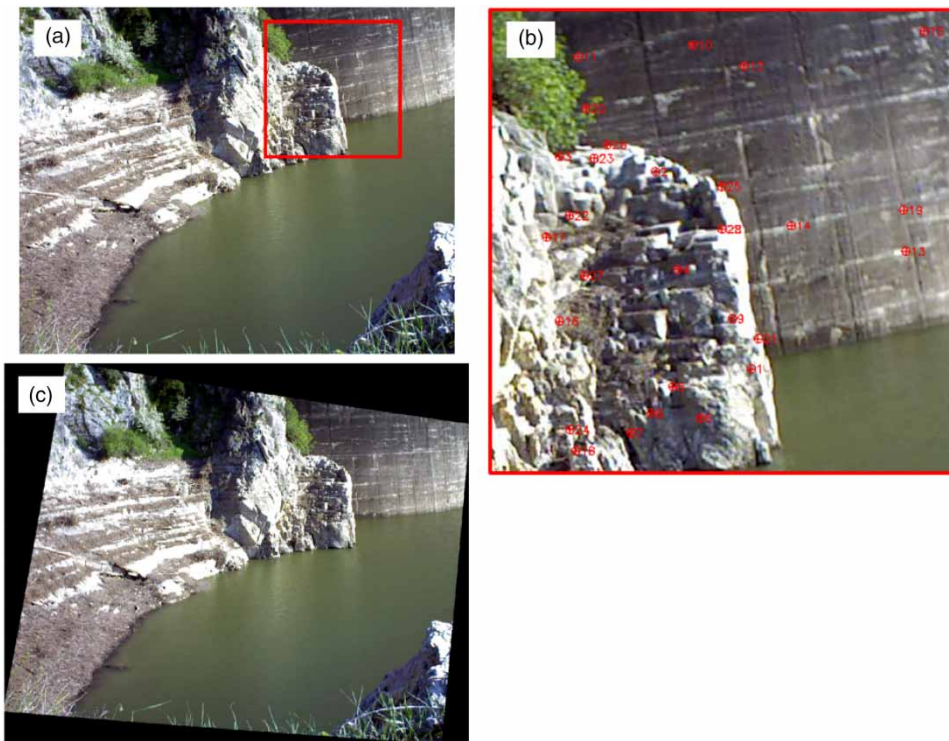
Figure 7 | Example of processed time-lapse photography: photo taken on 24/04/2013 in location 1 (near the dam): (a) original image, indicating the area geometrically adjusted by control points, (b) detail of control points considered, (c) geometrically transformed image.

The digital treatment performed has been basically oriented to achieve a very good geometric coincidence among all of the photographs of each set. For this purpose, we used the method of control points with transformation functions (Wolf 1983). For both the set of photographs obtained in the reservoir and the set obtained in the river, a photo was selected as reference, and the rest were adjusted to it. The adjustment was performed by applying first- and second-degree polynomial transformation functions, which were defined by a number of control points between 15 and 50. Control points were preferentially selected in the area of the frame where distance measurements were to be performed thereafter (Figure 7). The imposed condition was that the root-mean square error between the positions in the reference image and the positions in the transformed image should be less than 0.5 pixels and that the single residue for each point was a maximum of 1 pixel.

Without the geometric transformation it would not have been possible to make precise dimensional measurements between photographs. It should be noted that although all of the photographs were taken from the same point, the camera orientation suffered slight alterations as a result of the camera's own dimensional instability and because of variables and environmental conditions. After adjusting the images, we proceeded to determine the displacement of the water surface between successive photographs, expressed in image units (pixels). This displacement was measured in every image using the following routine: the mean of five measurements was considered after removing values that differed by more than 1 pixel from the mean.
