Investigating the Failure Mechanism of Wet eMachines in the Presence of Transmission Oils

This paper investigates the failure mechanisms in electric machines used in heavy trucks and buses exposed to transmission oil. Five machines from field operations were examined. Subsystem tests—copper corrosion testing, conductive deposit tests, material compatibility tests, and oil analysis—were conducted. Copper sulfide, known for its conductive properties, was found in failed machines and during subsystem tests with lubricants containing reactive sulfur components in contact with exposed copper. Two prerequisites for the chemical reaction—the presence of reagents and sufficient activation energy—were met at normal operating temperatures. Analysis revealed the sulfur presence in damaged machines and identified cracks in the polymer coating on copper wires, allowing corrosive substances to reach the copper surface. The proposed failure mechanism involves active sulfur reacting with copper to form copper sulfide. These layers can create contact bridges between phases in the eMachine, leading to short circuits, sharp temperature increases, electrical arcing, and total machine failure. Coating

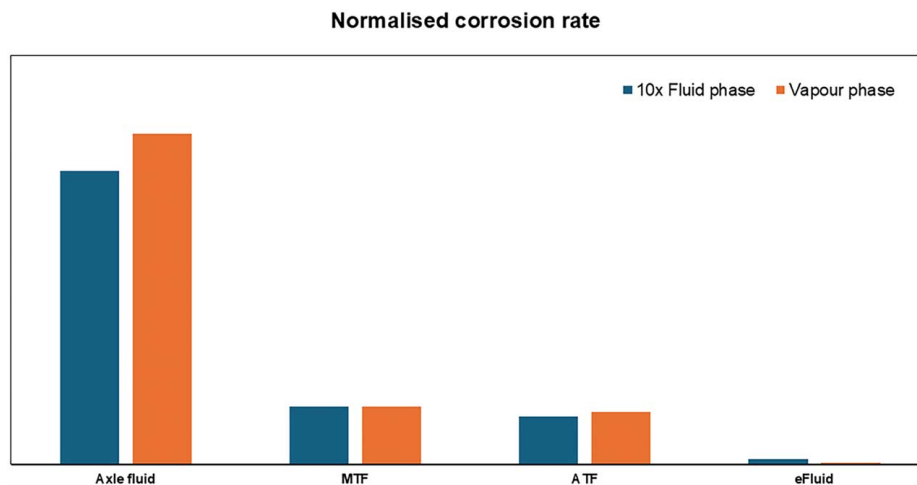
Fig. 1 Normalized relative corrosion rates between some common transmission and axle lubricants (reproduced with permission from Ref. [6]). N.B. The liquid phase here is referred to as the fluid phase.

Recently, lubricants have been developed which have sufficient wear and scuffing performance and excellent copper corrosion performance in addition to compatibility with the wire coatings in wet eMachines (Fig. 1). These fluids contain low sulfur concentrations and are known as eFluids [6,7].

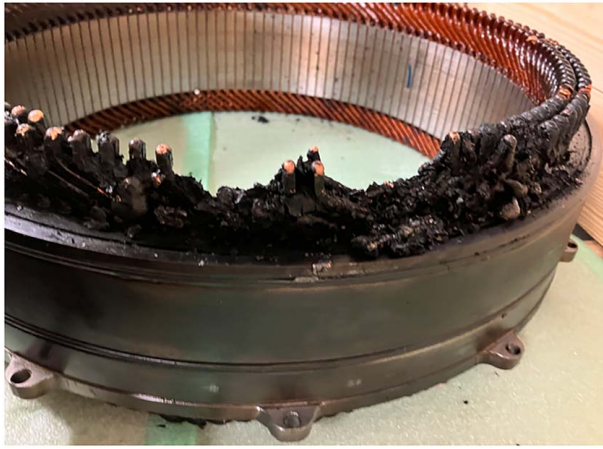
Fig. 2 Stator with severe damage

In this paper, we attempt to explain the chain of events leading to damages such as those shown in Fig. 2.

3.1 Motor Failure Analysis. Five eMachine stators from buses in customer operation in Sweden, Spain, and Norway have been analyzed. Four of these, units 1–4, have been reported to have electrical issues and short-circuiting between 120,000 km and 400,000 km. The damage severity differed between the units, one (unit 2) showing only a small dark spot in the end winding, and other three showing very severe breakdown with large pieces of copper missing (e.g., Fig. 2). In all cases, the damages occurred

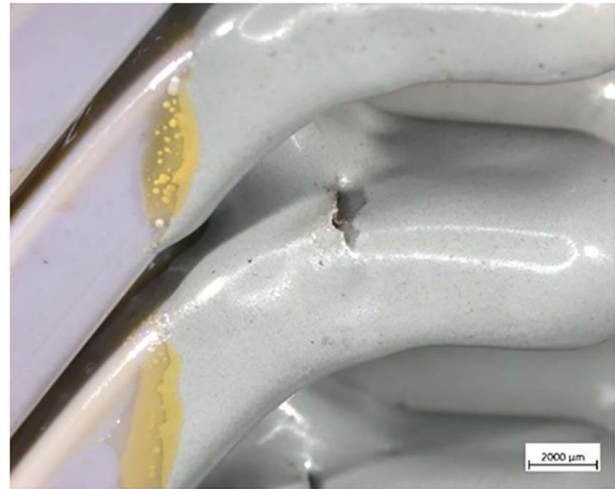
Fig. 6 Crack on the polymer coating close to the weld area in unit 2

Copper is normally not found in transmission oils when new, so elevated copper levels in the oil samples indicate the presence of corrosion. Optical microscopy was used to locate cracks in the polymer layers on the units with no or less severe damage, units 2 and 5. In units with severe short-circuiting, units 1, 3, and 4, the temperatures reached were high enough to melt copper, so there is no way of knowing if the polymer cracking occurred before or after the short circuit. Several locations were found with cracks, insufficient coating coverage, poor resin adhesion, and other damage to the coating layer (Figs. 6 and 7).

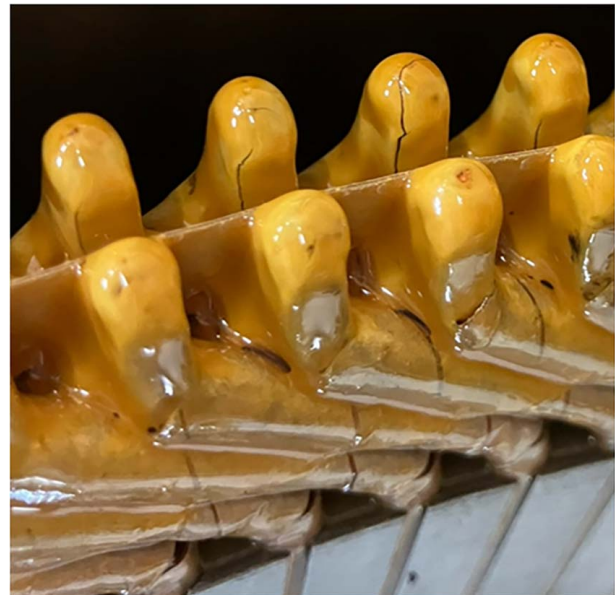
Fig. 7 Cracks in the insulation layers in unit 5

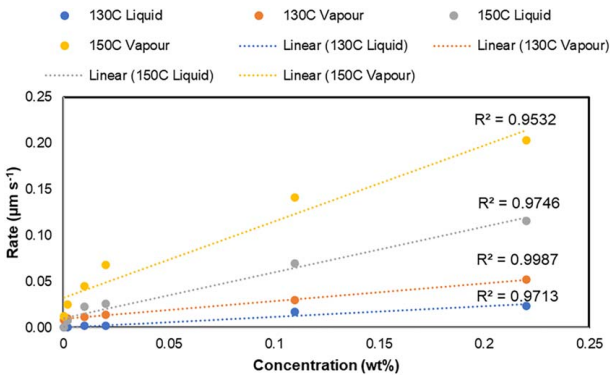
Fig. 12 Plot of rate versus concentration indicating a pseudo-first-order plot for the corrosion of copper in the presence of active sulfur concentration at 130 °C and 150 °C in both liquid and vapor phases

temperature. The rate information collected here can be used to provide an understanding of the temperature dependency of the active sulfur chemistry reaction with copper to form a copper sulfide adduct. To test the effect of active sulfur concentration on the rate of corrosion, a series of dilutions of active sulfur chemistry were performed. Dibutylpolysulfide was added at varying concentrations [5]. The results are shown in Fig. 12.

The rate of corrosion increases with increased concentration in a linear manner at 130 °C and 150 °C. The vapor phase reaction in both cases possesses an increased rate of reaction versus that of the liquid phase. In all cases, the reactions are likely first-order processes. Equation (4) outlines the most likely reaction process occurring.

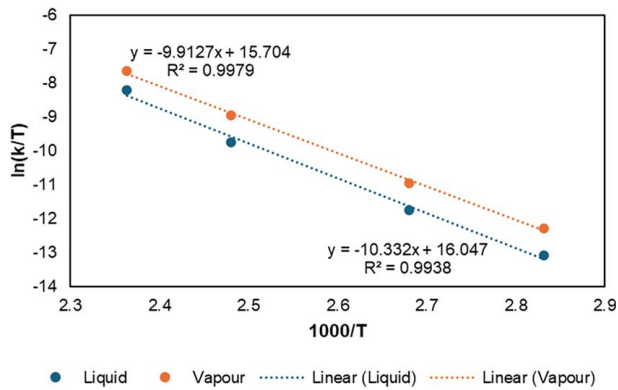
Fig. 13 Eyring plot for liquid and vapor phase EP chemistry reactions at 100–150 °C

corrosion will be the same in both phases. In this case, the vapor phase has an increased corrosion rate (Fig. 13). To estimate the reaction rate at actual motor temperatures, the use of half-life calculations is used. In chemical kinetics, the half-life of a reaction is the time taken for the concentration of a substance to fall to half its initial concentration. Assuming the reaction remains first order,

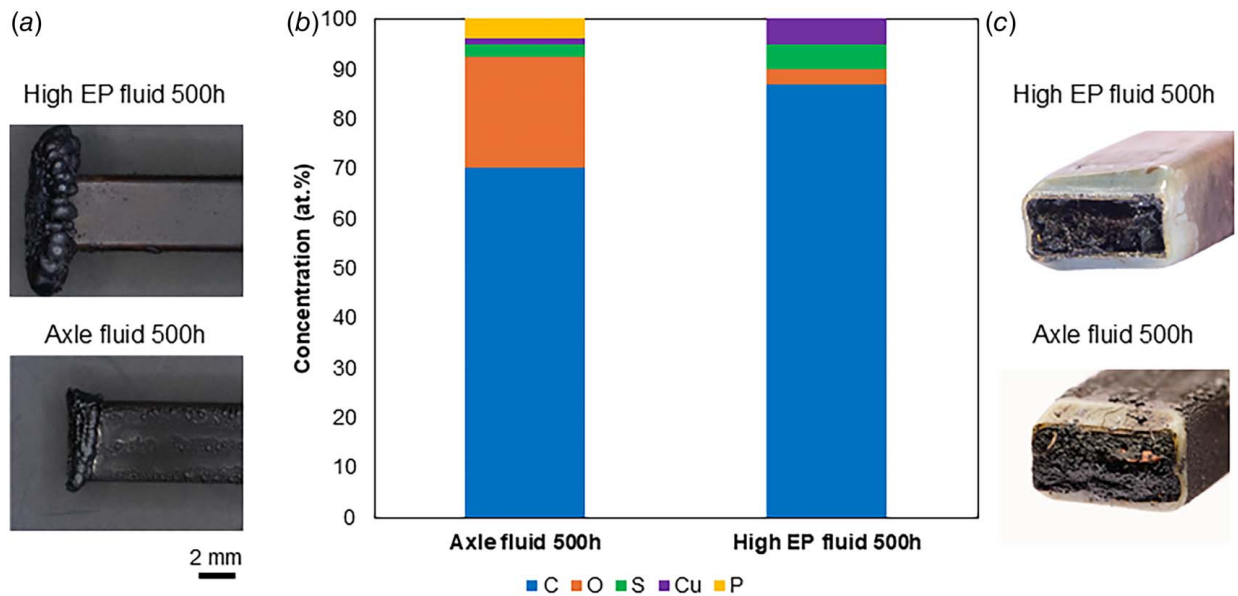
Fig. 18 Solid deposits found at the ends of wires aged in the liquid phase in high active sulfur fluid and axle fluid: (a) images of the deposits, (b) composition of the deposits measured by SEM-EDS, and (c) images of the wire after the deposit was removed

3.2.3.3 Effect of exposed copper in the fluid. The effect of the fluid on the exposed copper was determined from the aged straight wires. In most cases, when copper was exposed both in the liquid and vapor phases it appeared black after aging, however, the copper exposed in eFluid appeared unchanged, indicating good copper corrosion prevention properties of the eFluid. When copper was exposed in the liquid phase in high active sulfur fluid and axle fluid, a solid mass of decomposition products formed outside the end of the wire (Fig. 18(a)). SEM-EDS showed that these solids both contained carbon, oxygen, copper, and sulfur, and in the deposit from the wire aged in axle fluid phosphorus was also present (Fig. 18(b)).

and blackened beneath a gray and intact coating (Fig. 18(c)). When the deposit was removed from the wire aged in high active sulfur fluid, the coating was visibly gray and still intact, however, the copper wire had been damaged for about 2 mm within the coating, leaving a black solid that crumbled when probed (Fig. 18(c)). The copper has likely reacted with sulfur in the fluid to form copper sulfide, removing copper from the wire itself. Conversely, the deposit from the axle fluid did not consume as much copper and only contained 1.3% copper (compared with 5.1% from the high active sulfur fluid) and 2.4% sulfur (compared with 5.0%). Instead, the deposit contained phosphorus and higher levels of oxygen, possibly phosphates or phosphites deposited from the fluid.

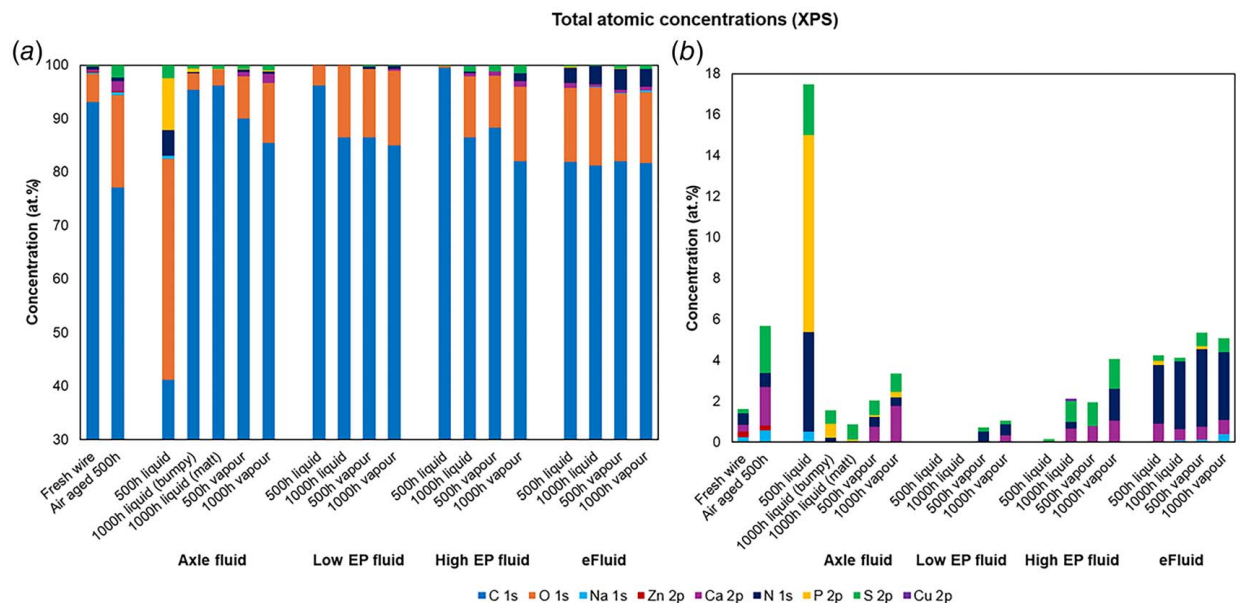
Fig. 19 Composition of the coating surface after aging in various oils, measured by XPS, showing (a) overall composition and (b) composition without carbon and oxygen allowing the other elements to be compared more easily

3.2.3.4 *Composition of deposits on the coating surface.* To assess the composition of the deposits on the coating surfaces after aging, XPS (Fig. 19) and SEM-EDS were used. The results from only the straight wires are presented here for simplicity but are similar to those from the bent wires.

The fresh coating contains primarily carbon and oxygen, with trace amounts of other elements (sodium, zinc, calcium, nitrogen, and sulfur) present. After aging in the air for 500 h, the oxygen concentration increased from 5.3% to 17.3%, and the concentrations of sodium, calcium, and sulfur increased (0.24–0.58%, 0.33–1.89%,

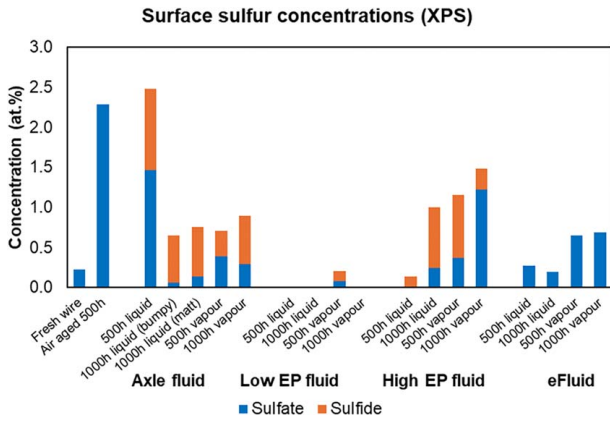
Fig. 20 Coating surface concentrations of sulfate and sulfide, measured by XPS

also yielded sulfide on the coatings ($2p_{3/2}$ peak position 163–164 eV, Fig. 20) [20]. Although copper sulfide formation is expected when active sulfur reacts with copper, no copper was seen on the surface. Therefore, the coating provides suitable protection against copper sulfide formation on the surface when intact under these conditions. Note that copper sulfide may have formed at the interface between the copper and the coating due to fluid penetration into the coating.

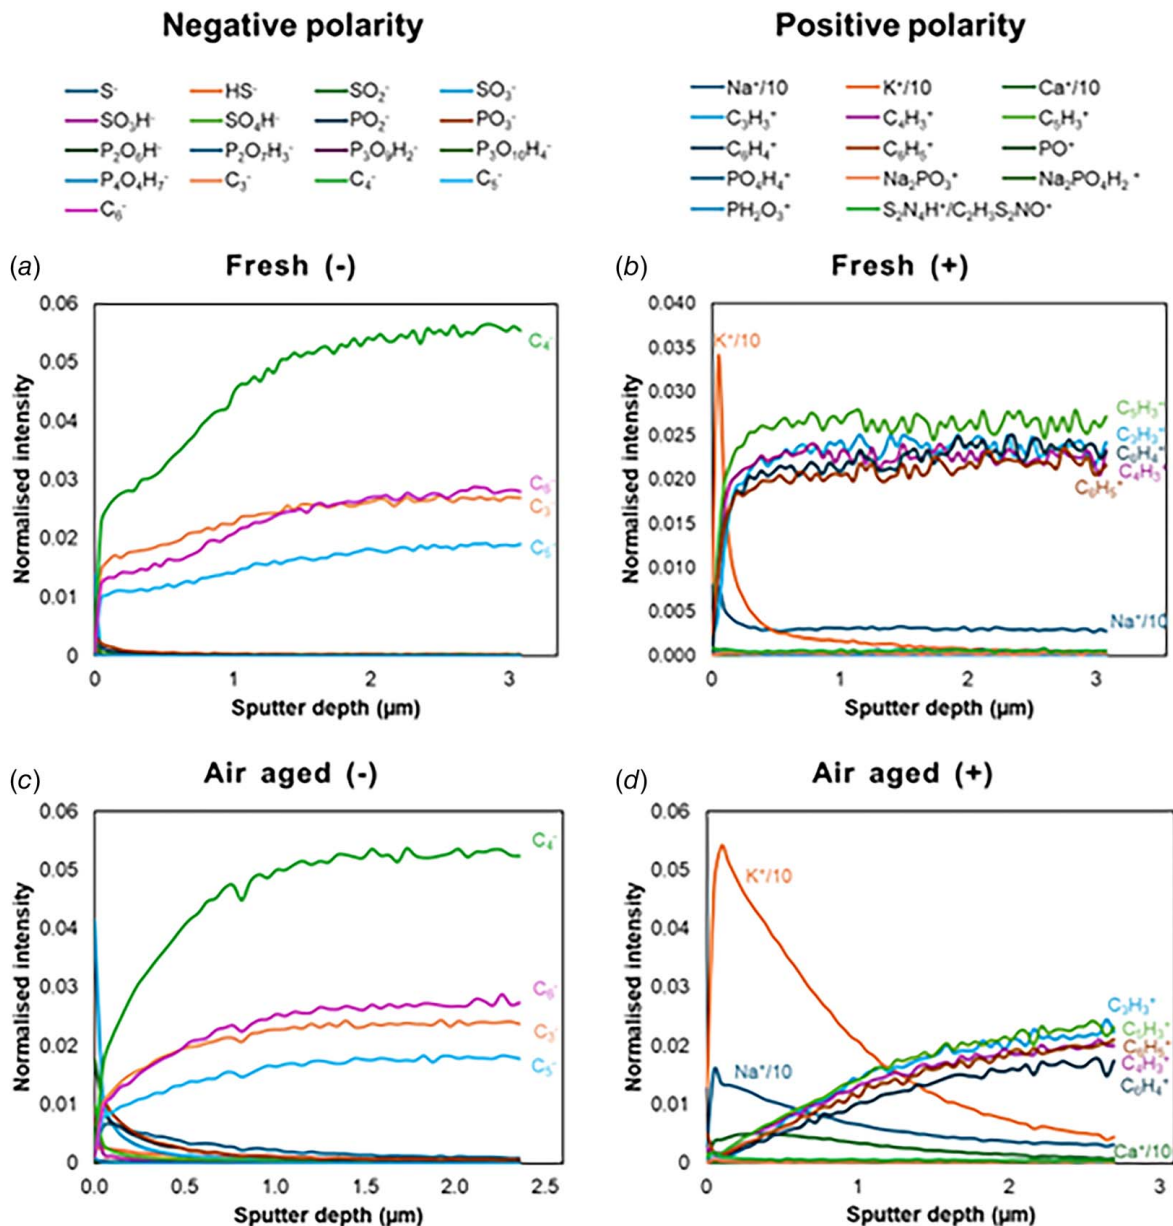
Fig. 21 TOF-SIMS depth profiles for (a) and (b) fresh; and (c) and (d) air-aged coated wires, showing selected ions relating to the polymer and the deposits on the surface. Intensities for Na^+ , K^+ , and Ca^+ have been divided by ten to keep data on a similar scale.

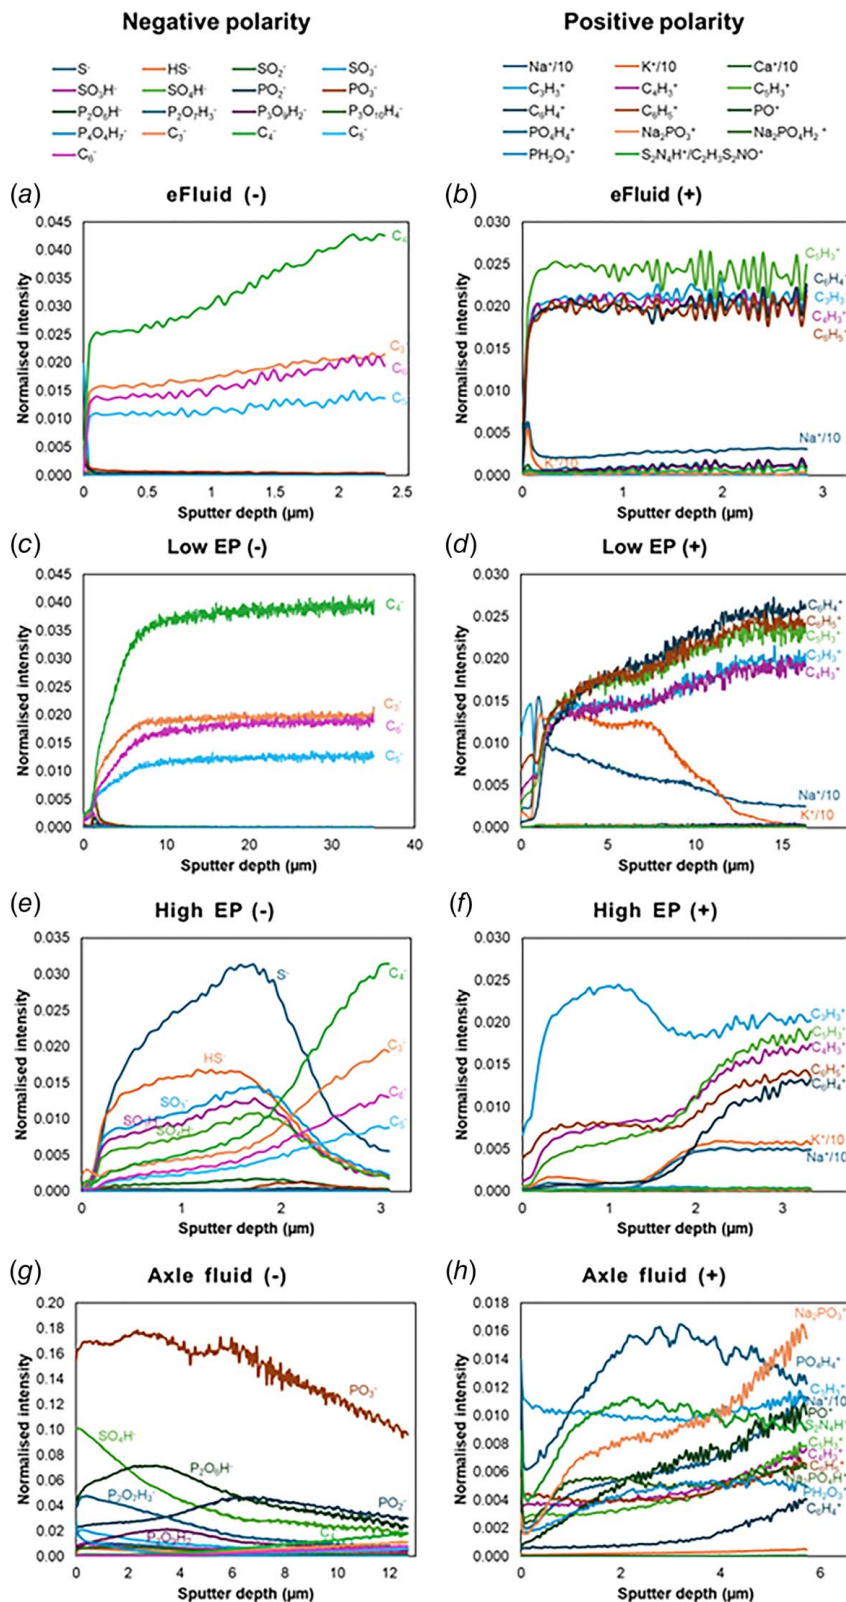
Fig. 22 TOF-SIMS depth profiles for coated wires aged in the four fluids (straight wires in the liquid phase), showing selected ions relating to the polymer and the deposits on the surface. Intensities for Na^+ , K^+ , and Ca^+ have been divided by ten to keep data on a similar scale.

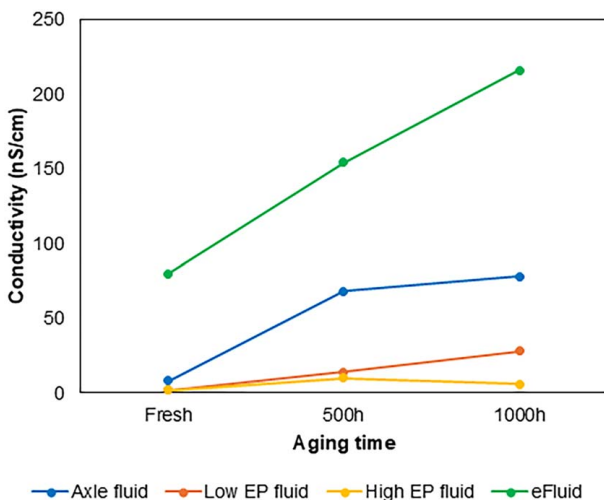
Fig. 23 Conductivity of the fluids after aging with bent wires partially immersed

The conductivity of the fluids typically increased during the test (Fig. 23, measured only on the fluids aged with bent wires). Lubricant formulations can degrade at high temperatures, producing small polar molecules which increase the conductivity of the fluid. Whilst there are measurable differences between the aged fluids, the conductivity of these fluids is still in the static dissipative region and would not be considered conductive [23].
