## Research Paper

# Water quality before and after a campaign of cleaning and disinfecting shallow wells: a study conducted during and after floods in Khyber Pakhtunkhwa, Pakistan

## ABSTRACT

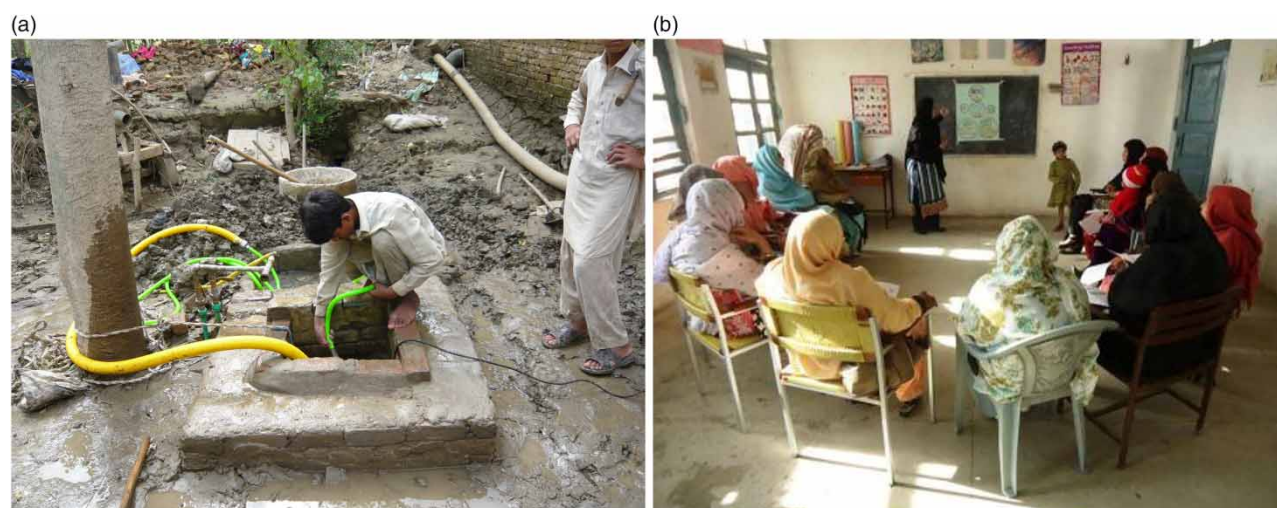
**Figure 1** | (a) 'Hard component' – well cleaning and well-rehabilitation activities after WHO Technical note No. 1 on drinking-water, sanitation and hygiene in emergencies: 'Cleaning and disinfecting wells'. (b) 'Soft component' – hygiene promotion, training of teachers and school children on water and hygiene.

service providers was trained in the management and maintenance of water supply facilities (where available). The two components of the program are illustrated in [Figure 1](#).

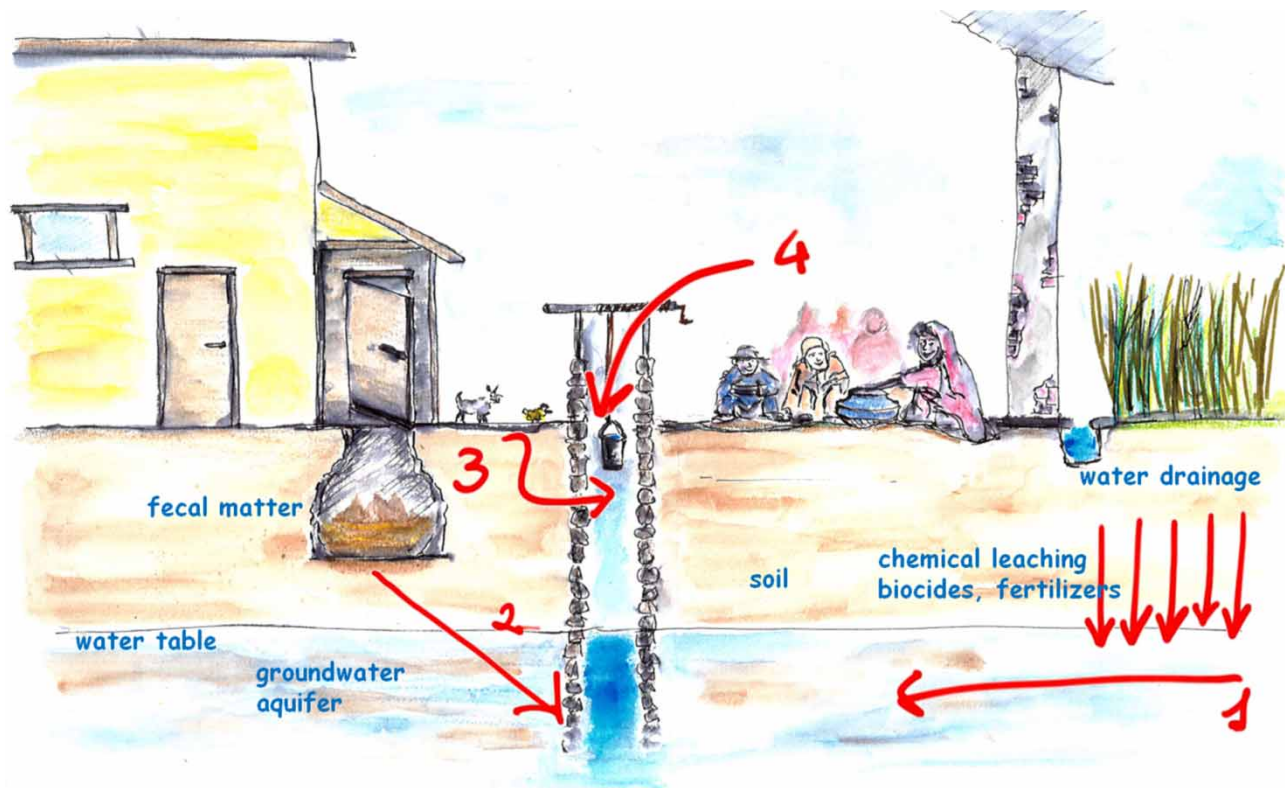
**Figure 4** | Possible paths of contamination (drawing by Pamela Principi, SUPSI).

Various possible paths of contamination of shallow wells were identified (Figure 4): (1) generalized contamination of the groundwater aquifers with agricultural chemical residues; (2) direct contamination with fecal matter; (3) infiltration of surface water in the well due to poor construction, such as the lack of an apron; (4) lack of protection and

hygienically inadequate use of domestic wells: contamination with dirty bucket and/or rope.

In order to minimize risk of contamination, the following recommendations were delivered to the local authorities and to the community: (i) installation of hand pumps where possible; (ii) teaching the 'safe usage of open hand-dug wells' and the safe handling of clean water; (iii) local authorities should be informed and advised in order to take proper preventive actions to address contamination of groundwater with biocides, providing that this study finding is confirmed by a reference laboratory.

Path 1 represents a diffuse contamination of the groundwater with agricultural chemical residues (e.g., biocides). Direct contamination with fecal matter due to the lack of Minimal Safety Distance of latrines (Path 2) and infiltration due to the lack of adequate aprons (Path 3) seem to be important, but Path 4, lack of protection and hygienically inadequate use of domestic wells, seems to be the main source of contamination with fecal matter.
