## Research Paper

# Water quality before and after a campaign of cleaning and disinfecting shallow wells: a study conducted during and after floods in Khyber Pakhtunkhwa, Pakistan

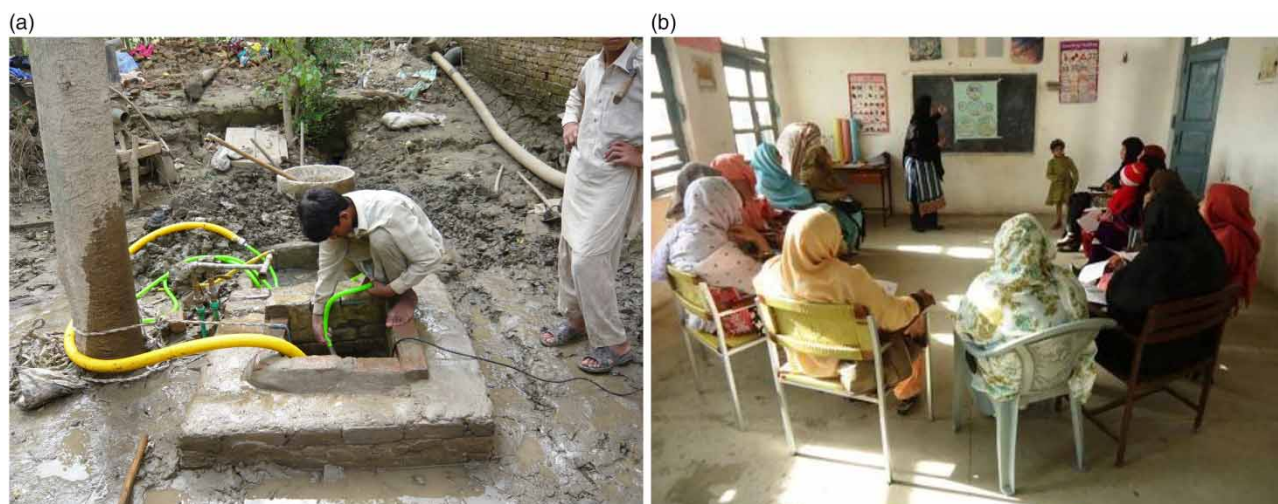
**Figure 1** | (a) 'Hard component' – well cleaning and well-rehabilitation activities after WHO Technical note No. 1 on drinking-water, sanitation and hygiene in emergencies: 'Cleaning and disinfecting wells'. (b) 'Soft component' – hygiene promotion, training of teachers and school children on water and hygiene.

service providers was trained in the management and maintenance of water supply facilities (where available). The two components of the program are illustrated in [Figure 1](#).

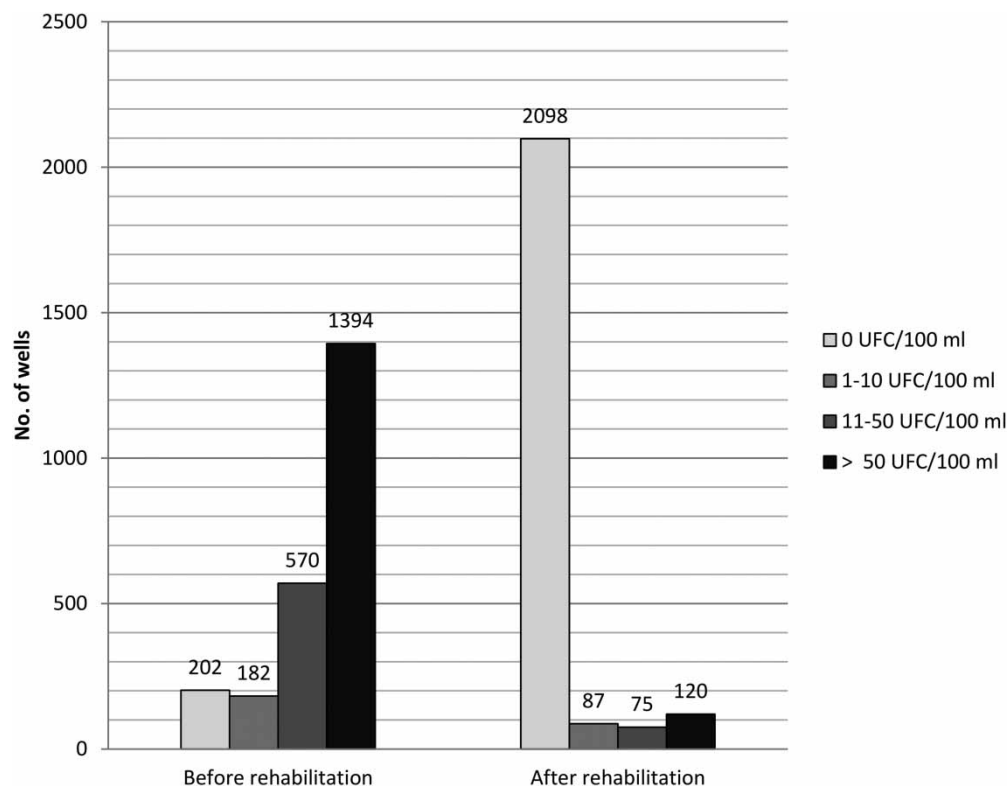
**Figure 2** | Stages of bacteriological analysis: fecal coliforms and/or *E. coli*.

Soon after the flood of 2010, over 4,500 wells were rehabilitated/cleaned, with over half analyzed before ( $n = 2,348$ ) and soon after cleaning ( $n = 2,380$ ). Figure 2 indicates the degree of contamination of wells with fecal coliforms and/or *E. coli* while Table 1 indicates the distribution of wells

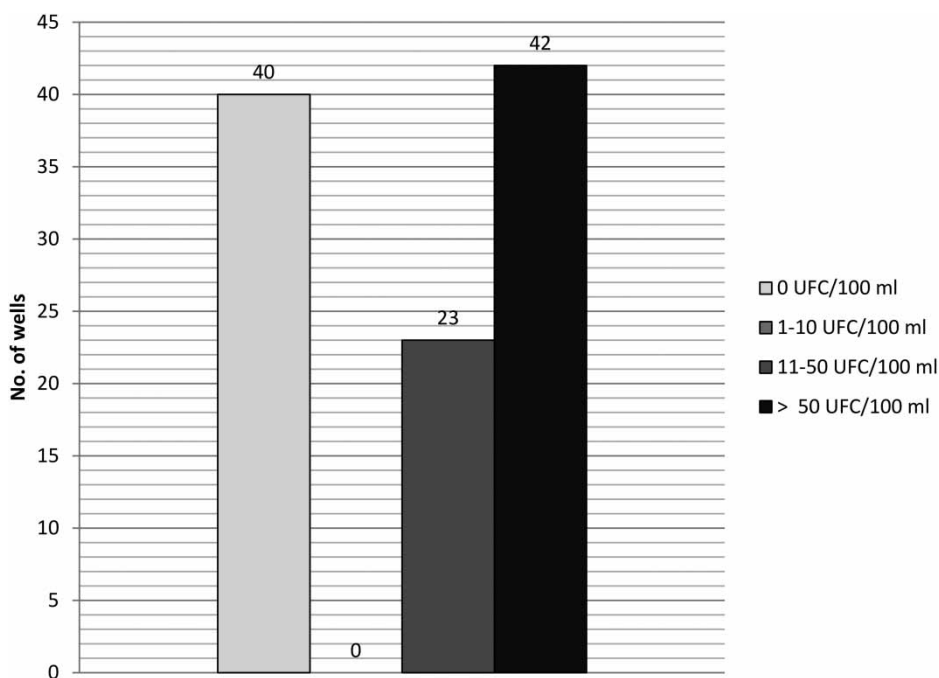
Figure 3 | Bacteriological analysis 2014–15: fecal coliforms and/or *E. coli*.

The distribution of fecal contamination is illustrated in Figure 3. Bacteriological analysis showed a significant presence of bacteria indicating fecal contamination, with roughly 65% of the samples being contaminated. A significant difference was found between wells rehabilitated by the addition of manual pumps as compared to those without manual pumps (see Table 2 below). Wells with manual pumps, implemented in the village of Dildar, presented

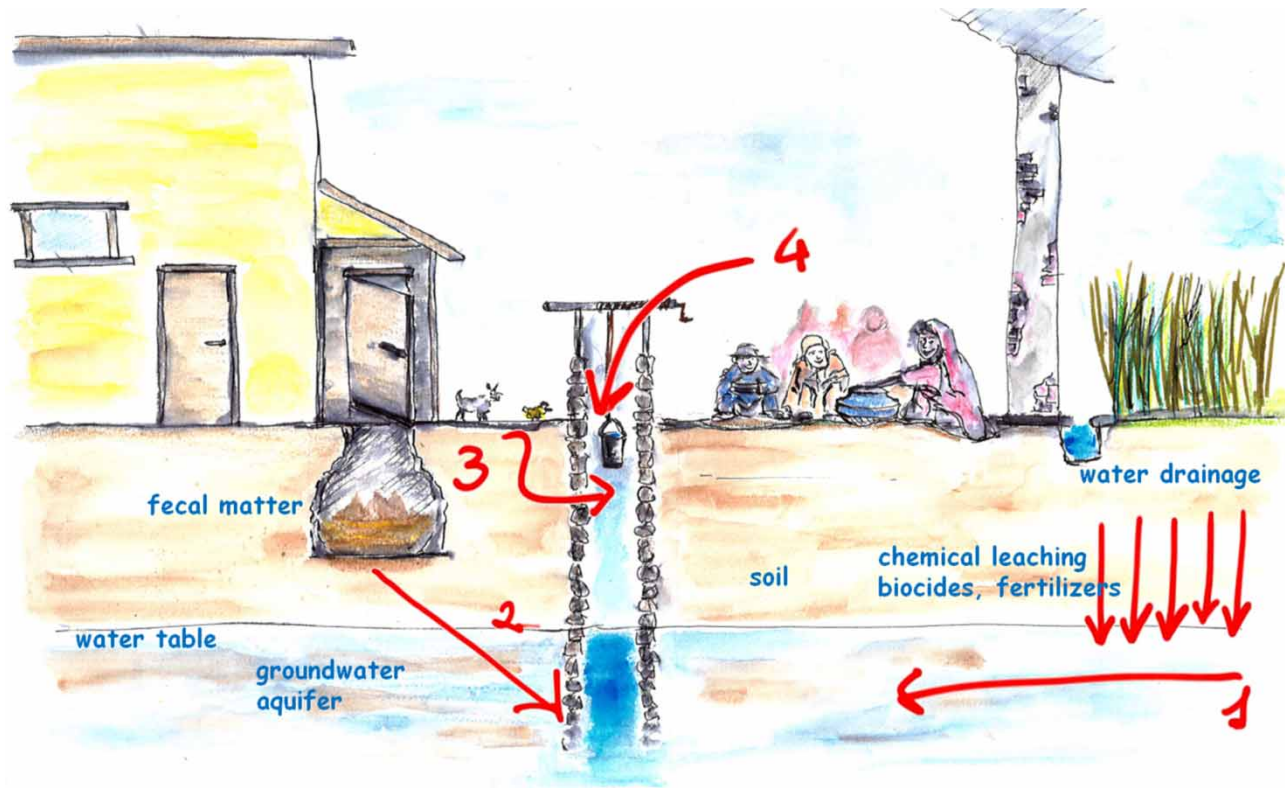
**Figure 4** | Possible paths of contamination (drawing by Pamela Principi, SUPSI).

Various possible paths of contamination of shallow wells were identified (Figure 4): (1) generalized contamination of the groundwater aquifers with agricultural chemical residues; (2) direct contamination with fecal matter; (3) infiltration of surface water in the well due to poor construction, such as the lack of an apron; (4) lack of protection and

hygienically inadequate use of domestic wells: contamination with dirty bucket and/or rope.

Path 1 represents a diffuse contamination of the groundwater with agricultural chemical residues (e.g., biocides). Direct contamination with fecal matter due to the lack of Minimal Safety Distance of latrines (Path 2) and infiltration due to the lack of adequate aprons (Path 3) seem to be important, but Path 4, lack of protection and hygienically inadequate use of domestic wells, seems to be the main source of contamination with fecal matter.
