Design and construction of household ventilated improved pit latrines: gaps between conventional technical guidelines and construction practices in Cape Coast, Ghana

Peter Appiah Obeng^{a,*}, Panin Asirifua Obeng^b and Eric Awere^b

^a Department of Water and Sanitation, University of Cape Coast, Cape Coast, Ghana

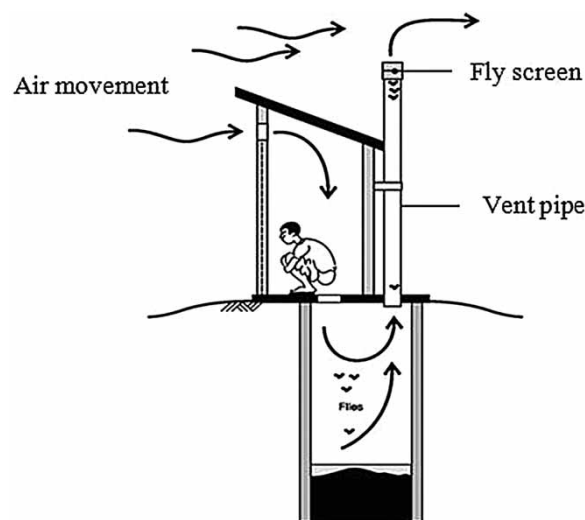
Figure 1 | The ventilation mechanism in a VIP latrine. Source: Harvey *et al.* (2002).

Odour control is achieved through the chimney effect, which allows the circulation of air from the superstructure into the pit via the squat hole and out via the vent pipe (Harvey *et al.* 2002). It is estimated that, a minimum of 10 m³/h of air flow through the vent pipe is required to achieve odourless conditions but 20 m³/h is recommended to ensure an adequate factor of safety (Ryan & Mara 1983a). The vent pipe is also responsible for controlling fly nuisance by directing flies produced in the pit to the external bright light at the top of the pipe where they are prevented from escaping by the insect screen and become dehydrated or fall back into the pit and die eventually (Brikké & Bredero 2003). To achieve optimum performance, a number of technical guidelines and design criteria are to be followed in the design and construction of the superstructure and the vent pipe. The scientific concepts underlying these technical guidelines have been detailed in classical works such as Kalbermatten *et al.* (1980), Ryan & Mara (1983a, 1983b), Mara (1984), among others, and
