Laboratory investigations on the quality of leak tests and visual inspections of wastewater connection pipes carried out by specialist contractors

ABSTRACT

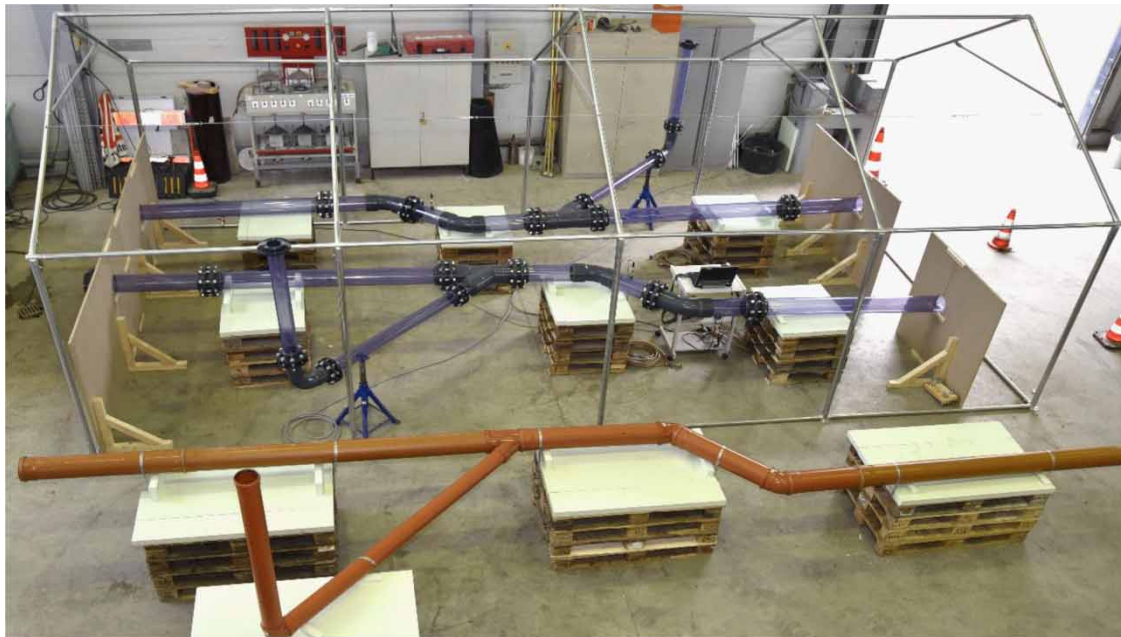
Figure 1 | Test set-up for the tests on the PVC-glass pipes (top) and sketch of the test set-up of the PVC and PVC-glass pipes with dimensioned detailed view of one pipe (bottom).

Two connection lines were constructed from transparent PVC glass (manufacturer: Simona AG) (Figure 1 below, pipes number 1 and 2) in order to visually obtain findings regarding defective shut-off elements, air inclusions during the water pressure test, and so on. A pressure measuring sensor (manufacturer: Sensortechnics GmbH, type: CTE7N01GY6) and a temperature sensor (manufacturer: B+B Thermo-Technik GmbH, type: Pt 1000) were attached to each of these lines, as the physical leak tests were carried out on these lines. The control measurement sensor and the temperature sensor were connected to a notebook (software: LabVIEW) and the time recorded in combination with the pressure as well as the temperature in the connection pipe during the tests. Also the room temperature in the tent was measured and documented.

The two connection pipes made of PVC glass (Figure 1 below, pipes number 1 and 2) were set up in a tent so that the testers could not visually assess the respective pipe conditions. Only the pipe ends were outside the tent to ensure access to the connection pipes.

The third connection pipe installed was made from opaque PVC pipes (Figure 1 bottom, pipe number 3) as in practice. Information required to carry out the leak tests, such as pipe course and length, was determined by visual inspection. The data was then available, for example, for calculating the permissible water addition for the water pressure test and for positioning the shut-off elements. Accordingly, no physical tests were carried out on this connection pipe. This pipeline was covered with a plastic tarpaulin during the inspection.

On the shown model construction of the PVC glass pipes DN 150 and DN 100 with an adjustable and quantifiable leakage opening (Figure 1 bottom, pipes number 1 and 2), tests were carried out taking into account the test specifications for the leakage test procedures by expert testers with their own test equipment.

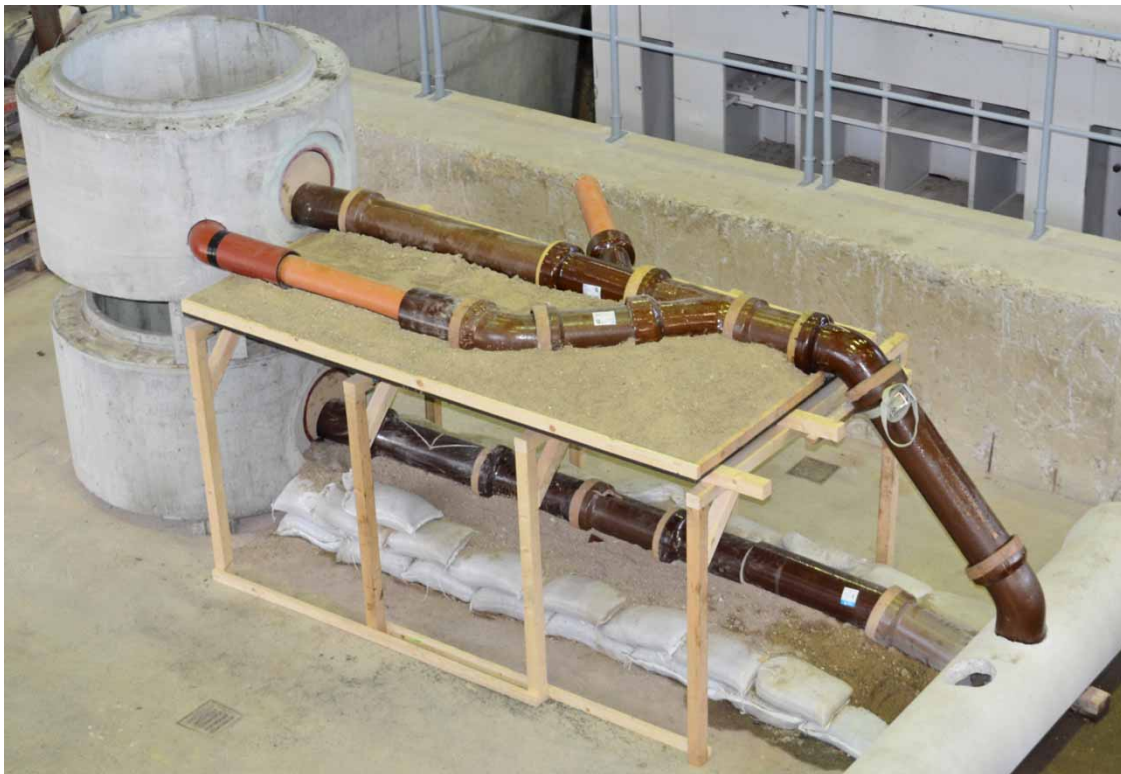
Figure 3 | Connection lines with the lower line to be inspected with four damage patterns.

Investigations on the **visual inspections** took place in a test hall with an area of approximately 6.0 m length and approximately 2.0 m width. Within the scope of this study, a DN 150 pipe string ($L =$ approximately 3.50 m) made of the pipe material clay was constructed on this area and connected to a DN 1000 concrete manhole and a DN 300 concrete main sewer (Figure 3, lower pipe). Four large damage patterns (damage class A) according to the North Rhine-Westphalian image reference catalogue (2014) were attached to this connection pipe made of clay pipe material (Figure 4). This pipe was covered with a plastic tarpaulin, so that the damage patterns were not visually recognisable for the expert testers, as in practice.

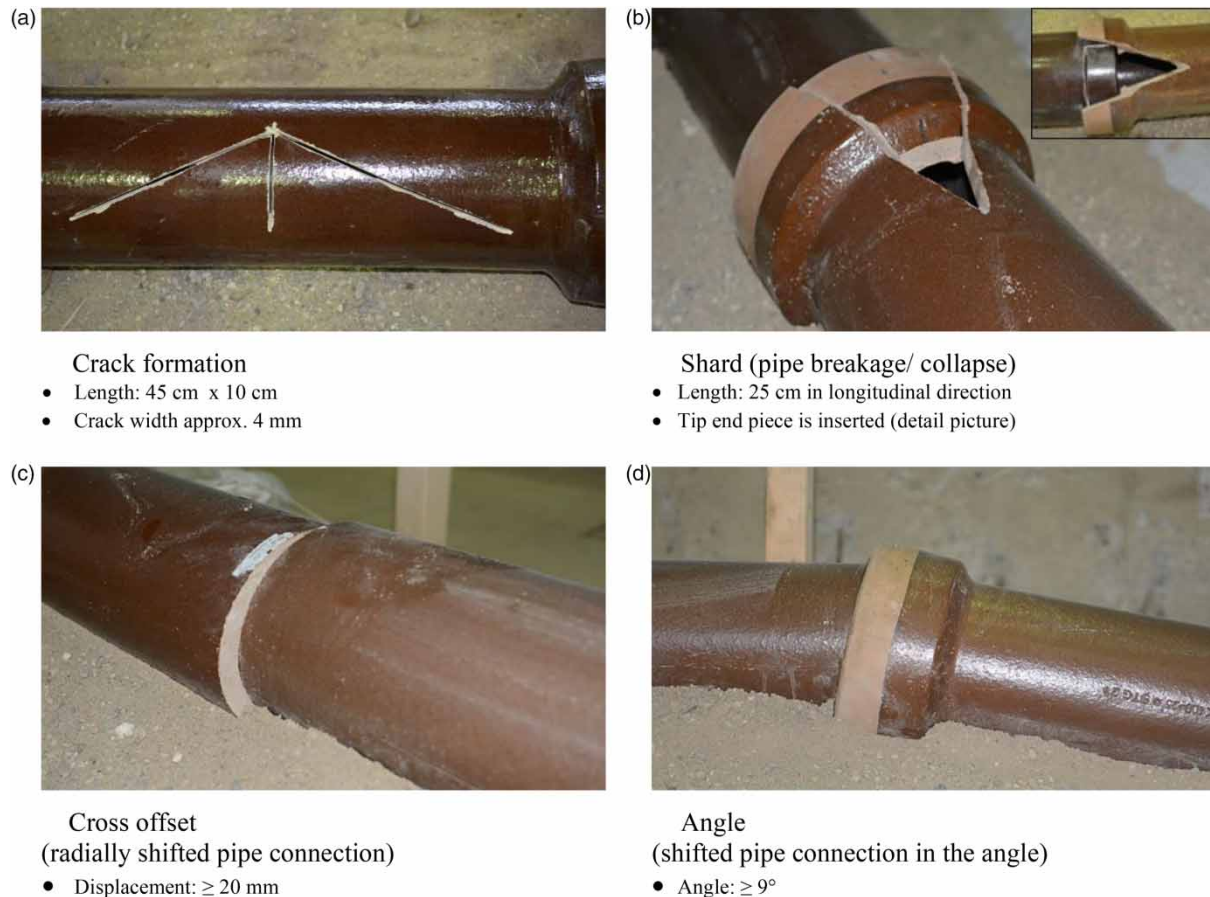
Figure 4 | Built-in large damages (a-d) for performing the visual inspection (Bosseler *et al.* 2018).

The task for the expert testers was to inspect the connecting pipeline using camera technology without groundwater influence and to document the results with regard to damage detection and naming as well as damage classification according to the North Rhine-Westphalian image reference catalogue (2014). The inspection results of the expert testers were compared with the correct inspection results and evaluated. Subsequently, the error rate with regard to damage detection and naming as well as damage classification of the four existing damages was determined in order to determine the quality of the visual inspection. When determining the error rate, incorrect damage detection in an intact pipe was also taken into account.

The results of the damage detection and naming of the four major damages (damage class A) show that 102 of 108 (rate 94%) results are correct. In one of the deficient results, the damage was not detected and in the remaining five deficient results, the damage was detected but incorrectly named. Overall, it could be determined that the damage detection and naming was essentially carried out sufficiently reliably by the expert testers. In comparison, considerable deficits were revealed in the classification of the damage, as only approximately 42% of the classification results were correct. In addition, 10 out of 27 expert testers incorrectly assigned damage to the intact pipe area. In the overall view of all results, there is an overall rate of 67% for correct results.

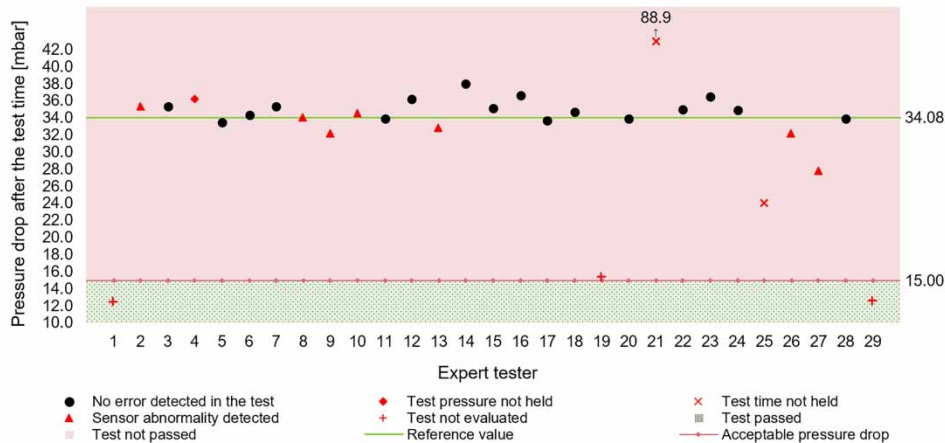
Figure 5 | Observed faults for pipe condition 'Not passed/Leaky' pipe condition with 0.8 mm leakage in air overpressure test according to DIN 1986-30 with test pressure: 100 mbar, test time: 90 s, permissible pressure drop: 15 mbar.

In the **air overpressure test for the pipe condition ‘Not passed/ Leaky’**, 26 of the 29 tests could be evaluated. No faults were observed in 16 of 26 tests (62%). In contrast, the following faults were found in 10 tests (38%):

- 7× Sensor abnormality detected (equipment)
- 2× Test time not held (tester)
- 1× Test pressure not held (tester)

Thus, 70% of the observed errors were caused by the equipment and 30% by the examiner. Three tests (tester no. 1, 19 and 29) could not be evaluated. In tests no. 1 and 29, there was a fault in the test set-up (blockage of the leakage and thus restricted air flow). In the case of tester no. 19, no comparable conditions were present, as the test was automatically terminated prematurely by software after exceeding the permissible limit value. As a result, the permissible pressure drop was exceeded in all 26 assessable tests, so that even with test errors, the correct test result ‘Not passed’ was determined for all observations (Figure 5).

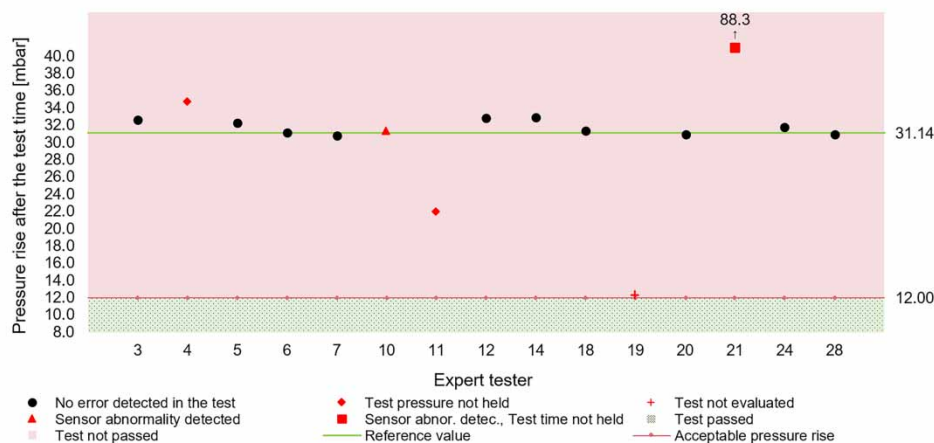
Figure 6 | Observed faults for pipe condition 'Not passed/Leaky' with 0.8 mm leakage in the air underpressure test according to DWA-M 149-6 with test pressure: -100 mbar, test time: 90 s, permissible pressure rise: 12 mbar.

In the **air underpressure test for the pipe condition ‘Not passed/ Leaky’**, 14 of the 15 tests could be evaluated. No faults were observed in 10 of 14 tests (71%). In contrast, the following 5 faults (1 test with two faults, tester no. 21) were found in 4 tests (29%):

- 2x Sensor abnormality detected (equipment)
- 2x Test pressure not held (tester)
- 1x Test time not held (tester)

Thus, 60% of the observed errors were caused by the tester and 40% by the equipment. One test (tester no. 19) could not be evaluated because of no comparable conditions (test ended automatically prematurely). The air

underpressure tests could only be offered by 15 out of 29 requested expert testers, as this test is comparatively rarely carried out in practice. As a result, the permissible pressure increase was exceeded in all 14 tests that could be evaluated, so that even with test errors, the correct test result 'Not passed' was determined for all observations (Figure 6).

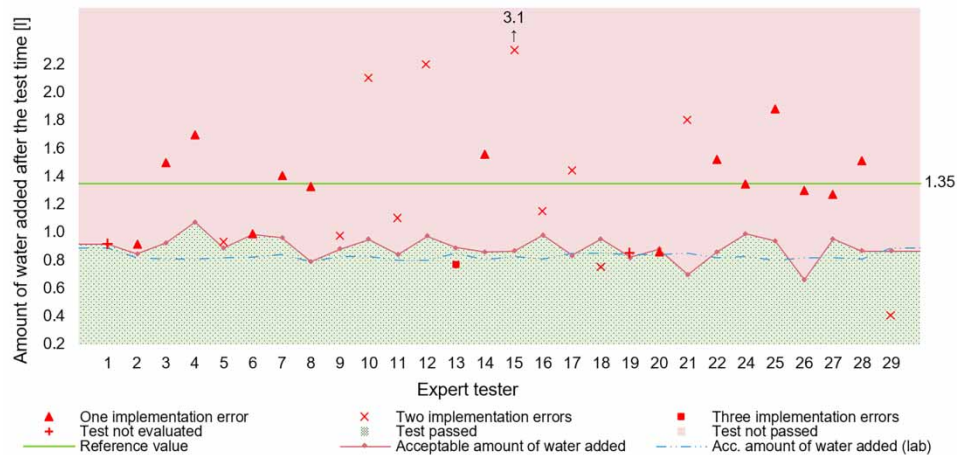
Figure 7 | Observed faults for pipe condition ‘Not passed/ Leaky’ with 0.8 mm leakage during water pressure test according to DIN 1986-30 with test pressure: 50 mbar, test time: 900 s, permissible water addition: variable, depending on wetted inner pipe surface.

In the **water pressure test for the pipe condition 'Not passed/Leaky'**, 26 of the 28 tests could be evaluated. Test errors were observed in 26 tests (100%). In 12 tests, more than one error was identified during the test. The test errors observed are shown below:

- 24x Test pressure not held (tester)
- 10x Incorrect determination of the water addition value (tester)
- 4x Test time not held (tester)
- 1x Leak in the test system (running behind the shut-off element) (tester)

Thus, 100% of the observed errors were caused by the examiner. Two tests (testers no. 1 and 19) could not be evaluated. In test no. 1 there was an error in the test set-up (simulated leakage closed too early) and in test no. 19 there were no comparable conditions (test ended automatically prematurely). As a result, in 22 of 26 assessable tests the water addition value was higher than the permissible water addition value, so that the pipe was correctly tested as 'Not passed'. In contrast, in four tests (testers 13, 18, 20, 29, Figure 7) the permissible water addition value was not exceeded, so that the leaking pipe was assessed as 'passed'. In the overall view, the correct test result 'Not passed' was determined, albeit with test errors, at 85% (Figure 7).

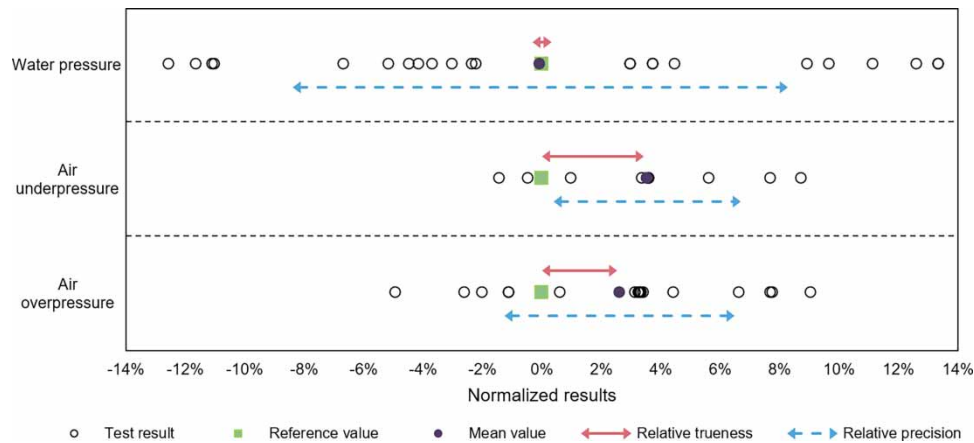
Figure 8 | Representation of accuracy (trueness and precision).

In order to be able to compare the different leak test methods with each other, the measured values were standardised. Subsequently, the precision and trueness were calculated in order to be able to make a statement about the accuracy of the leak test methods. To determine the relative precision, the coefficient of variation, the normed standard deviation, was identified and on this basis the relative precision for the individual methods was determined. With relative precision, the smaller the value or the shorter the arrow (blue dashed line), the more precise the test procedure (Figure 8). The trueness is determined by finding the distance from the assigned value (green square) to the mean values of the expert values (black circle). For relative accuracy, the smaller the value or the shorter the arrow (red), the more accurate the test procedure (Figure 8).

The investigations on the different leak test methods (Figure 8) showed that the air underpressure test provides the most precise result with 3.2%, followed by the air overpressure test with 3.9%. In contrast, the water pressure

test was found to have a relative precision of 8.3%. In terms of trueness, it could be seen that the best result was achieved with the water pressure test with 0.1%. A trueness of 2.5% was determined for the air overpressure test and 3.4% for the air underpressure test.

For leak test methods, there is no definition of the precision and accuracy that is still acceptable. Various limits of up to 15% (Kromidas 2011) or even 16.5% (Eurostat 2013) are discussed for different areas of application. In this case, the value for environmental analysis of 15% is used. Accordingly, a method (test procedure) is generally classified as sufficient if the determined value is a maximum of 15%. As a result, the values determined for all three methods were below 15% in terms of both precision and accuracy. Based on the test results, all leak test methods are therefore assessed as sufficiently accurate.
