## Quality deterioration of an Indian urban water source near an open dumping site

### ABSTRACT

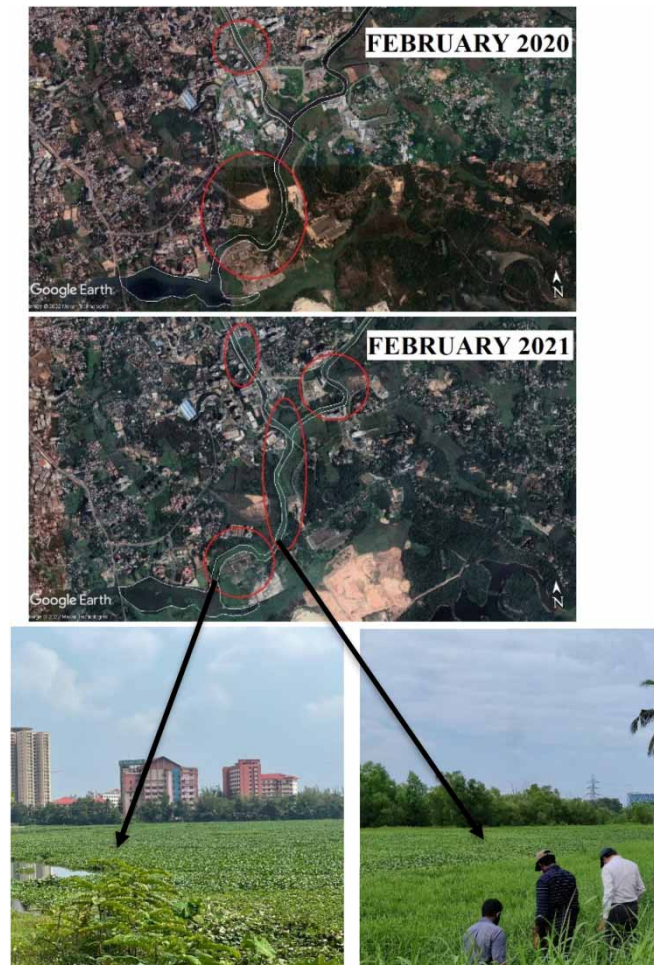
**Figure 3** | Infestation of water hyacinth in the river.

a river, affecting the water quality parameters of the river. The condition of the river in 2021 with the water hyacinth cover is given in [Figure 3](#) compared with 2020.

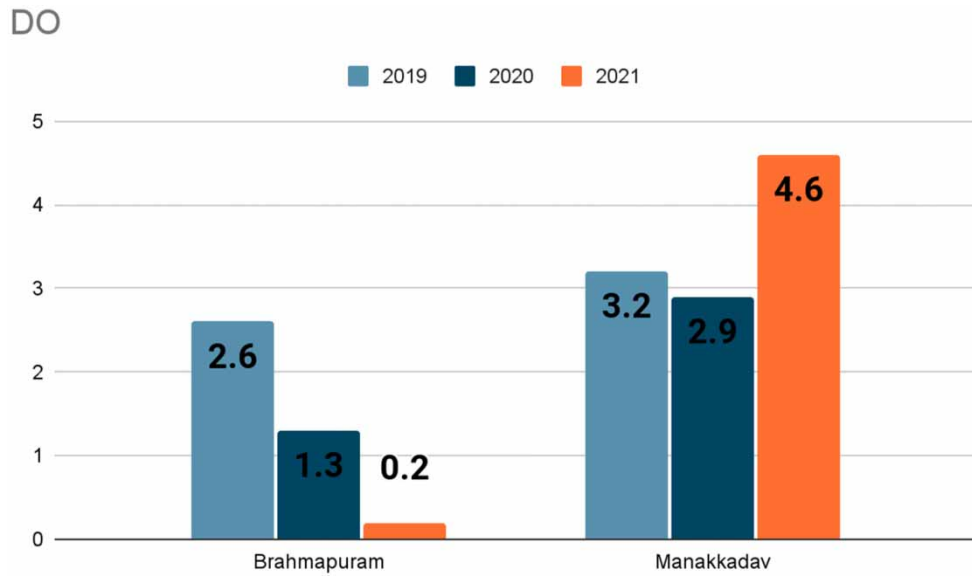
**Figure 5** | Trend of DO levels in River Kadambayar from 2019 to 2021.

The highest reported value of 4.6 mg/L is at station S8 Manakkakadav, located upstream ([Figure 5](#)). The DO levels decreased toward Brahmapuram, which is located downstream. At station S7, located at the Edachira drain, which joins the river, the DO value is 0 mg/L, and station S1 downstream is reported to be 0.2 mg/L. The trend in the DO values of the river over the years is shown in [Figure 5](#). The DO levels showed a decreasing trend downstream of the river (toward station S0) from a DO value of 2.6 mg/L in 2019 to 0.2 mg/L. However, upstream of the river, there is an improvement in the DO value from 2.9 in 2020 to 4.6 mg/L in 2021 ([Action Plan for Rejuvenation 2018](#)).

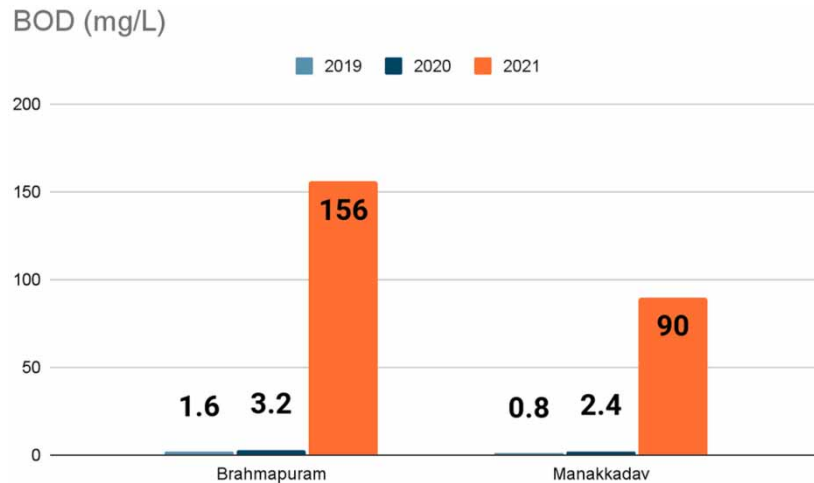
**Figure 7** | Trend of BOD levels in River Kadambrayar from 2019 to 2021.

BOD directly affects DO levels in water bodies. Oxygen is rapidly depleted when the BOD is higher in the stream, which threatens the survival of flora and fauna in the ecosystem. The variation in BOD in the river is shown in [Figure 7](#). The highest value reported was 228 mg/L at Station 4, located downstream near the open dumping site. At station S8, located upstream of the BOD, it was found to be 90 mg/L, and at station S7 in the Edachira drain, it was 114 mg/L. The lowest value of 9.8 mg/L was reported at station S1, located

downstream. As per IS 2296:1992 (BIS 1992) for Class B rivers categorized for outdoor bathing purposes, the BOD for 5 days at 20 °C should be 3 mg/L or less. However, at all stations, the BOD values were found to be higher than the standard limits (Figure 6). A drastic increasing trend is shown for the BOD values in the river both upstream and downstream of the river concerning the previous 3 years' values (Figure 7). The BOD at Brahmapuram downstream increased about 48.75 times in 2021 and at Manakkadavu there was an increase of about 37.5 times than in 2020 (Action Plan for Rejuvenation 2018).

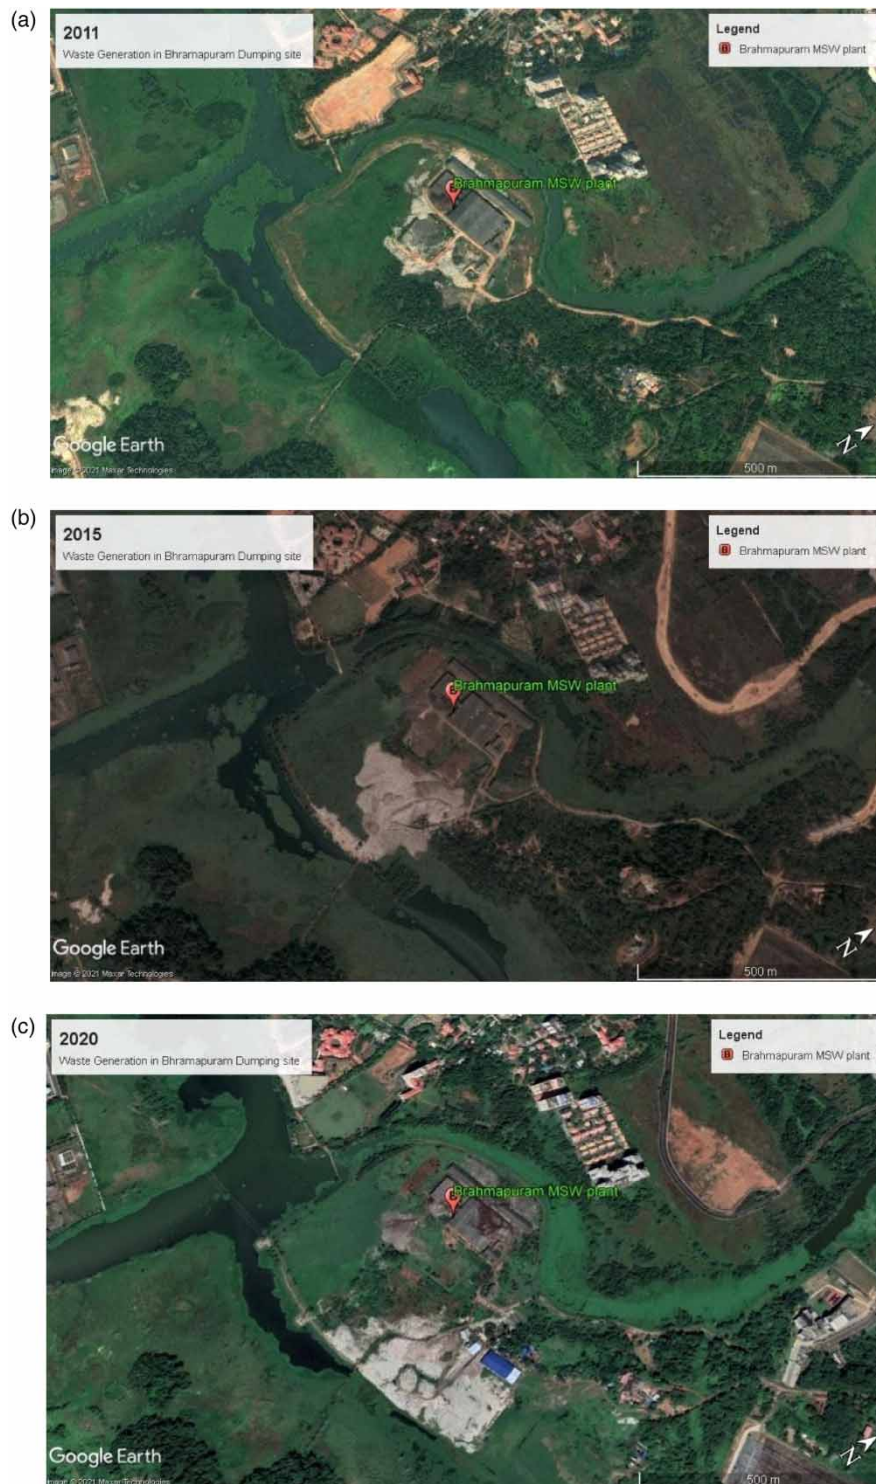
**Figure 9** | The increase in the waste generation (shown in white) in the Brahmapuram dumping site over years (a) 2011, (b) 2015, and (c) 2020 (Google Earth).

questionnaire survey conducted within a 5 km radius of the Brahmapuram plant, human health and the water environment near the plant are adversely affected. The increase in waste generation in the Brahmapuram Open dumping site is shown in Figure 9 (City Sanitation Plan for Kochi-Status Report 2010; Hridya *et al.* 2016; Arunbabu *et al.* 2017; Final EIA/EMP Report GJ Eco Power Private Limited 2019; Kerala Solid Waste Management Project Report 2020; Detailed Project Report, River Rejuvenation Committee 2021).
