Borehole water: a potential health risk to rural communities in South Africa

S. Taonameso, L. S. Mudau, A. N. Traoré and N. Potgieter

doi: 10.2166/ws.2018.030

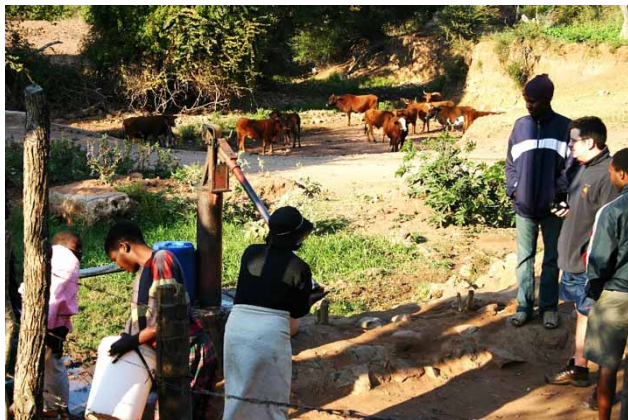
Figure 3 | Animals close to borehole.

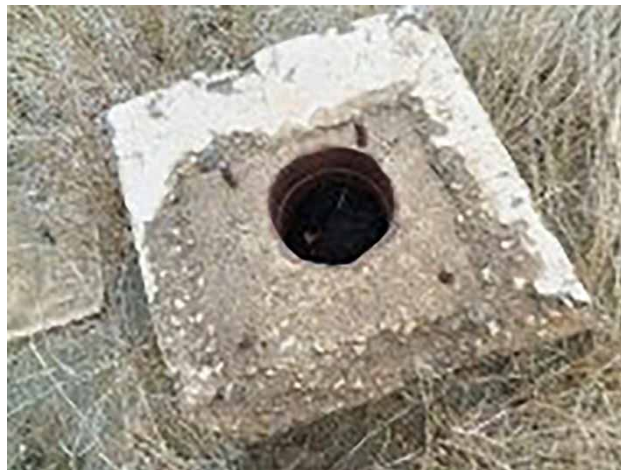
Figure 5 | Abandoned borehole; main hole destroyed.

Abandoned wells (Figure 5) are directly linked to aquifers and can channel harmful materials such as sewage, pesticides, fertilizer, toxic chemicals, and bacteria from the land surface into aquifers as they provide a good preferential

flow pathway to these contaminants (Nguyen *et al.* 2006). A preferential flow pathway is a short cut that a contaminant can take from the surface to the groundwater, or to an abstraction point. This means that the contaminants take much less time to reach the groundwater or abstraction point, than they would if the contaminants were to travel through undisturbed soils, sub soils and underlying bedrock (WHO 2004). Illegal dumping of waste material in these open main holes is a source of contamination of the aquifers. During the survey, many open abandoned boreholes were identified. Abandoned wells are not difficult to seal properly, but many remained open. Because of their large number and wide distribution, abandoned wells pose a significant threat to local ground water supplies (Mawdsley *et al.* 1995; ADEM 2001). When a well is no longer useful, it should not simply be left as an open hole because it is a threat to the environment (Cool *et al.* 2003; Onda *et al.* 2012).

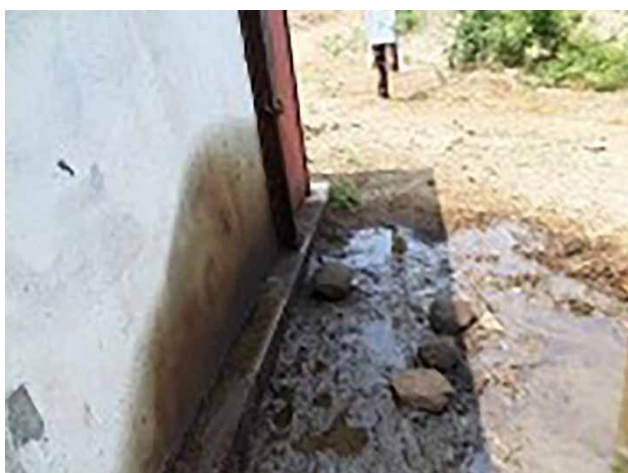
Figure 4 | Stagnant water around borehole.

The water point status for the borehole in Doveni is similar to that observed in Dididi where stagnant water accumulated around the borehole enabling underground contamination through seepage. Stagnant water, (Figure 4) found next to or upslope of boreholes, wells and springs has the potential to contaminate the water source (Nguyen *et al.* 2006). The penetration of surface water carrying animal waste or sewage to groundwater abstraction wells could lead to gastrointestinal illnesses as faecal material could carry various pathogenic microbes.
