Borehole water: a potential health risk to rural communities in South Africa

S. Taonameso, L. S. Mudau, A. N. Traoré and N. Potgieter

doi: 10.2166/ws.2018.030

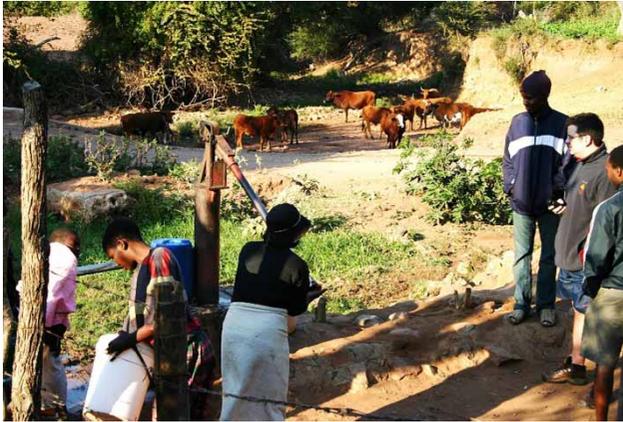
Figure 3 | Animals close to borehole.

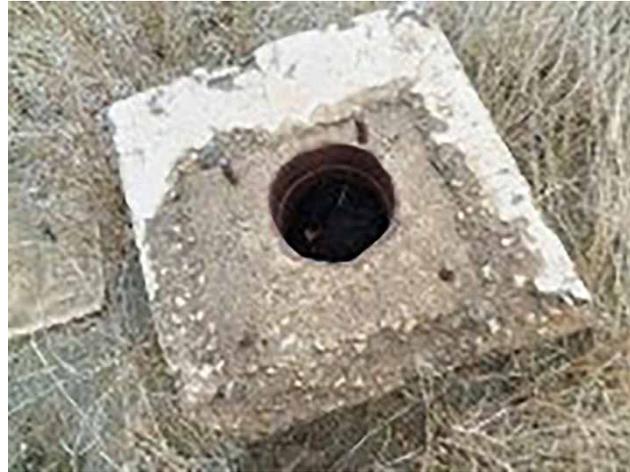
Figure 5 | Abandoned borehole; main hole destroyed.

Abandoned wells (Figure 5) are directly linked to aquifers and can channel harmful materials such as sewage, pesticides, fertilizer, toxic chemicals, and bacteria from the land surface into aquifers as they provide a good preferential

flow pathway to these contaminants (Nguyen *et al.* 2006). A preferential flow pathway is a short cut that a contaminant can take from the surface to the groundwater, or to an abstraction point. This means that the contaminants take much less time to reach the groundwater or abstraction point, than they would if the contaminants were to travel through undisturbed soils, sub soils and underlying bedrock (WHO 2004). Illegal dumping of waste material in these open main holes is a source of contamination of the aquifers. During the survey, many open abandoned boreholes were identified. Abandoned wells are not difficult to seal properly, but many remained open. Because of their large number and wide distribution, abandoned wells pose a significant threat to local ground water supplies (Mawdsley *et al.* 1995; ADEM 2001). When a well is no longer useful, it should not simply be left as an open hole because it is a threat to the environment (Cool *et al.* 2003; Onda *et al.* 2012).

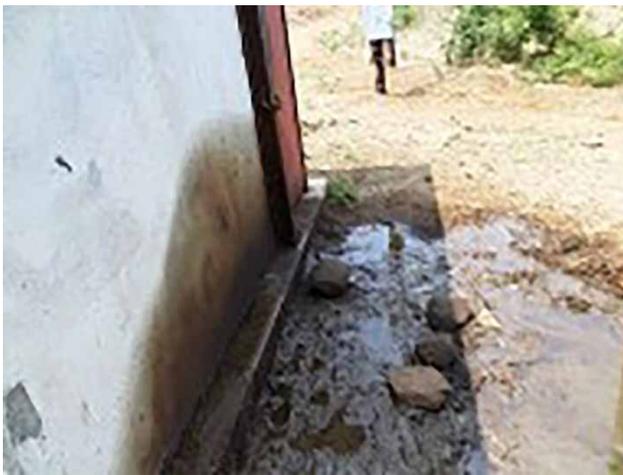
The water point status for the borehole in Doveni is similar to that observed in Dididi where stagnant water accumulated around the borehole enabling underground contamination through seepage. Stagnant water, (Figure 4) found next to or upslope of boreholes, wells and springs has the potential to contaminate the water source (Nguyen *et al.* 2006). The penetration of surface water carrying animal waste or sewage to groundwater abstraction wells could lead to gastrointestinal illnesses as faecal material could carry various pathogenic microbes.

Figure 4 | Stagnant water around borehole.
