## Borehole water: a potential health risk to rural communities in South Africa

### ABSTRACT

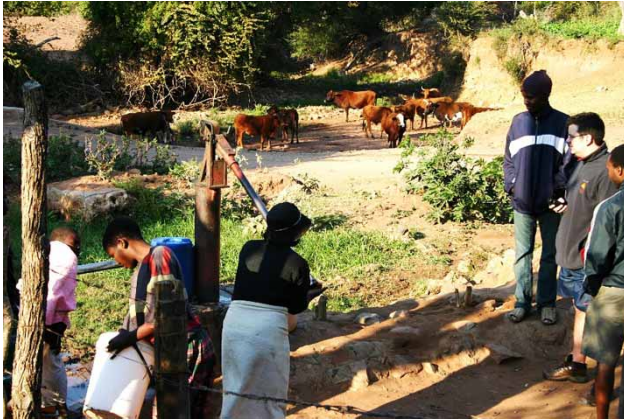
**Figure 3** | Animals close to borehole.

conducted in Libya using molecular identification, *E. coli* isolates cultured from 243 diarrhoeal stool samples obtained from children and 50 water samples showed 1.2% of the diarrhoeal cases were identified as EPEC, 3.3% were ETEC but EHEC was not detected (Ali *et al.* 2012). In a similar study, Varga and co-workers in Tanzania reported that diarrheagenic *E. coli* (35.7%) was the most isolated enteropathogens and was predominated by Enteroaggregative *E. coli* (EAEC), ETEC (9.3%) and EPEC (5.3%) (Varga *et al.* 2004). The contamination of the borehole water in Dididi is most probably a result of a swampy area observed around the borehole. A broken distribution water pipe conveyed water to the reservoir could be the main cause of contamination. Stagnant water accumulated next to the borehole was a drinking source for community livestock (Figure 3). Animal faeces were also observed and might be the source of pathogenic *E. coli* strains (Table 3). According to Todar (2008) dairy and beef cattle are primary reservoirs of *E. coli* (EHEC) serotype 0157:H7 which causes bloody diarrhoea and they carry it asymptotically and shed it in faeces. The review by Onda *et al.* (2012) indicated that unprotected wells without sanitary protection are capable of causing groundwater contamination. It is reported that groundwater resources are at less risk of being contaminated by animal faeces when livestock densities are low or when livestock are spread out over a wide area of land (DWAF 2004).

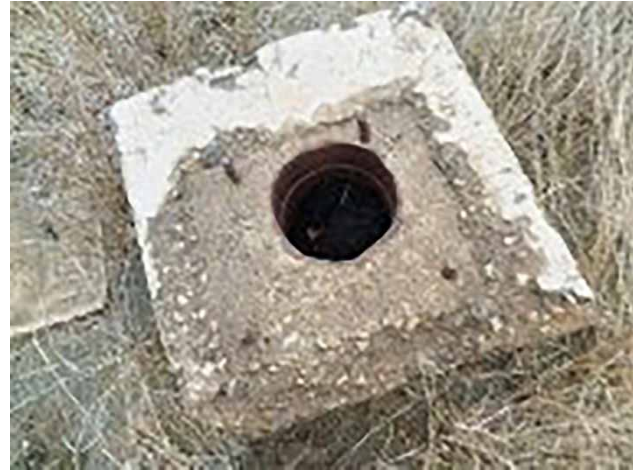
**Figure 5** | Abandoned borehole; main hole destroyed.

Abandoned wells (Figure 5) are directly linked to aquifers and can channel harmful materials such as sewage, pesticides, fertilizer, toxic chemicals, and bacteria from the land surface into aquifers as they provide a good preferential

flow pathway to these contaminants (Nguyen *et al.* 2006). A preferential flow pathway is a short cut that a contaminant can take from the surface to the groundwater, or to an abstraction point. This means that the contaminants take much less time to reach the groundwater or abstraction point, than they would if the contaminants were to travel through undisturbed soils, sub soils and underlying bedrock (WHO 2004). Illegal dumping of waste material in these open main holes is a source of contamination of the aquifers. During the survey, many open abandoned boreholes were identified. Abandoned wells are not difficult to seal properly, but many remained open. Because of their large number and wide distribution, abandoned wells pose a significant threat to local ground water supplies (Mawdsley *et al.* 1995; ADEM 2001). When a well is no longer useful, it should not simply be left as an open hole because it is a threat to the environment (Cool *et al.* 2003; Onda *et al.* 2012).

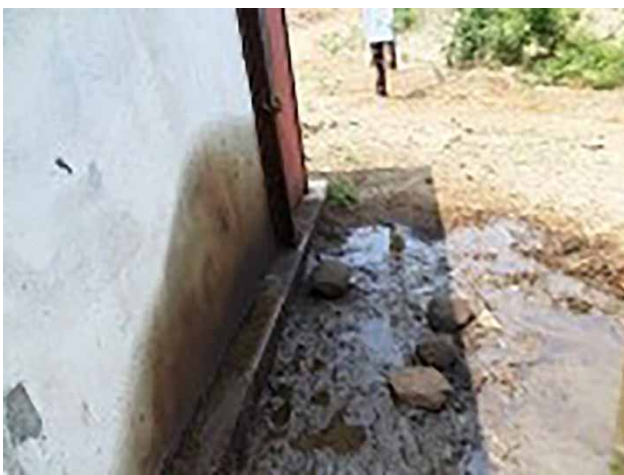
The water point status for the borehole in Doveni is similar to that observed in Dididi where stagnant water accumulated around the borehole enabling underground contamination through seepage. Stagnant water, (Figure 4) found next to or upslope of boreholes, wells and springs has the potential to contaminate the water source (Nguyen *et al.* 2006). The penetration of surface water carrying animal waste or sewage to groundwater abstraction wells could lead to gastrointestinal illnesses as faecal material could carry various pathogenic microbes.

**Figure 4** | Stagnant water around borehole.
