River rehabilitation in urban areas – restrictions, possibilities and positive results

Michael Weyand and Ludgerus Rullich

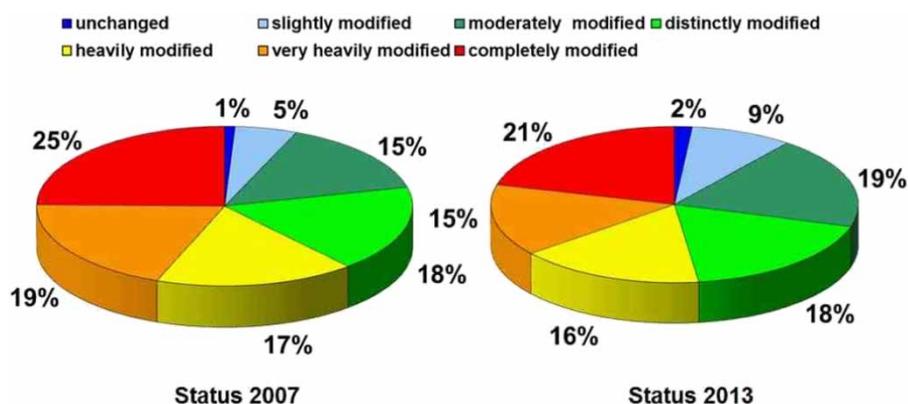
Figure 1 | Percentage of hydromorphological classification of rivers in the western part of the Ruhr River Basin.

The status of most water bodies located in the Rhine-Ruhr region still reflects the above described situation. Historically, the Rhine-Ruhr region has experienced enormous pressure on its water resources due primarily to the high level of urbanisation and industrialisation. Despite fundamental structural change the Ruhr area has undergone since the peak of industrialization, the region continues to be characterised by high population density. Thus, it is no surprise that almost all water bodies, in particular the smaller ones in the urbanised zones, have been heavily regulated, reshaped and confined in concrete channels. Numerous water bodies in this region have been classified at level 5 or higher on the scale from 1 (unchanged) to 7 (completely modified) in the assessment of the hydromorphological water status ([Landesumweltamt 1998](#)). Only to the south of the Ruhr River do some less modified and more natural river stretches still exist. This situation is more or less ongoing, although some efforts to improve river morphology have begun (see [Figure 1](#)).

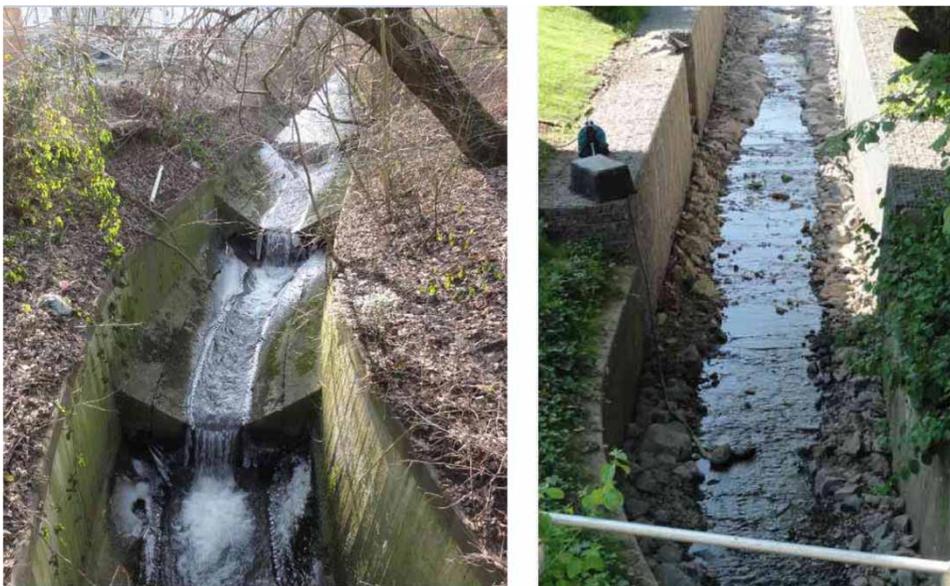
Figure 2 | Existing drop structure (left) and new river course at the former drop structure (right).

However, only 150 metres downstream of this 'new' river stretch, a big drop structure with a subsequent long culvert disrupted the continuity of Sprockhoevel creek (see [Figure 2](#)). Thus, the next step of the agreed implementation procedure was the removal of that obstacle. Just

above the drop structure, the course of the water body was heavily narrowed by the adjacent housing on the left side and its bottom was reinforced with placed stones. The first thoughts of re-designing the river course at that section included the use of a nearby un-farmed meadow on the right side of the river suitable for bypassing the large drop structure via a natural little creek. But when discussing that idea with the staff of the city of Sprockhoevel responsible for river maintenance, it was learned that this area had been sold as a building plot to a property developer a few months previously. The new plot boundaries were drawn at the existing embankments and to further complicate matters, additionally raised by one metre. Thus, the only remaining solution was the development of a new structure within the longitudinal axis of the river. Construction of the new river bed was only possible within the limited given space and using the river itself as a construction site. This led to frequent interruptions, especially during flood periods, and an extension of the construction period.

Fortunately, the existing culvert was oversized for the given maximum runoff in the river. As the bottom of the culvert could be raised by 0.7 metres, the remaining height to overcome was decreased to 1.4 metres. In the area just before entering the culvert, the existing supporting walls

made of concrete remained for structural and static reasons. The subsequent banks near the buildings had to be secured with heavy weighted walls in the form of gabions. The original river bottom was removed and replaced by natural substrates. After completion of work, the Sprockhoevel creek consisted of over 200 m of natural river structure, which made it possible for fish to migrate and rest in specially created pools (see [Figure 2](#)).

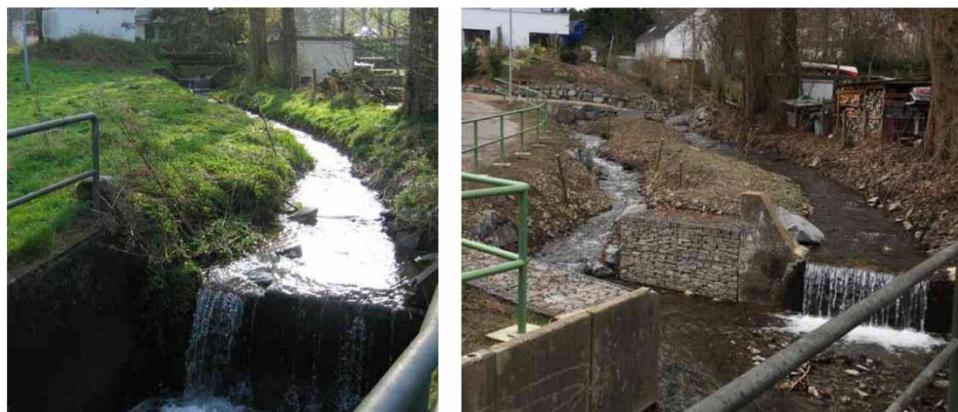
Figure 3 | Restoration of river continuity at an existing drop structure (left) by bypassing it via a new water course (right).

The last step was the removal of a drop structure two meters in height in the upstream part of the urban section of the Sprockhoevel creek. Due to the limited space, a bypass water course was created to receive all discharges up to the long term statistical flow of 330 days of a year (see [Figure 3](#)). Every drop of water exceeding that value is drained via the old river section, which is controlled by a special dividing structure. The slope of that bypass reaches the upper limit of the typical slope for the given creek and creates flow velocities of up to 1.3 m/s.

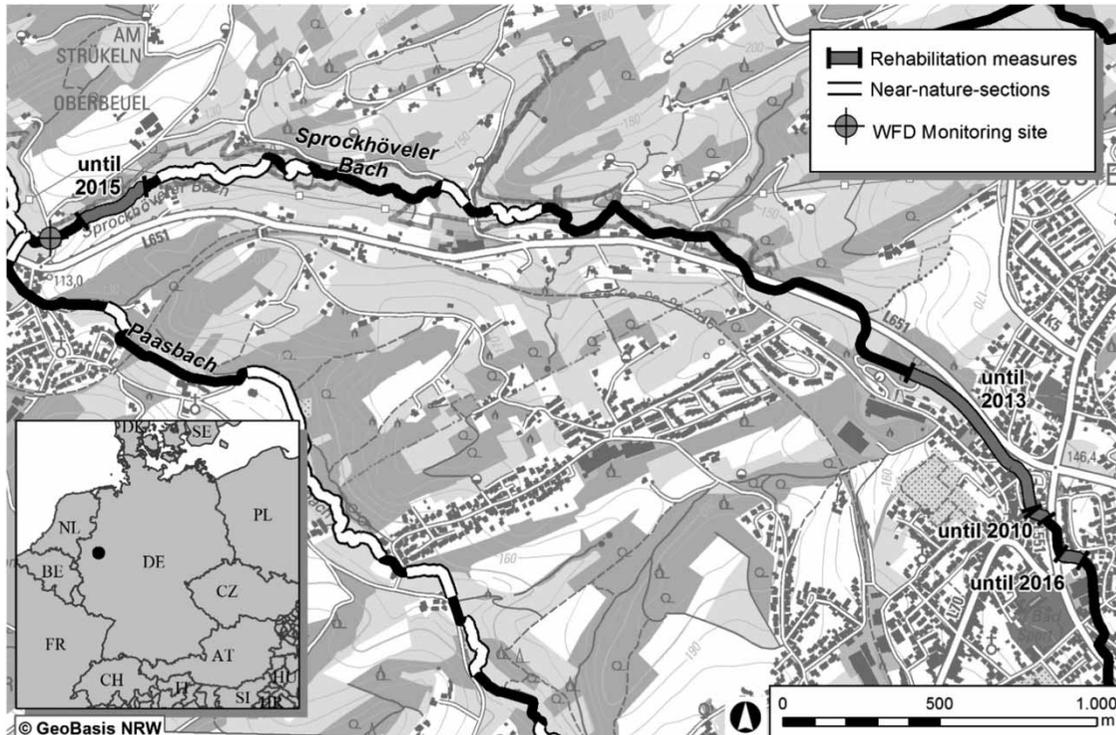
Figure 4 | Topographical map of the lower part of the Sprockhoevel creek showing the position of the rehabilitation measures and of the WFD monitoring site.

The chronological development of these rehabilitation measures and their geographic position within the Sprockhoevel creek is depicted in [Figure 4](#) appended by an additional measure near to the WFD monitoring site.
