## The concentration and prevalence of asbestos fibres in Christchurch, New Zealand's drinking water supply

### ABSTRACT

Asbestos cement was a common construction material for water pipes during the twentieth century, as a replacement for metal piping that was vulnerable to corrosion. We report on the presence of asbestos fibres in drinking water supply in Christchurch, New Zealand from ageing asbestos cement reticulated water supply. By sampling the mains water supply via hydrants, 19 of our 20 samples showed long asbestos fibres ( $>10\ \mu\text{m}$ ), with an average concentration 0.9 million fibres per litre (MFL). Short asbestos fibres ( $>0.5\ \mu\text{m}$ ) had an average concentration of 6.2 MFL. Sampling was targeted to pipes from 1930 to the 1960s and there was abundant evidence of fibres being released from pipes of this age. Municipalities cannot continue to rely on ageing asbestos-cement piping, as it appears to be releasing asbestos fibres into drinking water with uncertain health implications, and should prioritise replacing pipes greater than 50 years in age, especially where high water pressures or land disturbance occur, to reduce the risk of water-carried asbes

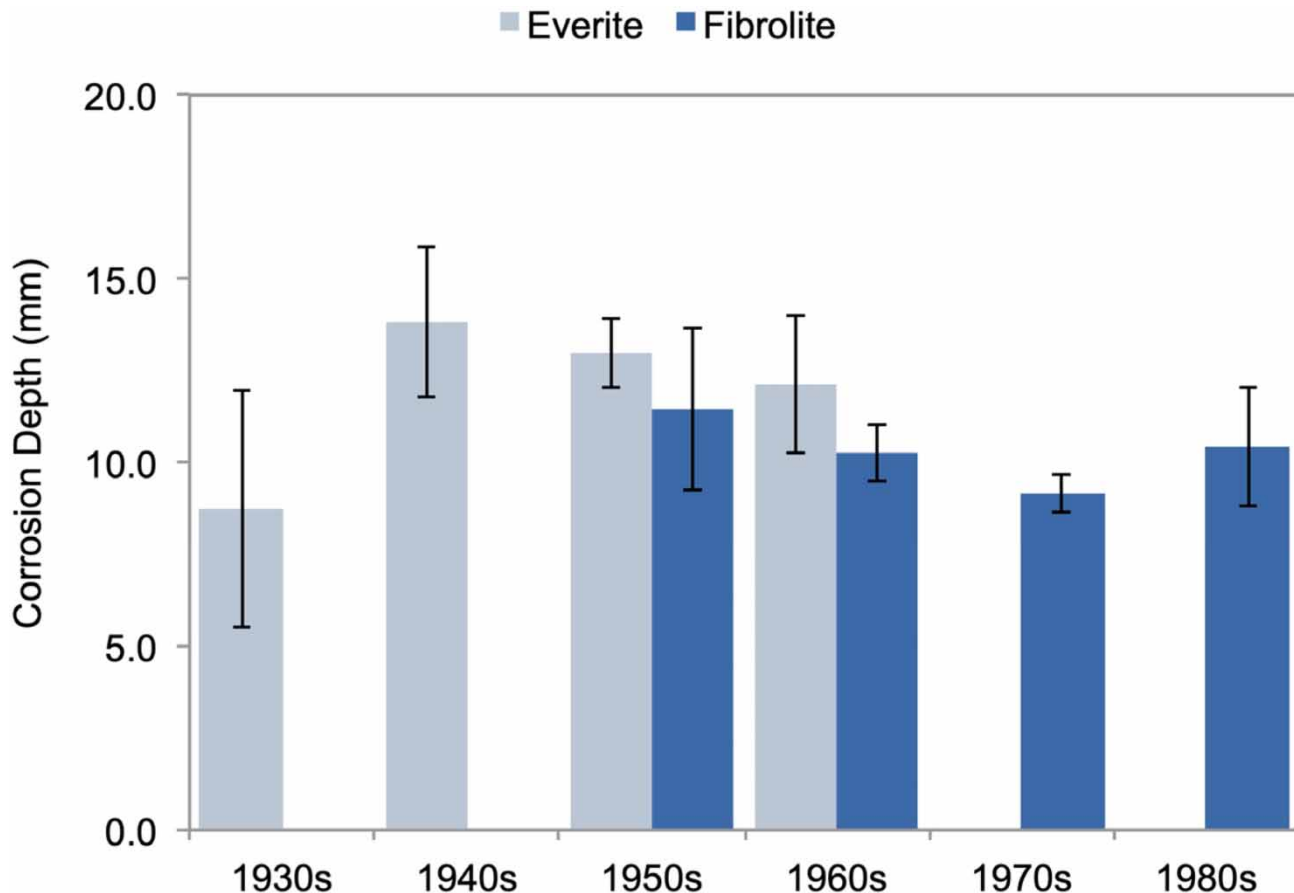
**Figure 1** | Comparison of corrosion depths in asbestos piping in Christchurch plotted relative to decade of installation and manufacturing brand (Everite, UK and Fibrolite, NZ).

Of the asset database, 123 pipe sections were measured to determine total deterioration as a corrosion depth (in mm) (Figure 1). The average corrosion depth of asbestos pipes in Christchurch was  $11.0 \pm 0.5$  mm across the asset database of inspected, repaired, or replaced piping. There was a slight difference in the corrosion depth with manufacturer type,  $12.8 \pm 0.8$  mm for Everite compared to  $9.8 \pm 0.5$  mm for Fibrolite; however, this may in part reflect an age-bias, as Everite does not have any pipes from the mid-1960s onwards.

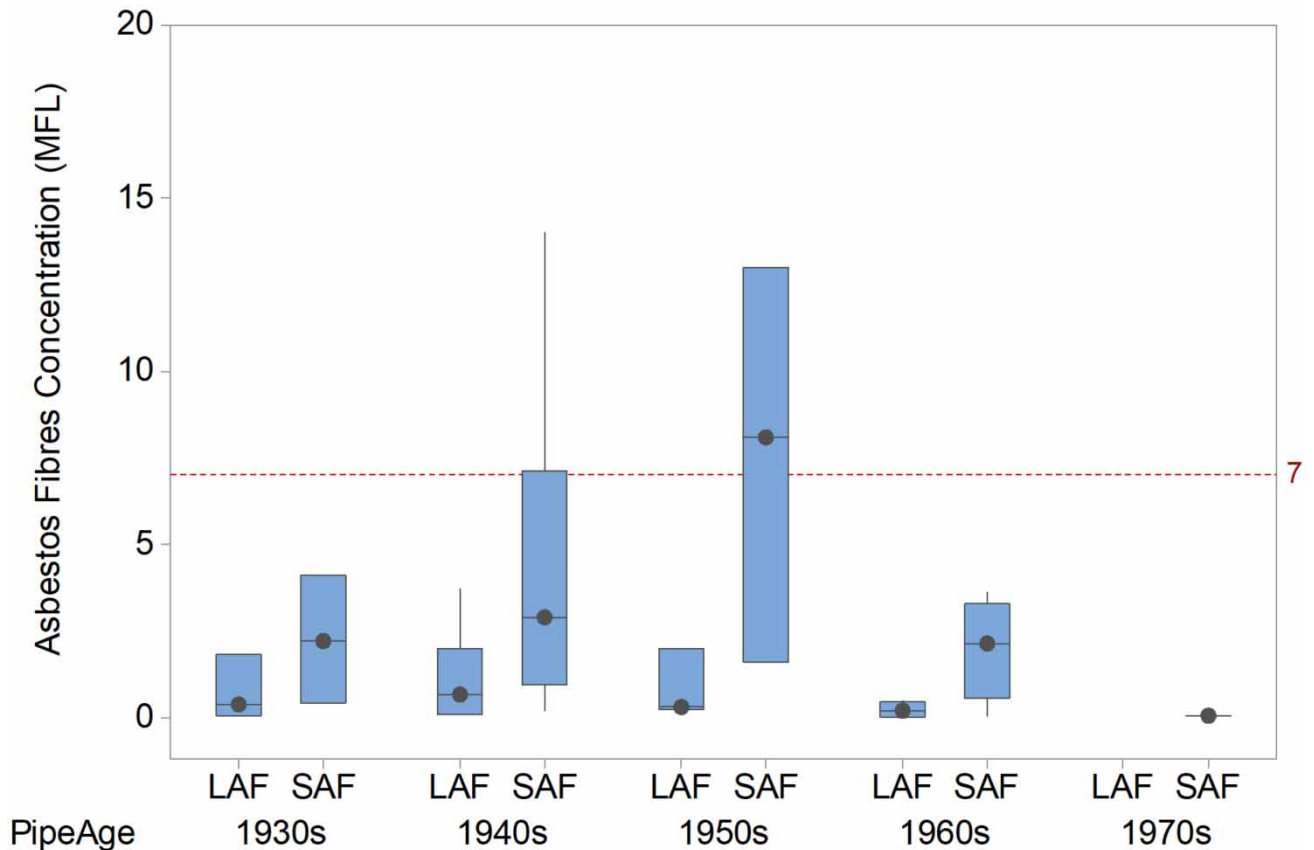
**Figure 3** | Box and whisker plots of the concentration of asbestos fibres detected in Christchurch’s water mains and household taps ( $n=24$ ). Data are plotted relative to estimated age of pipe installation and size of detected fibres for long asbestos fibres (LAF) and short asbestos fibres (SAF). Note an extreme outlier of 56 MFL or SAF from the 1950s has been omitted from the plots for clarity. Dots indicate the median value, and the dashed horizontal line marks the US-EPA regulatory threshold for LAF of 7 MFL.

The average calculated water aggressive index (Table 1) from hydrant samples was 11. This indicates that Christchurch's water supply is classified as 'moderately aggressive' to cement pipe infrastructure. The age of the mains pipes was extracted using geospatial data provided by the Christchurch City Council. The highest concentrations of LAF and SAF were detected in pipes laid during the 1940s and 1950s (Figure 3), with an extreme outlier of 56 MFL detected in a 100-mm diameter pipe laid in 1958. The oldest pipes we sampled dated from 1930 and 1936 and had lower concentrations of asbestos relative to later pipes, although this was not statistically significant as one sample had a LAF concentration at the method detection (0.062 MFL) and the other was 1.8 MFL (Figure 3).
