## Performance evaluation of buried PVC pipelines for tank irrigation: a case study of Deevanur tank

**Key words:** command area, cropping intensity, performance evaluation, PVC buried pipelines, tank irrigation

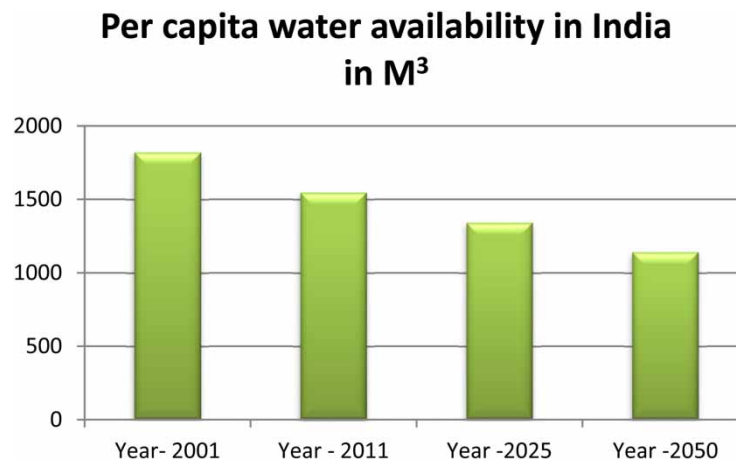
**Figure 1** | Per capita water availability in India.

In India, it has been estimated that the average annual per capita water availability in the years 2001 and 2011 was 1,820 and 1,545 cubic meters, respectively. It is anticipated that this may reduce further to 1,341 and 1,140 cubic meters in the years 2025 and 2050, respectively, as shown in [Figure 1](#) (Department of Water Resources and Ministry of Jal Shakthi 2014).

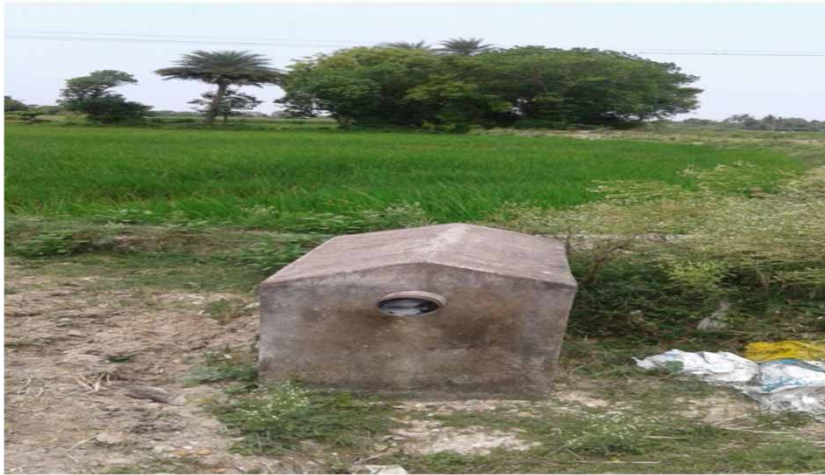
**Figure 3** | Water distribution system in Deevanur tank.

In view of the vital importance of water for the sustenance of all living beings, maintaining the fragile ecological balance, promoting economic growth, fostering developmental activities of all kinds and taking into consideration its increasingly prevalent scarcity, the Deevanur tank was modernized under the World Bank Scheme in the year 2012–13. During the upgradation initiative, the conventional open field channel irrigation was modernized with the installation of buried PVC pipelines in the ayacut area for the conveyance of water for irrigation purposes. This tank initially irrigated the ayacut area through open natural field channels up to 2011–12. With the implementation of modernization measures, underground PVC pipelines were laid to irrigate the ayacut area, thereby significantly reducing the conveyance, evaporation and infiltration water losses (Figure 3).

The cropping intensity in the command area of the tank irrigation system depends on the existing and improved physical conditions of the tank. Channel lining and sluice management help in enhancing the cropping intensity of the tank irrigation system. In the Deevanur tank irrigation system, buried PVC pipelines are introduced to facilitate the conveyance of the water stored in the tank to the fields for irrigation. The performance of the Deevanur tank is evaluated using the performance indicator, Cropping Intensity (Bos *et al.* 2005). It is calculated based on the ratio of the actual cropped area to the irrigable area of the tank in a particular year.

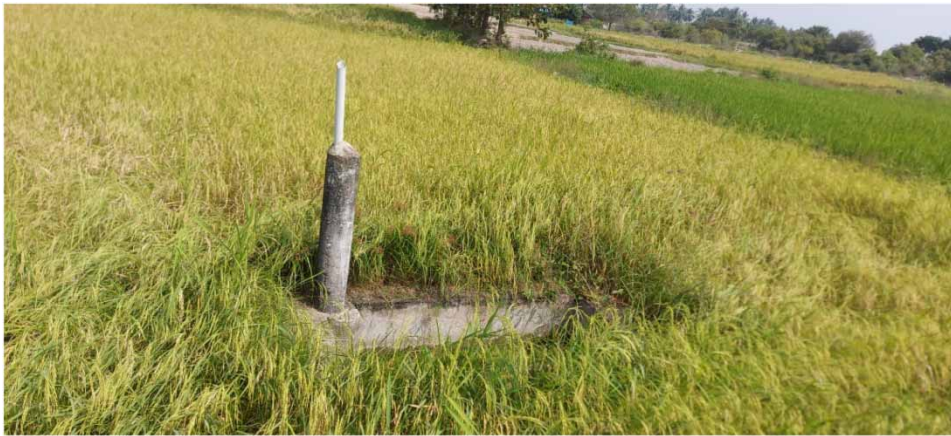
**Figure 4** | Air vent pipe in the distribution system in Deevanur tank.

In order to assess the impact of the modernization measures implemented in the Deevanur tank, a long-term comparative research study was conducted for evaluation of the performance of the tank irrigation system, from 2006 to 2012 for pre-evaluation and from 2012 to 2018 for post-evaluation (Figure 4).

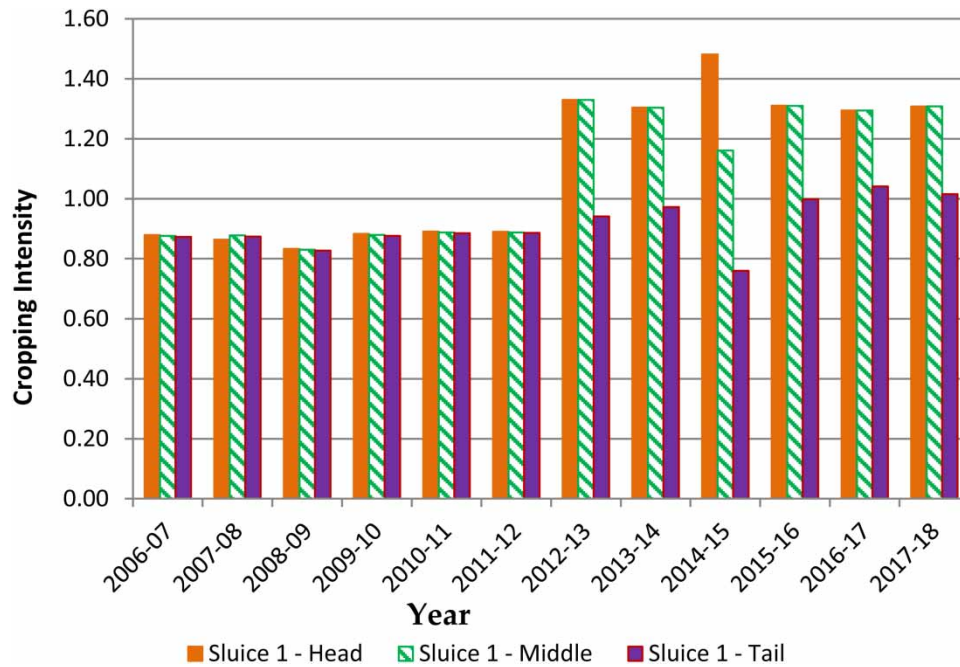
Figure 5 | Reach-wise Cropping Intensity in Sluice no. 1.

The sluice-wise tank performance is calculated, and it is shown in [Figures 5](#) and [6](#) for sluices nos. 1 and 2, respectively. In sluice no. 1, in the head reach, the highest value of cropping intensity is observed as 1.48 in the year 2014–15, whereas the lowest value of cropping intensity is seen to be 0.83 in the year 2008–09. In the middle reach of the same sluice, the highest value of cropping intensity is reported to be 1.33 in the year 2012–13 and the lowest value of 0.83 is found in the year 2008–09. In the case of tail reach of sluice no. 1, the highest and lowest values of cropping intensity are 1.04 and 0.75 recorded in the years 2016–17 and 2014–15, respectively.
