# Wastewater collection system failures in a capital city: analysis and sustainable prevention

## ABSTRACT

An analysis of failures in a capital city's wastewater collection system was carried out and recommendations were made for sustainable preventive measures based on a risk of failure assessment. Most failures in sewer lines were associated with blockage caused by sediment accumulation and clogging from fats, oils and/or grease dumped by restaurants along several streets, combined with poor or nonexistent maintenance of the lines. Sewer lines in streets with higher risk levels due to multiple food establishments along those streets experienced most of the failures. Sustainability of the proposed maintenance was evidenced since it reduces costs and exposure to harmful substances and hazardous conditions as well as minimizing environmental impacts.

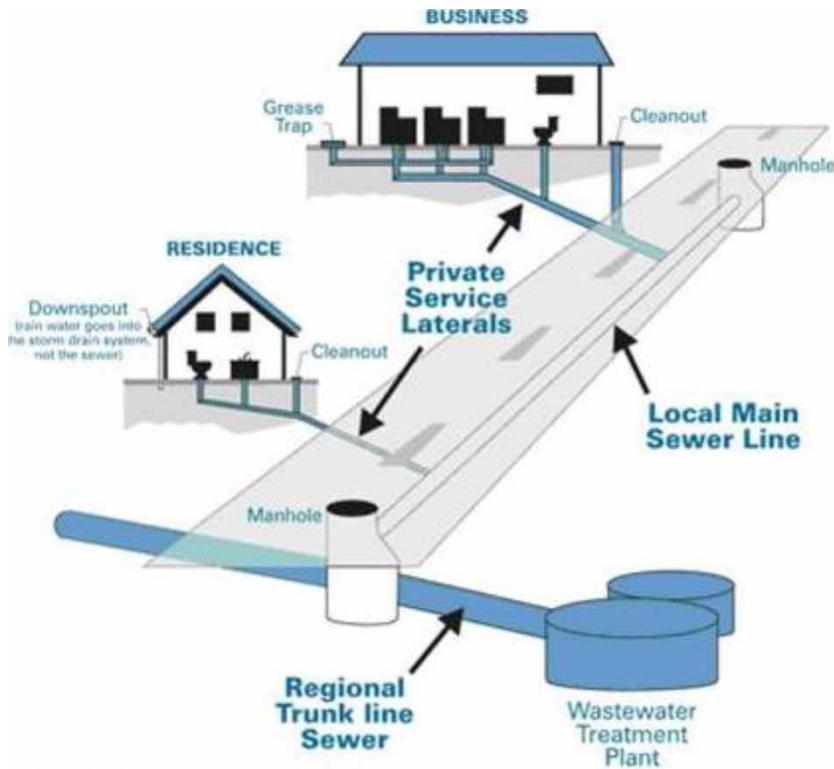
The WWCSs in Trinidad and Tobago carry only sanitary waste. Therefore, for illustration purposes, in Figure 2 a schematic of typical independent sanitary sewer collection and distribution system components (a WWCS without rain drainage lines) is shown (Department of Public Works). It can be seen that the main components of an uncombined WWCS (Department of Public Works; Wastewater Treatment Plant 2002; State of Technology for Rehabilitation of Wastewater Collection Systems 2010) are private service laterals (Department of Public Works) from the points of origin, a local (Department of Public Works) main sewer line, manholes, and regional trunk sewer lines (Department of Public Works). Usually, the main sewer lines that suffer a number of failures are installed under streets (discussed later). The manholes allow the entry of maintenance personnel and can be also used to change the direction of the wastewater flow and to interconnect main sewer lines to other main sewer lines and/or to trunk sewer lines. These lines are also prone to different kinds of failures. All sewer lines analyzed in this work are referred to as *gravity sewer pipes* (Department of Public Works; Wastewater Treatment Plant 2002; State of Technology for Rehabilitation of Wastewater Collection Systems 2010; R. Tanaka Mark Thomas and Company Inc. 2014; Laakso *et al.* 2018a; Wastewater Snyder & Associates 2020).

Figure 2 | Sanitary sewer collection and distribution system components (Department of Public Works).

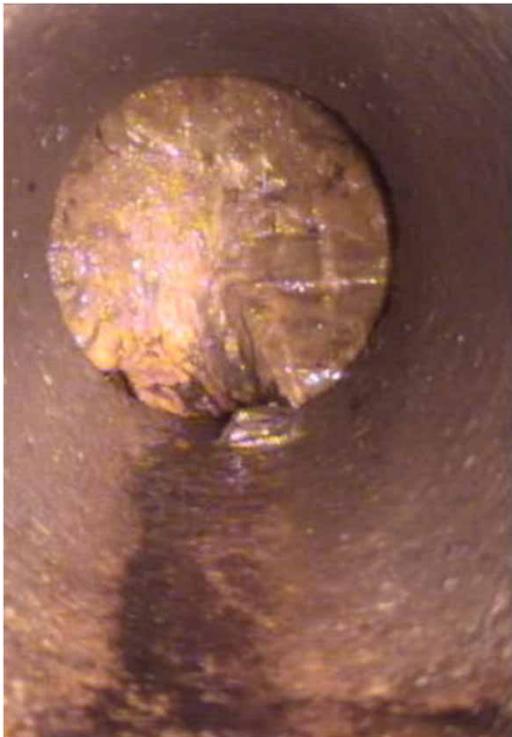
**Figure 4** | Hydraulic restriction (blockage) failure along Henry Street, downtown Port of Spain, caused by the solidification of FOG; it caused an SSO, needing an emergency intervention to be cleared (still from CCTV footage WASA).

From the most common types of failures, it is completely clear that human activities, regular sewage discharge, restaurant effluents, combined with poor maintenance (or perhaps lack thereof in most instances) are the main cause of the WWCS failures in downtown Port of Spain. Since population growth and development is unstoppable all over the world (Trinidad and Tobago's capital city is definitely not an exception), it can be inferred that a preventive, aggressively active and sustainable maintenance practice at WASA needs to be implemented to successfully minimize repeated and undesirable WWCS failures in the capital city. Public education and awareness must also be implemented for important issues such as installing and

operating some kind of FOG removal or pretreatment device at restaurants that may help in the foundation of a reduction-oriented FOG program. That will enhance the sustainability of the maintenance practice and will make it more effective as there will be less waste ending up in sewer lines.

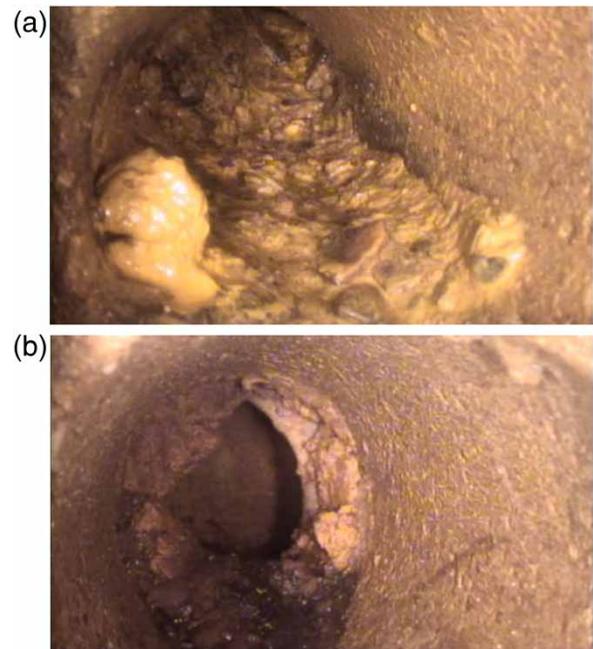
**Figure 5** | (a) Sediment accumulation failure within a main sewer line in Independence Square Street, downtown Port of Spain; (still from CCTV footage WASA). (b) Another main sewer line failure due to sediment accumulation, this time along Duke Street, Port-of-Spain (still from CCTV footage WASA). In both cases, the sediment accumulation caused SSOs that needed to be cleared by emergency interventions. Sediment accumulation may solidify inside sewer lines in some instances, aggravating the failure and increasing the time needed for removal/clearing.

Performing preventive maintenance every 2 months, including flushing of the sewer line (by using sewer jetting equipment noted in the cost analysis section), on those streets with higher risks will ensure a more sustainable maintenance practice. The maintenance personnel are commonly exposed to some harmful/toxic substances and/or hazardous conditions every time they clear an SSO-related sewer line failure during an emergency intervention. Through regular maintenance, the maintenance personnel will be less exposed to hazardous conditions since the amount and possibly the concentration of raw sewage will be lessened (also less waste to manage and dispose of). The public will be less exposed to some extent to those conditions as well, and potential environmental impacts will be significantly reduced because less waste would be flooding the streets.

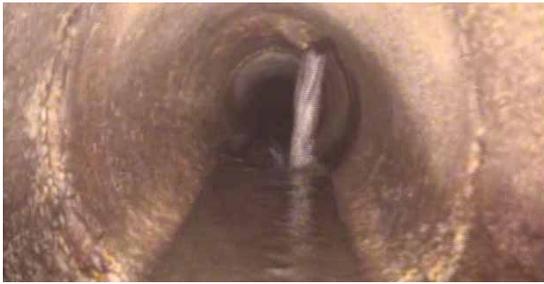
There were around 45 reported failures due to either excessive inflow/infiltration (Wastewater Treatment Plant 2002; Damvergis 2014; Wastewater Collection System Toolbox 2017; Mohammadi 2019; Balacco *et al.* 2020), pipe deformation and inadequate slope causing a reduction of hydraulic capacity failure (Mohammadi 2019) triggering SSOs (Table 2). Figure 6 shows an example of this type of failure in a street in downtown Port of Spain. Infiltration in a sewer line may originate, for example, from the pipe breaking, or defects/deformations in the pipe, or from a manhole cover having defects or being absent, which, in combination with excess flow (during the rainy season) might induce SSOs. This failure mode can be exacerbated if the main sewer line diameter is too narrow.

**Figure 6** | CCTV still showing excessive infiltration in the sewer line along Park Street, Port-of-Spain (still from CCTV footage WASA). It eventually caused an SSO, leading to an emergency intervention as well.

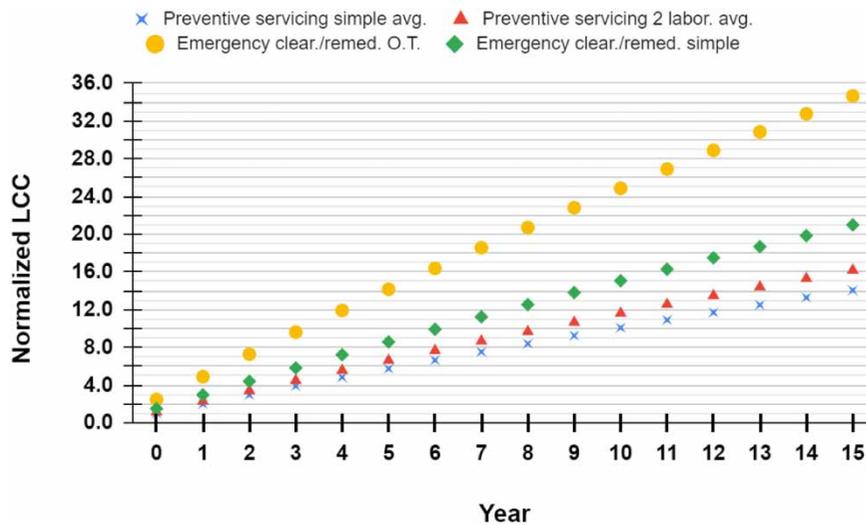
**Figure 7** | Cumulative discounted and normalized LCC for four scenarios, two for each maintenance alternative. The 'simple' for the preventive maintenance indicates that one craftsman I is included in the scenario, while 'avg.' stands for the average 173 WWCS failures per year that took place in the 3-year period of this study. The '2 labor. avg.' means that two craftsmen I are included and the same average of 173 failures per year are considered. On the other hand, for the current emergency intervention alternative, the 'clear./remed.' stands for clearing/remediation; while 'simple' means a regular work day cost; and, 'O.T.' indicates overtime costs are included.

cost basis for normalizing all discounted LCC costs. Although not obvious in Figure 7 because of the scale of the graph to cover all data shown, it is the reason for the value of 1.0 for the first year of the LCC scenario 'preventive servicing simple avg.'

interventions (Figure 7) the average of 173 failures per year are definitely considered since those are *real costs that most likely have already been incurred by WASA*. In fact, it has been reported (WASA) that in some cases, due to the severity of the failure, maintenance personnel were repairing the failure for more than a day and overtime costs (another scenario, Figure 7) were even incurred. Therefore, the costs for the emergency interventions have been conservatively underestimated.
