## Study of traffic-related pollution and its treatment with a particular focus on microplastics in tunnel wash and road runoff water

**Key words:** microplastics, road runoff water, tunnel wash water

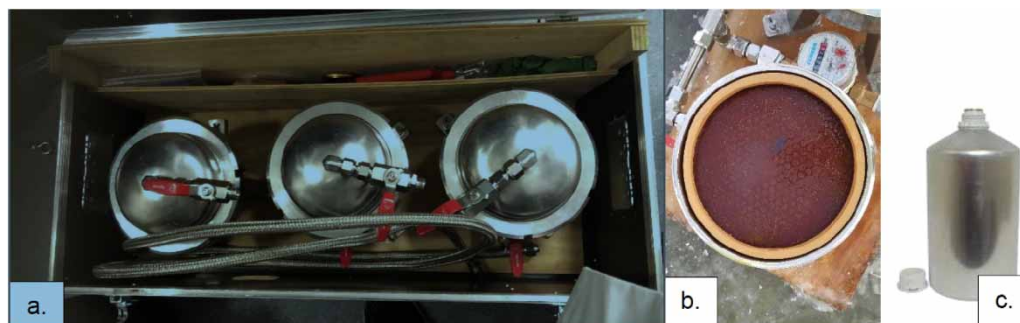
**Figure 1** | The filtering unit with metal tubing and metal pump head (a), metal filter (b), and aluminum sampling container (c).

In many cases, MP concentrations of water samples can be very small, which makes it necessary to analyze large amounts to get reliable results. Handling huge water volumes is neither economical nor practical. Therefore, a specially developed filtration unit made of metal with metal tubes with 10 µm stainless-steel mesh was used to concentrate particles of larger water volumes (Figure 1).
