Case Report

A Severe Reaction to Ni-Containing Orthodontic Appliances

Olga Elpis Kolokitha^a; Evangelia Chatzistavrou^b

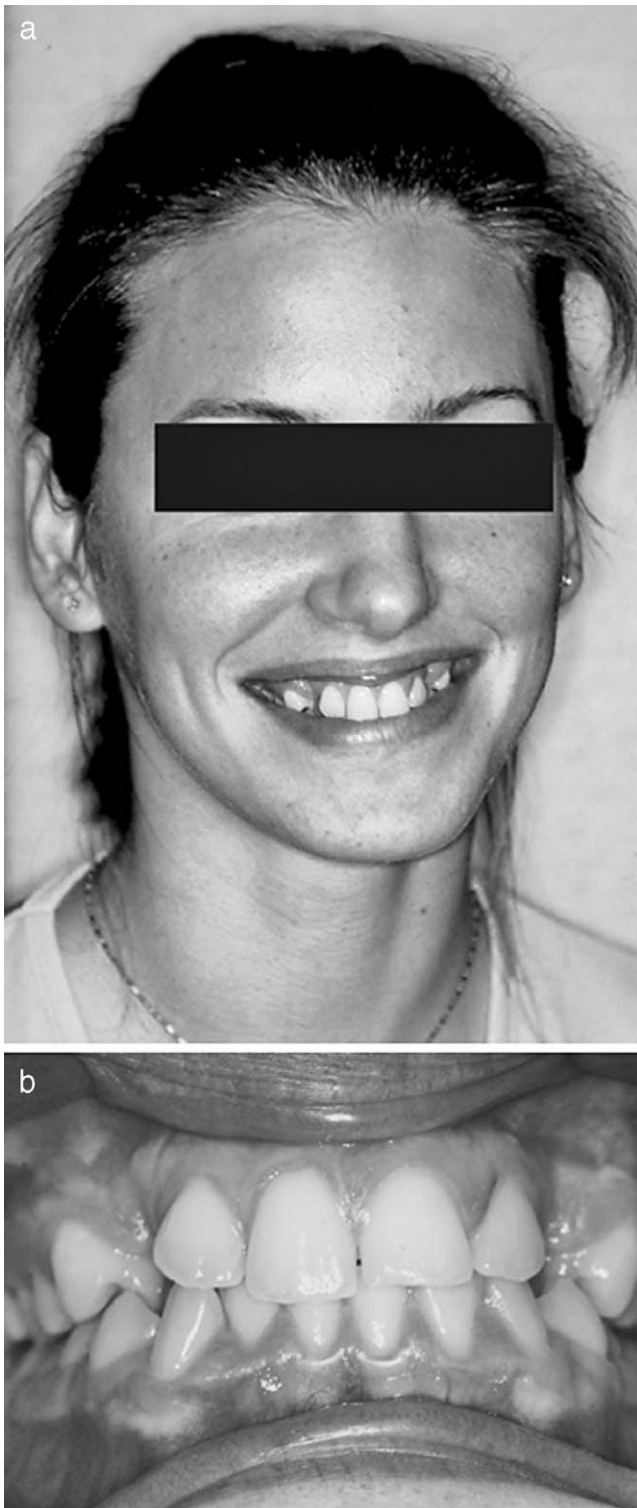
The patient presented with an orthognathic facial type and a straight profile (Figure 1a). The intraoral examination and the study models revealed a Class I

Figure 1. (a) Initial facial and (b) intraoral photographs.

malocclusion with minor rotations at her anterior maxillary and mandibular teeth (Figure 1b). The initial orthopantomogram demonstrated impactions of both maxillary canines with 23 more mesially inclined (Figure 2a). The occlusal radiograph taken at the time of

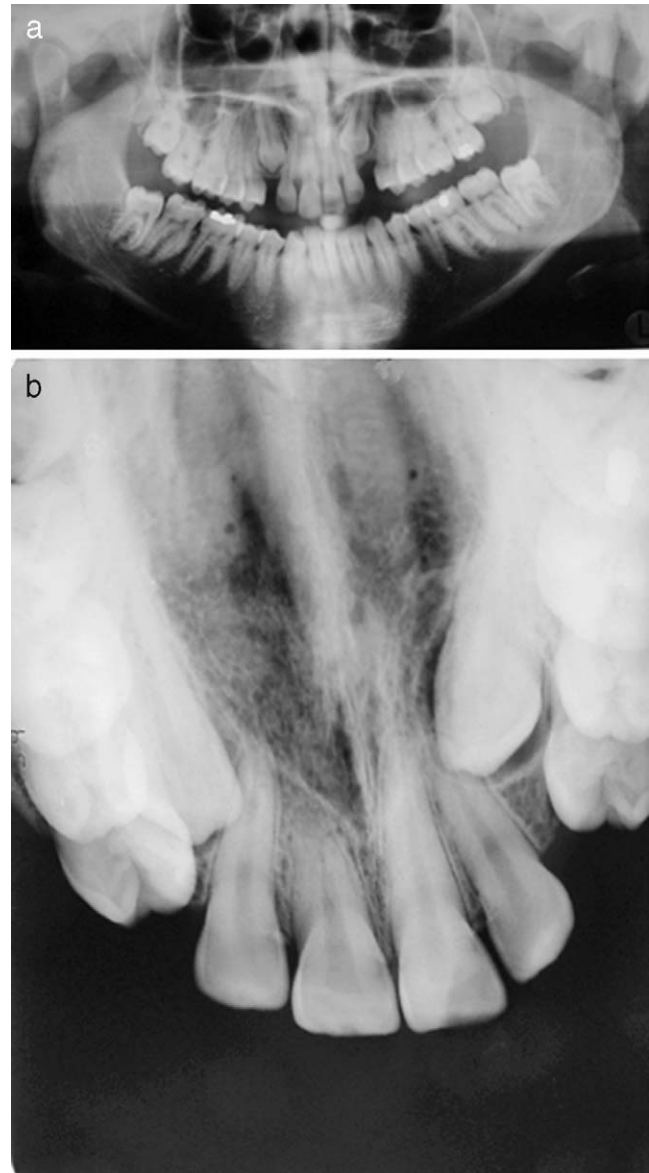
Figure 2. (a) Initial orthopantomogram and (b) occlusal radiographs.

the examination showed that both canines were labially positioned (Figure 2b).

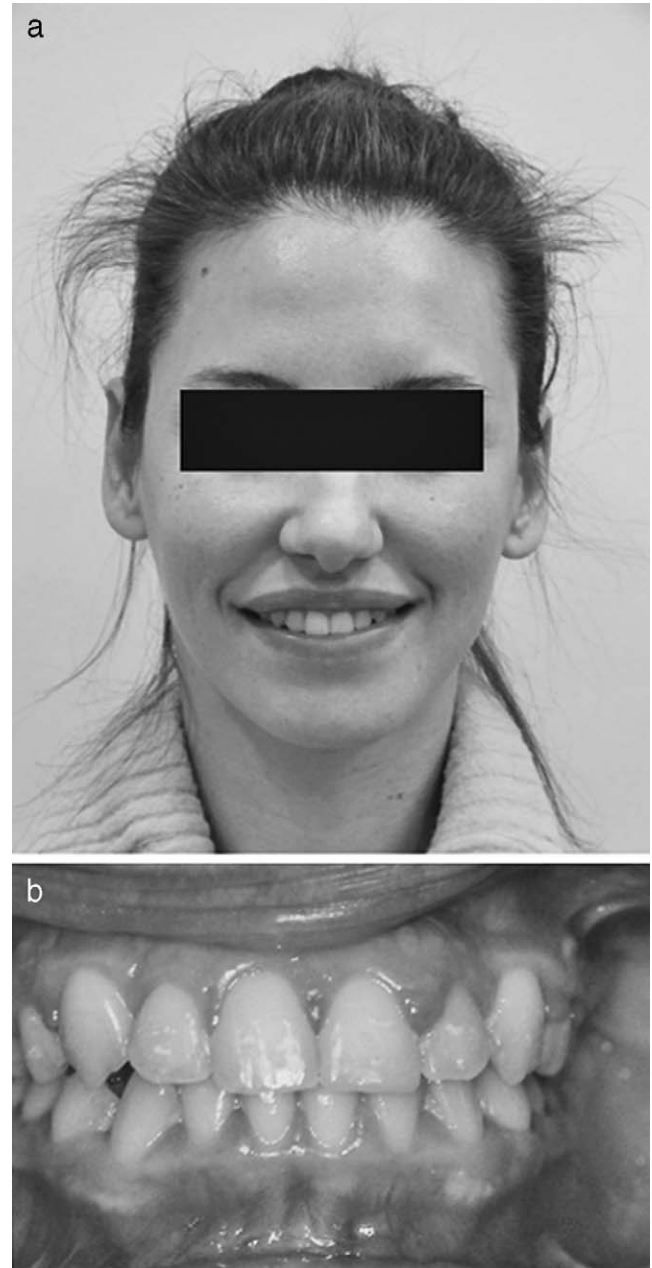
sion, rectangular stainless steel wires were used for finishing and detailing. After about 3 years of total treatment, all fixed appliances were removed as the treatment goal had been achieved. The patient was satisfied with the result, and there were no signs of allergic reactions on her skin (Figures 8a,b).

Figure 8. Final (a) facial and (b) intraoral photographs.
