REAGGLOMERATION AS A CAUSE OF TREAD GROOVE CRACKING*

W. M. HESS AND K. A. BURGESS

COLUMBIAN CARBON COMPANY, PRINCETON, NEW JERSEY

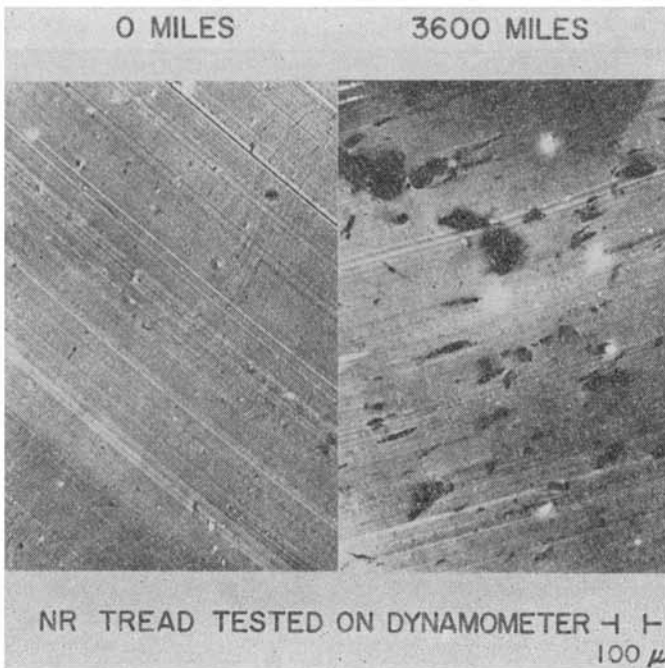
FIG. 4.—Carbon reagglomeration.

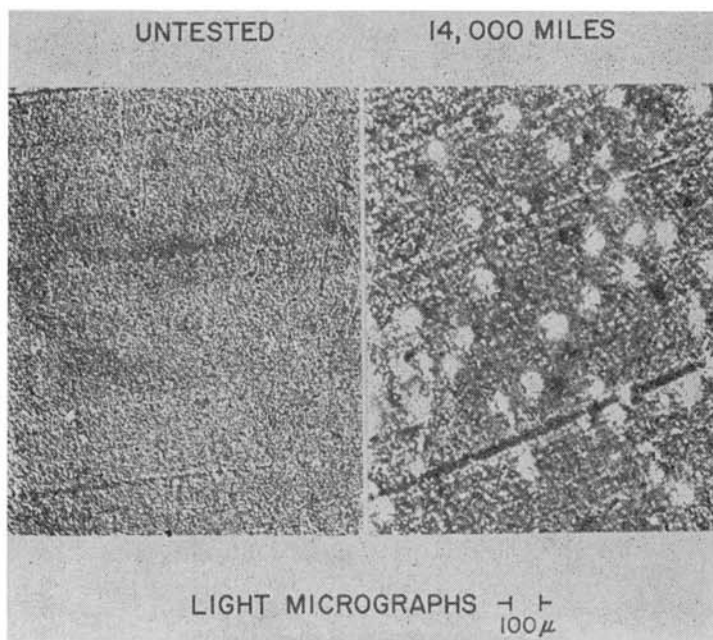
FIG. 5.—Non-Carbon reagglomeration.

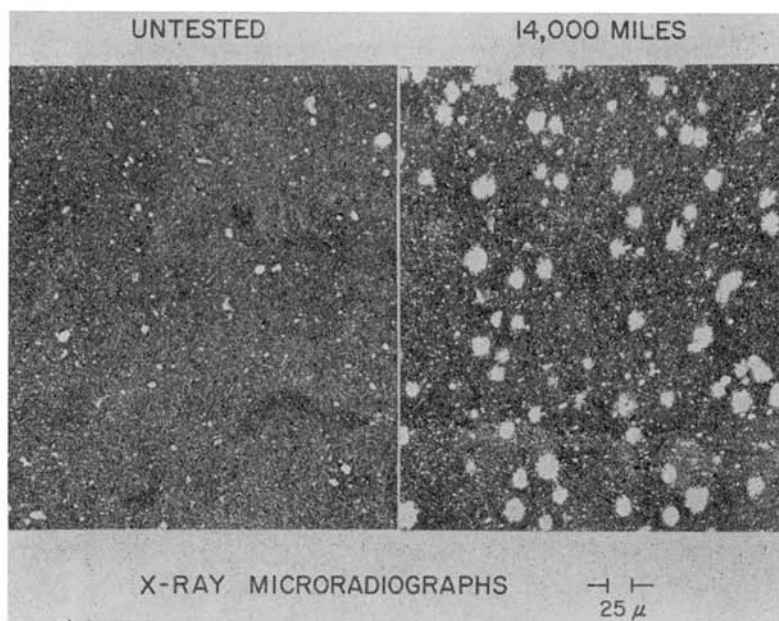
FIG. 6—Non-Carbon reagglomeration.

The remainder of this paper will deal with a phenomenon broadly termed "non-carbon reagglomeration". This refers to an actual physical rearrangement of compounding ingredients other than carbon black. The rearrangement occurs after vulcanization, during the time that the tire is in service. An example of non-carbon reagglomeration is shown in Figure 5 in which light micrographs of an oil extended SBR tread are shown with no mileage and after 14,000 miles on the road at speeds of 60-65 mph. The tested tread shows numerous light areas which at first glance appear to be holes. However, examination of the same stocks by microradiography show conclusively that these "light" areas are actually high in x-ray absorption (Figure 6). Inasmuch as the light microscope examination indicated lower carbon content for these reagglomeration areas it was concluded that they must contain relatively high amounts of some of the other compounding ingredients. In all probability it was thought that they were rich in zinc which would then explain their high opacity to soft x-rays.

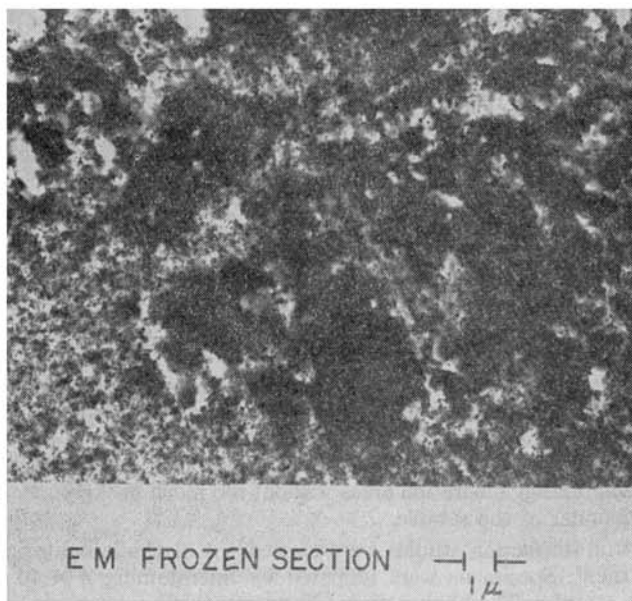
FIG. 9.—Reagglomeration area, OEP tread

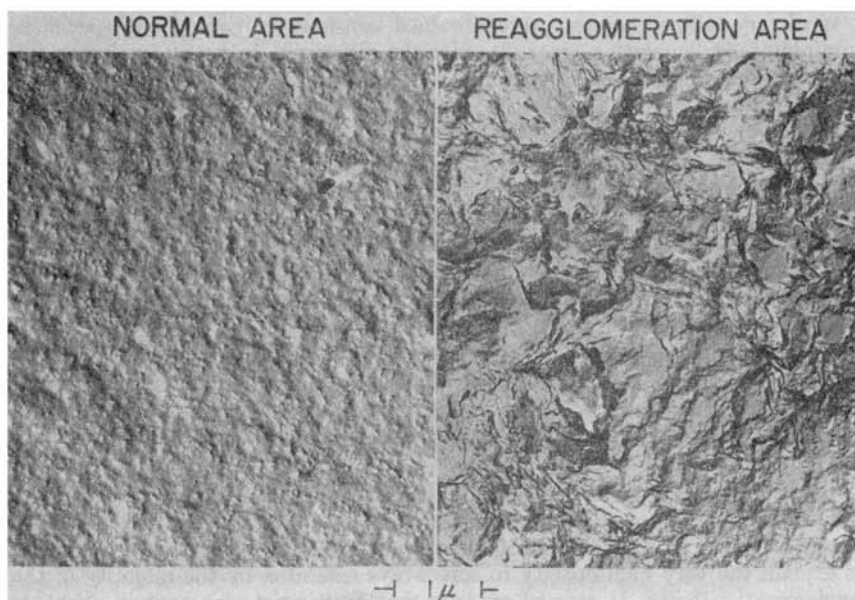
Employing the freeze-fracture replication technique used recently by Prestridge¹⁴ it was possible to study the internal structure of the reagglomeration areas in greater detail. In Figure 10, employing this method, a normal area of carbon black loaded rubber is compared to a non-carbon reagglomeration area. The latter region clearly exhibits cleavage planes showing a stepwise structure. Inclusions of what appear to be some smaller, discrete particles can also be seen.

FIG. 10.—EM replicas—OEP tread.

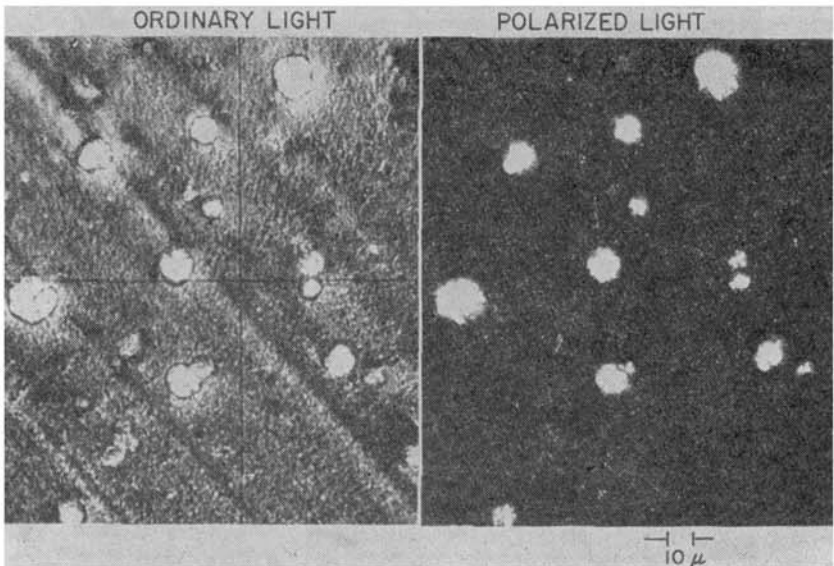
In support of the electron diffraction results, is a tendency toward birefringence in the reagglomeration areas observed when they are examined under polarized light. This effect is shown in Figure 14. Birefringence in the areas shown here was quite strong. However, many of the reagglomeration areas appeared quite weak in this respect.

FIG. 14.—Reagglomeration areas showing birefringence.

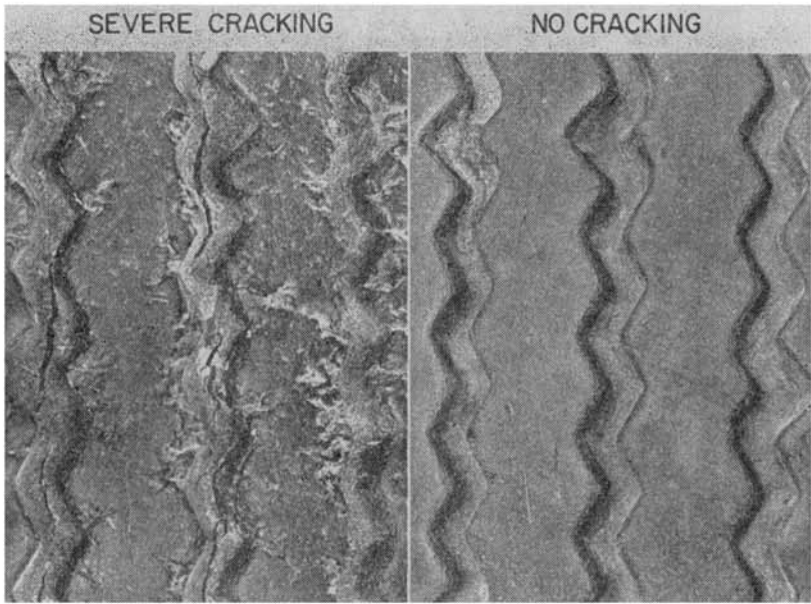
Treads exhibiting a high degree of non-carbon reagglomeration have shown poorer resistance to crack development than those in which reagglomeration had not taken place or was present to a lesser degree. Examples of good and poor crack resistance in natural rubber treads are shown in Figure 15. The badly cracked tread is the same one listed as sample "A" in Table 2. Microradiographs of sections from the grooves of these two tires are illustrated in Figure 16. Both tires had been run for approximately 20,000 miles.

FIG. 15.—Comparison of worn threads

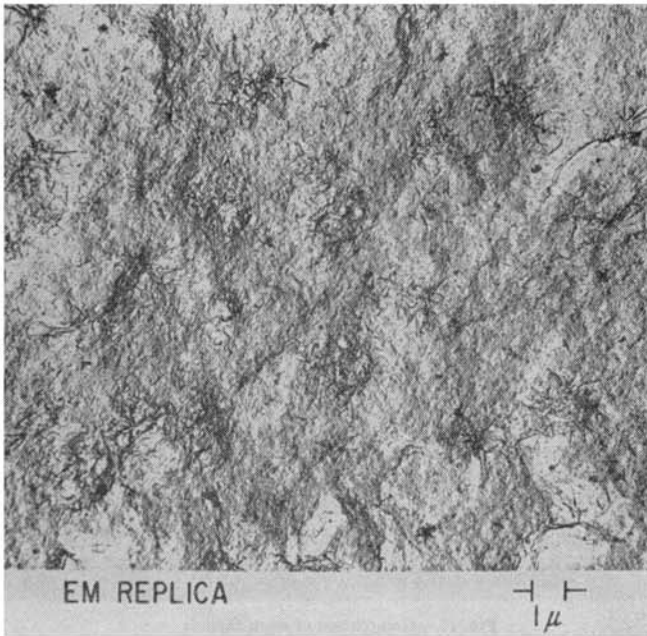
FIG. 17.—Smaller reagglomeration areas.

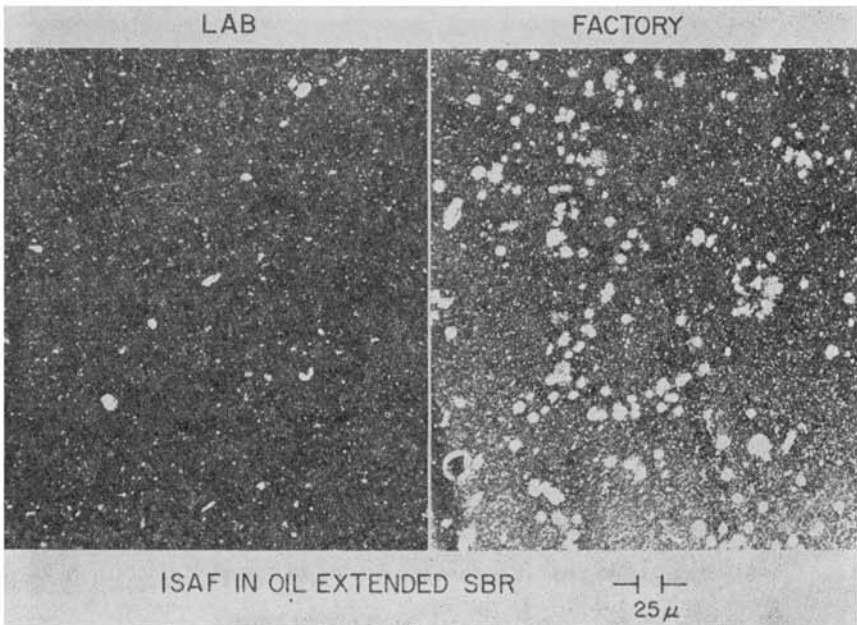
FIG. 18.—Effect of mixing conditions

reagglomeration than laboratory mixed stocks indicating the need for a good initial dispersion of all of the compounding ingredients. Excessively high mixing temperatures which are more apt to occur in the factory may also be a contributing factor. Typical examples of factory and laboratory mixed oil extended SBR treads are shown in Figure 18. Both tires had been road tested for about 10,000 miles. Severe cracking occurred in the grooves of the factory tread, no cracking at all in the lab mixed tire.

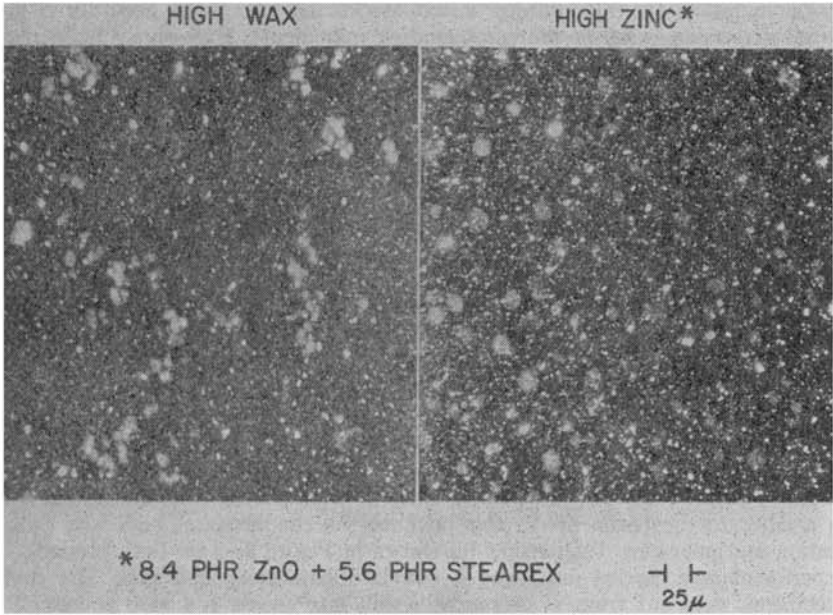
Certain compounding ingredients appear to influence the extent of reagglomeration particularly, as stated above, if they are not dispersed properly. The effect of excessive wax (5 PHR Paraffin) and zinc oxide addition in oil extended SBR treads are illustrated in Figure 19. In the case of the high zinc stock, double the normal amounts of zinc oxide and stearic acid were added to the compound. Both tires failed because of tread separations caused by large cracks in the grooves. Total mileages on the treads were comparatively low, in the range of 6000-7000 miles.

FIG. 19.—Effect of compounding variables.

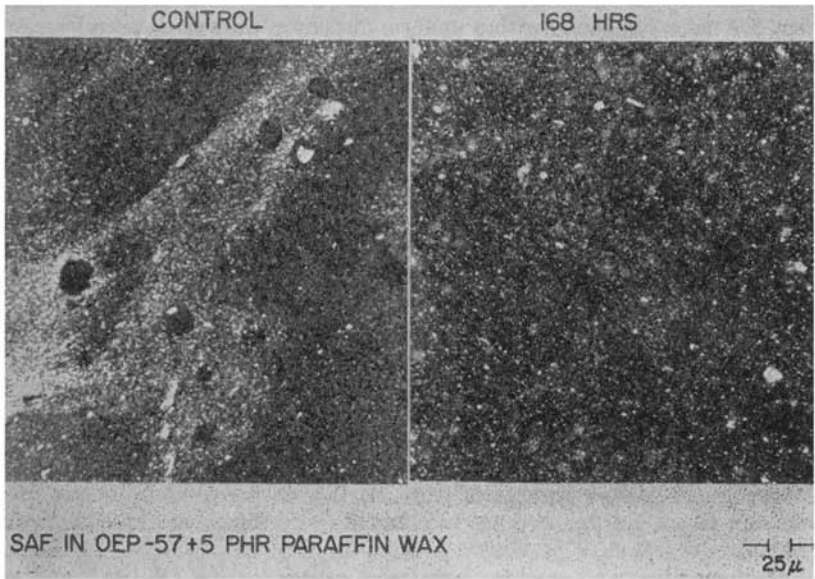
At this time it should be mentioned again that the phenomenon of reagglomeration has been found almost exclusively in tires that have been run on the road. Very extensive laboratory tests including DeMattia and Firestone Flex have been carried out with widely varying time and temperature conditions. These have all failed to produce reagglomeration. Only in one case did reagglomeration occur in a laboratory experiment. In this instance the conditions of high wax concentration and poor zinc distribution (as shown in Figure 3) were both present. The experiment was carried out using a standard laboratory ball mill. The rubber specimens were cut from a stress-strain slab into pieces 1/4 inch square. Steel balls 5/8 inch in diameter were employed. The ratio of the weight of the balls to the sample weight was about 150-1. Reagglomeration was first observed after about 100 hours of ball milling. Figure 20 shows a microradiograph of one of the ball milled specimens at 168 hr. Also shown is an area on the control stock illustrating the uneven zinc oxide distribution prevalent in this stock. These streaky areas were not dissipated by ball milling as they had been on the dynamometer as mentioned earlier. A similar compound with a uniform dispersion showed no reagglomeration via the ball mill test even after 300 hr.

FIG. 20.—Effect of ball milling.

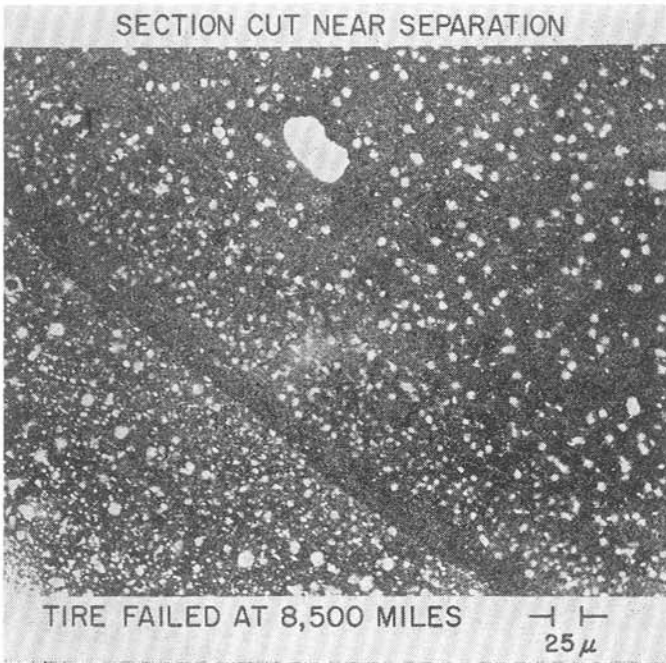
Fig. 26.—LS-ISA in OEP—groove bottom.
