## Water supply operation: diagnosis and reliability analysis in a Lisbon pumping system

A. B. Almeida and H. M. Ramos

An abnormal accident with no flow in a pumping system occurred with a large displacement of the pipe system. A slow closure of an isolation valve installed in a large suction pipe was the main action. As soon as the valve was closed the 1.6 m diameter pipe moved and the pipe supports were broken, presenting an expansion joint almost fully opened and the main pipe almost broken. This was a critical event that took place in one of the most important pumping stations of the water supply system in Lisbon. In order to avoid future accidents, a detailed analysis was developed as a priority in order to identify the cause of this event. The paper describes the event and the methodology followed in order to fully validate the diagnostic and the proposed chain of events that caused the pipe movement. The process included a careful, *in situ* observation of the system, hydraulic and structural analyses and some site tests. Ironically, the explanation of abnormal events can give the opportunity to better understand the operation of water supply systems. Weak points in the de

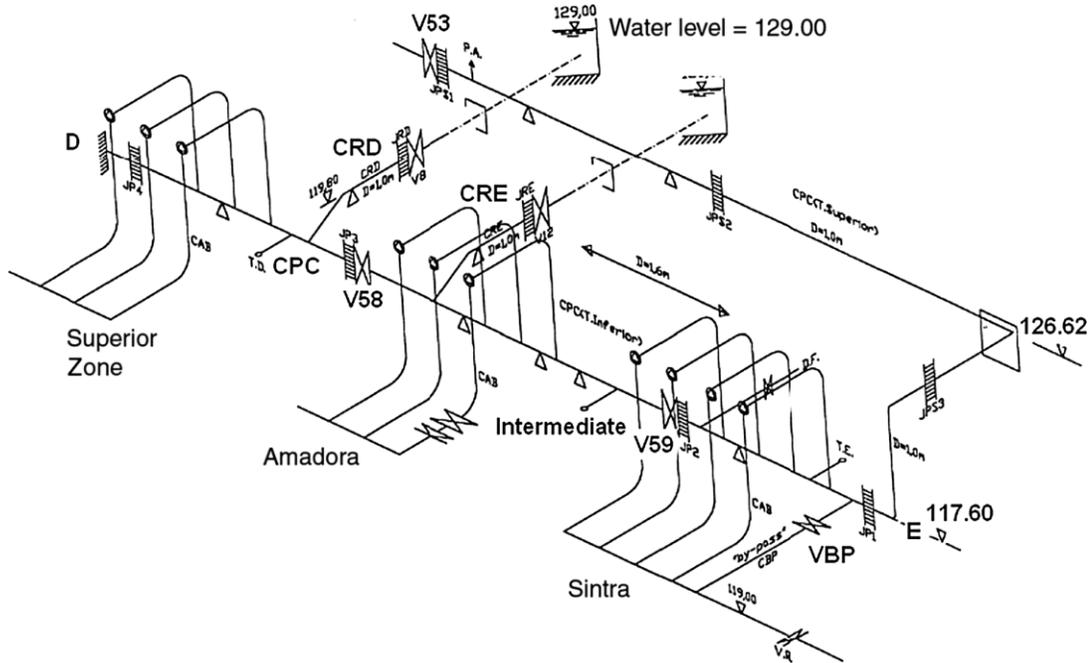
Figure 3 | Pumping-station layout.

Just before the accident, the system operating conditions were as follows (Figure 3):

- *Valves*: V53 – closed; V58 – opened; V59 – opened; V8 – opened; V12 – opened; VBP – closed
- *Pumps*: Lisbon superior zone – two pumps operating ( $780 + 820 \text{ m}^3 \text{ h}^{-1}$ ); Amadora – three pumps ( $900 + 1,030 + 900 \text{ m}^3 \text{ h}^{-1}$ ); Sintra – out of service
- Reservoir level = 129.00.

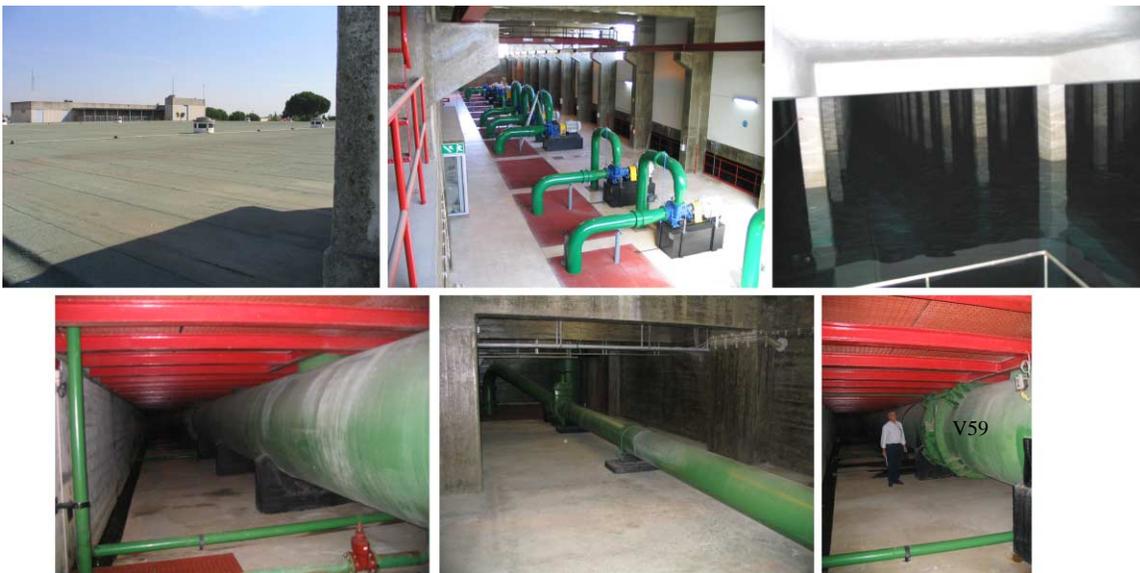
Ten pipes ( $D = 0.4$  m) link the main pipe to the suction side of the pumps. A bypass ( $D = 0.4$  m) connects the high pressure pipe for Sintra ( $D = 1.0$  m) and the CPC main pipe. This pipe has an isolating valve (valve VBP) that is permanently closed. All pumps have a non-return valve and the reverse flow from Sintra pipe is also avoided by means of a non-return valve VR. Figure 4 shows some detailed views of the Telheiras pumping-station.

Figure 4 | Views of Telheiras pumping-station: the concrete roof of the water reservoirs, the pump suction pipes, the water level inside the reservoirs, the CPC pipe, the bypass pipe and valve V59.

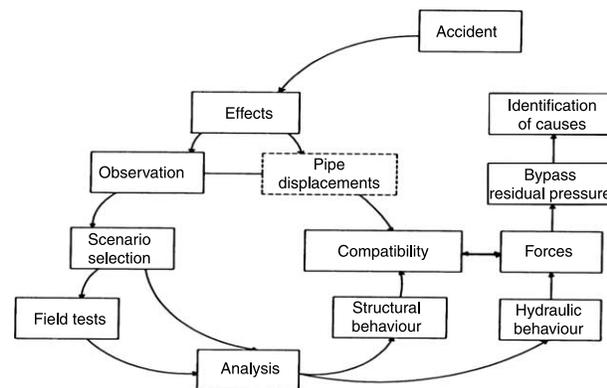
Figure 8 | Procedure for the identification of accident causes.

causes. **Figure 8** shows the evolution of the analysis developed in order to find and identify the main causes of this accident. It was necessary to make compatible the non-operating conditions and the possible action forces with the pipe displacements and the differential pressure in the system.
