## Failure mechanisms and condition assessment of PVC push-fit joints in drinking water networks

André Marques Arsénio, Ilse Pieterse, Jan Vreeburg, Rob de Bont and Luuk Rietveld

**Key words** | CCTV, condition assessment, field inspections, joints, PVC

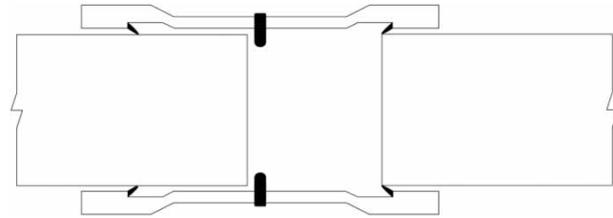
Longitudinal tensile stresses in water mains causing axial movements may be induced through temperature changes, ground movements and tensile forces. For example, water mains will contract (axially and to a minor extent circumferentially) upon a subsequent drop in water and ground temperatures (Rajani *et al.* 1996). The same authors showed that the axial strain due to the contraction or expansion of pipes is not constant throughout the pipe length. As expected, the portion of the pipe near the joint is freer to move than the centre of the pipe. Axial displacement can also occur due to the Poisson effect or due to installation procedure (Figure 3).

In fact, with an axial contraction of the pipe, a complete pull-out of the pipe from the inside of the rubber ring can occur. This leads to joint leakage. The pipes can also move

**Figure 3** | Alignment of a joint during axial displacement. The pipe on the right-hand side is almost pulled out from the rubber gasket (not to scale).

towards each other (e.g., pipe expansion due to temperature increase) and this may lead to contact between pipe and joint and between the two pipes and to joint/pipe breakage. The length of a 10-m PVC barrel can vary 8 mm over a temperature variation of 10–25 °C, considering a linear expansion coefficient for PVC of 54  $\mu\text{m}/\text{m}\cdot\text{K}$  (AWWA 2002).

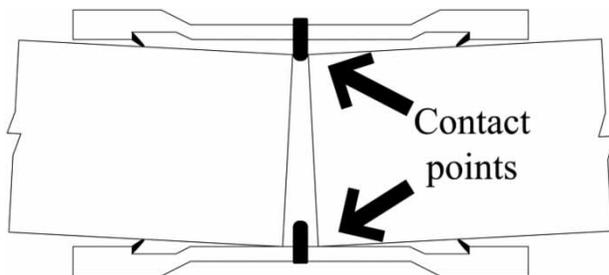
different sections of the pipe will experience different levels of settlement. When the bending angle exceeds a threshold value, contact points arise between the pipe and the joint or, in extreme situations, between the two pipes inside the joint. Figure 4 presents some contact points inside a joint. These contact points lead to high bending moments longitudinal tensile stresses in the pipe, which may induce pipe or joint burst (Rajani *et al.* 1996).

Figure 4 | Alignment of a joint during bending (not to scale).
