Properties of Aging Pentachlorophenol-Treated Douglas-Fir Crossarms

Christoph Schauwecker Milo Clauson Matthew J. Konkler
Arijit Sinha Jeffrey J. Morrell

©Forest Products Society 2020.
Forest Prod. J. 70(3):364–369.
doi:10.13073/FPJ-D-20-00025

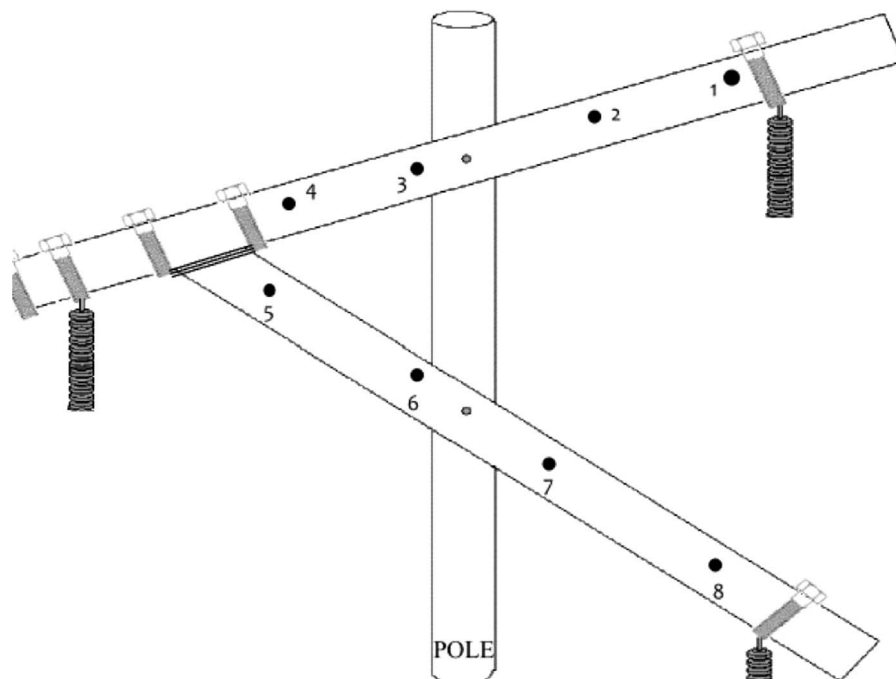
Figure 1.—Example of crossarms in a wishbone configuration. Increment cores (black dots numbered 1 to 8) were removed at sites near the ends of each arm as well as near the pole attachments to the pole.
