## Durability control of UV radiation in glass fiber reinforced polymer (GFRP) - A review

AIP Conf. Proc. 2031, 020033 (2018)

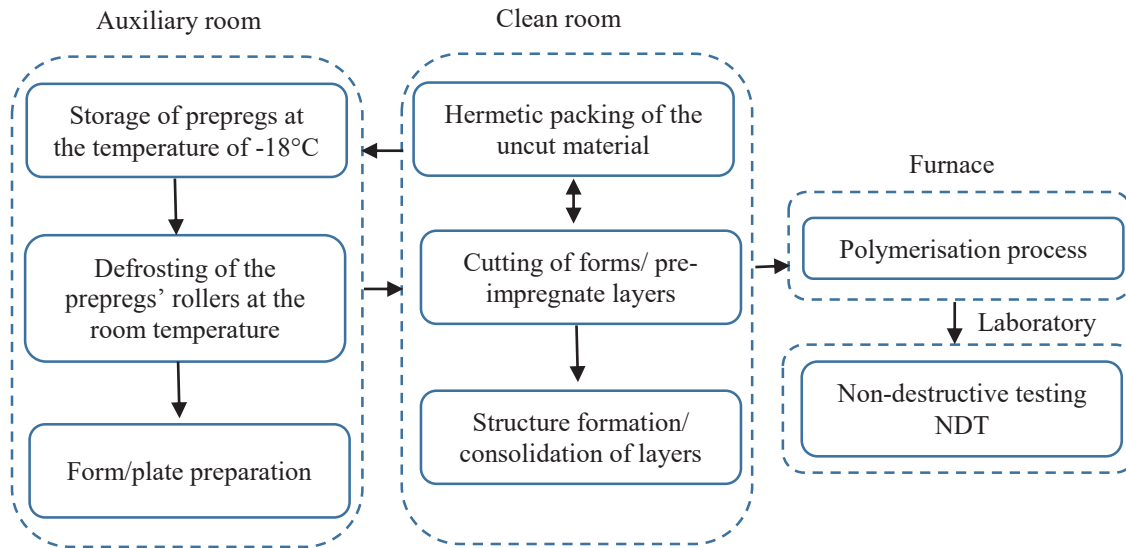
FIGURE 1. Manufacture diagram of composite element [9]

There was some researcher studied the quality control in manufacturing of composite structures. Szymanski studied the composite material which was used in the aviation industry. Manufacture diagram of composite element with polymer matrix was presented and the quality process in every stage was discussed briefly [9].
