## **Deterioration in the Water Quality of Groundwater in Some Municipal Water Extraction Plants in Finland**

**Pertti Lahermo and Jouko Parviainen**

Geological Survey of Finland, Otaniemi and National Board  
of Waters, Mikkeli

In this study the changes in the quality of groundwater are described on the basis of material collected at some groundwater extraction plants situated mainly in urban areas. The causes of the marked increase in the content of dissolved solids are evaluated from the 1960s onwards.

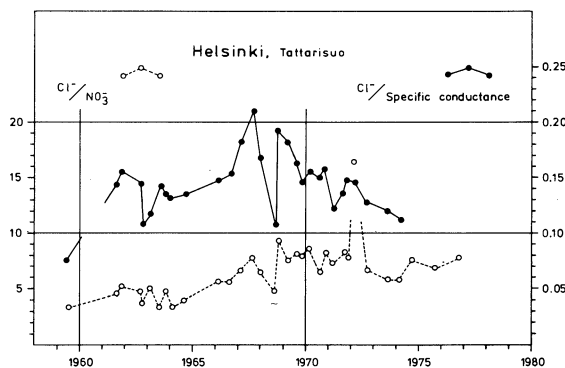
Fig. 3. The ratio of chloride contents to nitrate contents and specific conductance values respectively as function of time.

The electrolyte contents, total hardness and alkalinity of the groundwater increased conspicuously in the late 1960s when the motorway and other roads passing the well field were built (Fig. 2). There is no correlation between the development of water quality and the large fluctuations in pumping rate in the 1960s. The amounts of groundwater extracted have been much lower in the 1970s

1970s the chloride contents have decreased in relation to specific conductance, i.e. the amount of dissolved electrolytes. The ratio referred to correlates strongly with the amounts of groundwater pumped (cf. Figs. 2 and 3). At the low pumping rates employed in the 1970s the ratios have decreased. This may be because of the higher electrolyte contents of the groundwater, whose retention time is longer during a low extraction rate. It is also possible that the recovery in microbiological activity in the soil after road construction affects the growth of total electrolytes and hardness. Because of the growth and destruction of organic material, more carbon dioxide enters the soil and groundwater and thus carbonate and silicate minerals are leached more effectively. The iron contents have been below 1.5 mg/l, however, fluctuating considerably.
