## **Deterioration in the Water Quality of Groundwater in Some Municipal Water Extraction Plants in Finland**

**Pertti Lahermo and Jouko Parviainen**

Geological Survey of Finland, Otaniemi and National Board  
of Waters, Mikkeli

In this study the changes in the quality of groundwater are described on the basis of material collected at some groundwater extraction plants situated mainly in urban areas. The causes of the marked increase in the content of dissolved solids are evaluated from the 1960s onwards.

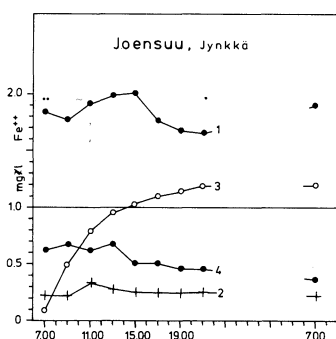
Fig.12. The development of iron contents in wells 1-4 during one 24-hour period (15-16.8.1977).

During the last twenty-five years the marked growth in water intake has led to an increase in iron contents although the total dissolved solids have remained nearly constant. Initially there was only one well but in the 1960s the iron contents rose so high that the construction of additional screened wells became essential. During regulation works carried out on the Pielisjoki, the water level dropped by 1.0 to 1.5 m in 1971. The corresponding decline in the groundwater table in the well field close to the shore caused an increase in iron contents (from 0.5 to 1.5 mg/l). In the 1970s still more wells were constructed; the safe yield was exceeded, however, and the diluting of the concentrations was only temporary. The concentrations vary from well to well, and even in the same well during a single day. (Fig. 12).

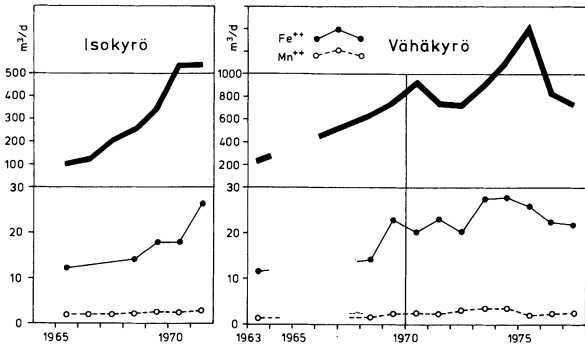
Fig.14. The dependence of iron and manganese contents on the amounts of groundwater pumped. For Vähäkyrö, the determinations are arithmetic means from three closely spaced wells. Only one analysis annually.

The groundwater extraction plants of Suolanen at Isokyrö and Vedenoja at Vähäkyrö are located on a flat cultivated plain, where the groundwater occurs in sand and gravel deposits overlain by clay beds 3 to 6 m thick. In hidden eskers of this kind or other clay-covered glaciofluvial deposits increased water intake has a strong influence on iron contents (Fig. 14). This is true especially when the safe yield is exceeded.
