Deterioration in the Water Quality of Groundwater in Some Municipal Water Extraction Plants in Finland

Pertti Lahermo and Jouko Parviainen

Geological Survey of Finland, Otaniemi and National Board
of Waters, Mikkeli

In this study the changes in the quality of groundwater are described on the basis of material collected at some groundwater extraction plants situated mainly in urban areas. The causes of the marked increase in the content of dissolved solids are evaluated from the 1960s onwards.

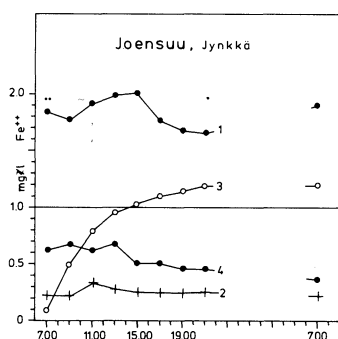
Fig.12. The development of iron contents in wells 1-4 during one 24-hour period (15-16.8.1977).

During the last twenty-five years the marked growth in water intake has led to an increase in iron contents although the total dissolved solids have remained nearly constant. Initially there was only one well but in the 1960s the iron contents rose so high that the construction of additional screened wells became essential. During regulation works carried out on the Pielisjoki, the water level dropped by 1.0 to 1.5 m in 1971. The corresponding decline in the groundwater table in the well field close to the shore caused an increase in iron contents (from 0.5 to 1.5 mg/l). In the 1970s still more wells were constructed; the safe yield was exceeded, however, and the diluting of the concentrations was only temporary. The concentrations vary from well to well, and even in the same well during a single day. (Fig. 12).
