Deterioration in the Water Quality of Groundwater in Some Municipal Water Extraction Plants in Finland

Pertti Lahermo and Jouko Parviainen

Geological Survey of Finland, Otaniemi and National Board
of Waters, Mikkeli

In this study the changes in the quality of groundwater are described on the basis of material collected at some groundwater extraction plants situated mainly in urban areas. The causes of the marked increase in the content of dissolved solids are evaluated from the 1960s onwards.

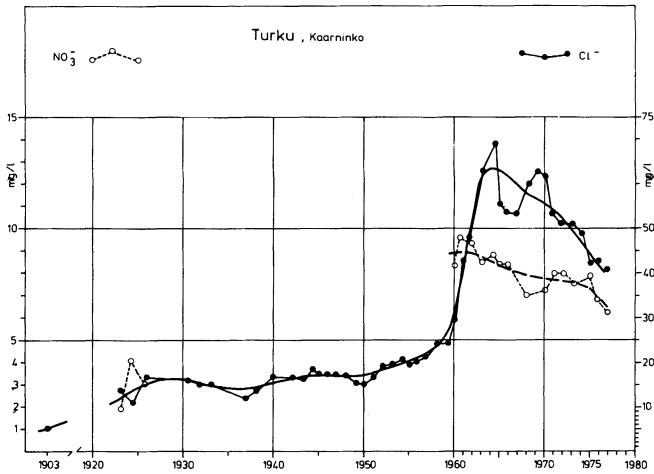
Fig. 6. The development of nitrate and chloride contents.

since 1903 (Fig. 6). The peak may be attributed partly to the excavation of gravel close to some wells and to the saline snow dumped in the pits during that period. Since the peak, the chloride contents have decreased considerably, possibly because waste soil is no longer dumped. Likewise, the nitrate contents have decreased somewhat since the peak.

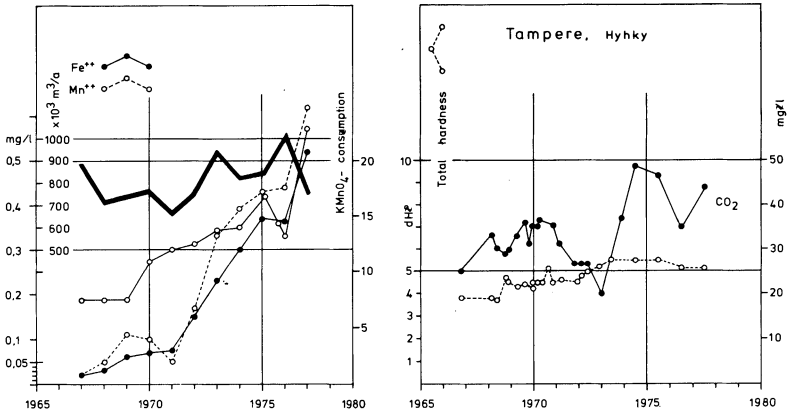
Fig. 7. The development of iron and manganese contents and KMnO_4 -values (left-hand graph), total hardness values and carbon dioxide contents (right graph). The heavy line indicates the amounts of water pumped. In the picture on the left the values are the annual arithmetic means (of 12 to 46 determinations), as they are in the picture on the right from year 1973 onwards.

In the 1970s, shortly after the construction of the new motorway, the iron and manganese contents and the KMnO_4 consumption values increased to such a level that the plant had to be closed a few times (Fig. 7). The amount of water pumped has not changed conspicuously; thus, the reasons for the increase in the contents have nothing to do with hydrodynamical changes in the groundwater. The general opinion is that the deterioration in the quality of the groundwater is due to infiltrated surface water from the lake into the aquifer. Underwater earth removal on the shore has broken the impermeable bottom sediments and caused large-scale infiltration from the lake into the esker. Surface water containing more organic material than groundwater caused reduced conditions in the aquifer, as is shown by the increased chemical oxygen demand (COD) of the water (KMnO_4 consumption in Fig. 7). As a result, the CO_2 -contents also increased, and this in turn produced conditions that favoured the dissolving of iron and manganese (Fig. 7). Total hardness and total dissolved electrolyte content increased only slightly (from 18-20 to 20-23 mS/m).

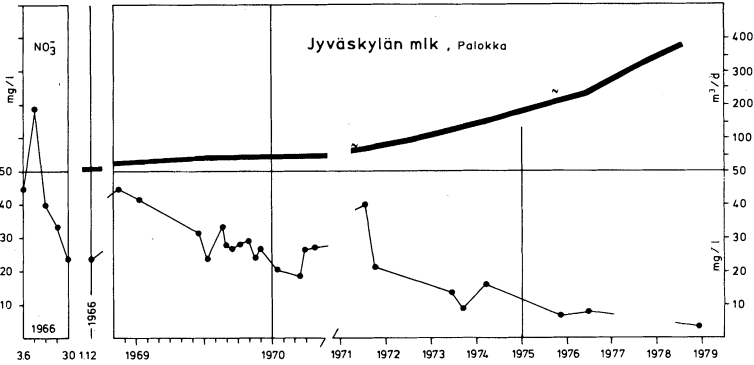
Fig.16. The development of nitrate contents. The heavy line indicates the amounts of water pumped.

The nitrate contents were high during test pumping but then started to decrease conspicuously (Fig. 16, cf. also Paavinlampi). After the completion of the well field they continued to decrease slightly. This trend may have been due to earlier agricultural activity, in the course of which nitrogen compounds were deposited in the soil. Nowadays the recharge area is largely occupied by an urban residential area. Increasing pumping rates have caused more effective leaching in the recharge area. Another reason for the trend may be the dilution of concentrations as a result of mixing with pure groundwater flowing from more distant areas of the aquifer. From 1974 onwards, nitrogen-poor groundwater from Kirri well field, 1 km to the north, has mixed with groundwater from Palokka and notably reduced the more recent concentrations.
