## **Deterioration in the Water Quality of Groundwater in Some Municipal Water Extraction Plants in Finland**

**Pertti Lahermo and Jouko Parviainen**

Geological Survey of Finland, Otaniemi and National Board  
of Waters, Mikkeli

In this study the changes in the quality of groundwater are described on the basis of material collected at some groundwater extraction plants situated mainly in urban areas. The causes of the marked increase in the content of dissolved solids are evaluated from the 1960s onwards.

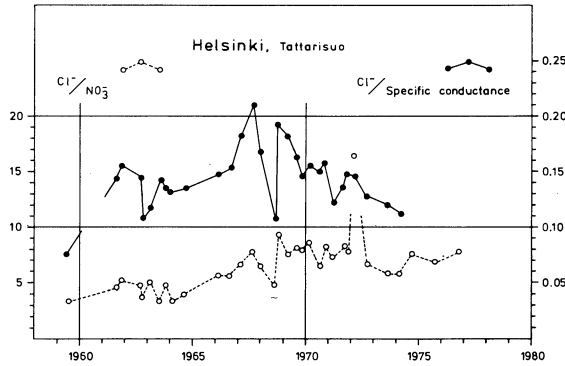
Fig. 3. The ratio of chloride contents to nitrate contents and specific conductance values respectively as function of time.

This is because of the overall increase in urban population as a result of extensive building programmes. The large excess of chlorides over nitrates suggests that the bulk of the external matter entering the groundwater originates from traffic and, particularly, from the defrosting salt put on roads. The increase in the  $\text{Cl}^-/\text{NO}_3^-$  ratio in the 1960s adds weight to this point of view (Fig. 3). In the

1970s the chloride contents have decreased in relation to specific conductance, i.e. the amount of dissolved electrolytes. The ratio referred to correlates strongly with the amounts of groundwater pumped (cf. Figs. 2 and 3). At the low pumping rates employed in the 1970s the ratios have decreased. This may be because of the higher electrolyte contents of the groundwater, whose retention time is longer during a low extraction rate. It is also possible that the recovery in microbiological activity in the soil after road construction affects the growth of total electrolytes and hardness. Because of the growth and destruction of organic material, more carbon dioxide enters the soil and groundwater and thus carbonate and silicate minerals are leached more effectively. The iron contents have been below 1.5 mg/l, however, fluctuating considerably.

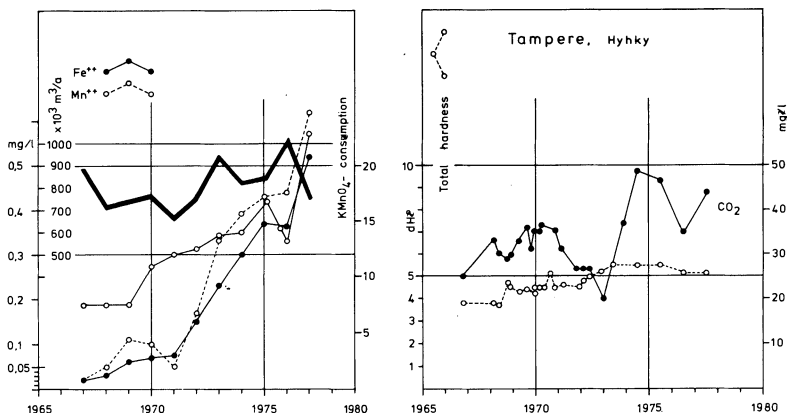
Fig. 7. The development of iron and manganese contents and  $\text{KMnO}_4$ -values (left-hand graph), total hardness values and carbon dioxide contents (right graph). The heavy line indicates the amounts of water pumped. In the picture on the left the values are the annual arithmetic means (of 12 to 46 determinations), as they are in the picture on the right from year 1973 onwards.

In the 1970s, shortly after the construction of the new motorway, the iron and manganese contents and the  $\text{KMnO}_4$  consumption values increased to such a level that the plant had to be closed a few times (Fig. 7). The amount of water pumped has not changed conspicuously; thus, the reasons for the increase in the contents have nothing to do with hydrodynamical changes in the groundwater. The general opinion is that the deterioration in the quality of the groundwater is due to infiltrated surface water from the lake into the aquifer. Underwater earth removal on the shore has broken the impermeable bottom sediments and caused large-scale infiltration from the lake into the esker. Surface water containing more organic material than groundwater caused reduced conditions in the aquifer, as is shown by the increased chemical oxygen demand (COD) of the water ( $\text{KMnO}_4$  consumption in Fig. 7). As a result, the  $\text{CO}_2$ -contents also increased, and this in turn produced conditions that favoured the dissolving of iron and manganese (Fig. 7). Total hardness and total dissolved electrolyte content increased only slightly (from 18-20 to 20-23 mS/m).

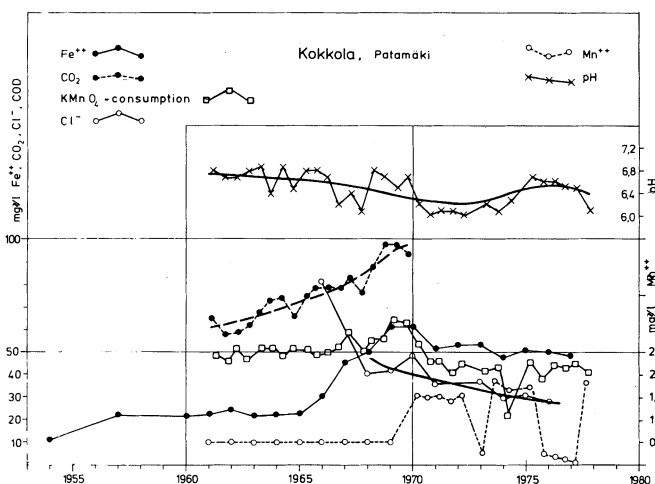
Fig.11. The development of iron, manganese,  $\text{CO}_2$  and chloride contents, and the  $\text{KMnO}_4$  consumption and pH values.

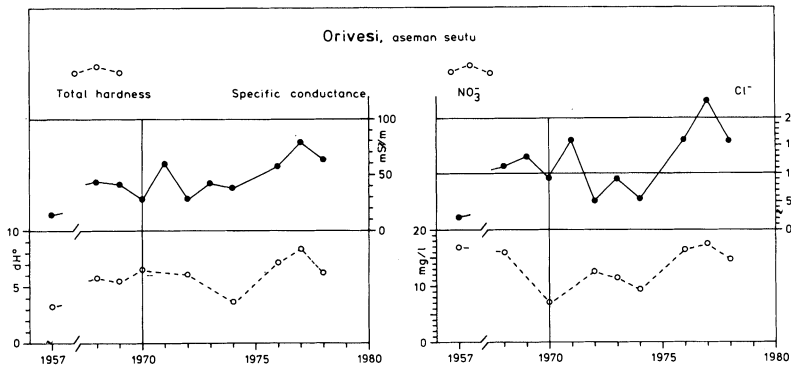
Fig.17. The development of total hardness and specific conductance values (left-hand graph), and nitrate and chloride contents (right-hand graph). The values are single or annual arithmetic means of two determinations.

Asemanseutu groundwater extraction plant is an example of observed groundwater pollution. The well field is located in a built-up area, near Orivesi railway station, at the terminal part of an esker sloping towards a lake partly covered by silt deposits. Half a kilometre upstream there is an old abandoned gravel pit which had served as a store for defrosting salts for the roads. Furthermore, near the wells a septic underground container was leaking into the ground. Thus pollutants entered the ground from overall human activity, but especially from the two sources mentioned. As a result the concentrations of nitrates and especially of chlorides were high (Fig. 17). Alterations in concentrations were marked because of variations in polluting activity and the rate of leaching and infiltration in the
