The Use of Unmanned Aerial Vehicles for Sloped Roof Inspections – Considerations and Constraints

Abstract

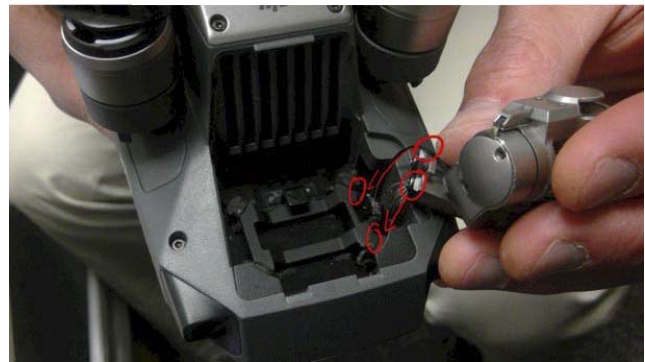
ILLUSTRATION 1.—Gimbal Mounting Plate Breaking Point

mounting plate snapped, in another the mounting plate was bent and the gimbal itself was damaged requiring replacement. In both cases the camera itself was not damaged. The gimbal plate is made of a fragile cast metal (“pot metal”). This plate might have been designed as a deliberate weak spot to avoid damage to the camera itself. It is possible to replace the plate at home with some technical skills (the authors succeeded in doing it twice), but the process is unnecessarily awkward and time-consuming because of the cable routing to the camera. The Mavic was clearly not designed to be repaired by an average owner, yet with a minor change of cable routing the job could be done simply and quickly. Given the probability of crashing the Mavic in the application in question, this is seen as a significant issue. Illustration 1 shows the mounting plate's weak spot.

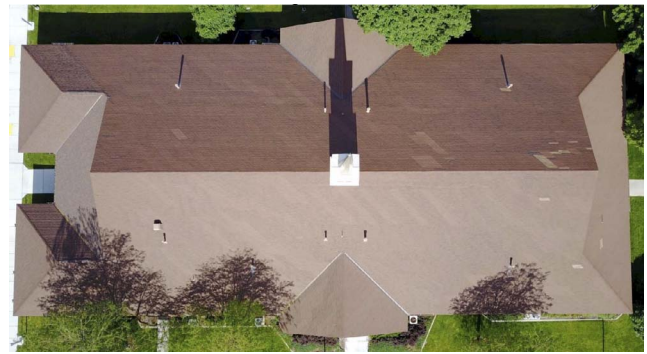
ILLUSTRATION 4.—Initial Image at 180 Feet to See Defect Zones

was found that if the entire roof was pictured at the 10-15 foot level, it was hard to keep track of which part of the roof was being shown. It is possible to get a good overview of the general condition of the roof by zooming in on the quadrant-height images, supplemented by the detail-height images. The vertical still image approach is the preferred method. It is the most efficient method to manage, and can be expanded to give more detail by dividing the roof into more sections if the quadrant height is reduced from 70 feet. Examples of image quality using this approach can be seen in Illustrations 4 and 5.
