# Composite Patch Repair for Underwater Aluminum Structures

*Both experimental and numerical studies were conducted to investigate the effectiveness of composite patch repair on underwater structures, especially aluminum alloy structures. Physical samples were prepared using 5XXX aluminum plates with a pre-machined hole and E-glass woven fabric layers. The epoxy resin was selected such that it could be cured underwater. Test samples were prepared under different curing conditions such as dry curing and wet curing with different durations of in-water exposure. Strain gages were attached to all samples. The samples were tested for both tensile and four-point bending loads. Furthermore, numerical modeling and simulations were conducted, and the numerical models were validated against the experimental measurements. Then, the interface normal and shear stresses were determined from the numerical models so as to understand the delamination failure at the interface between the aluminum and composite patches. Underwater composite patching showed good interface strength and potential for successful usage in repairs.*

**Keywords:** composite patching, underwater application, aluminum alloy

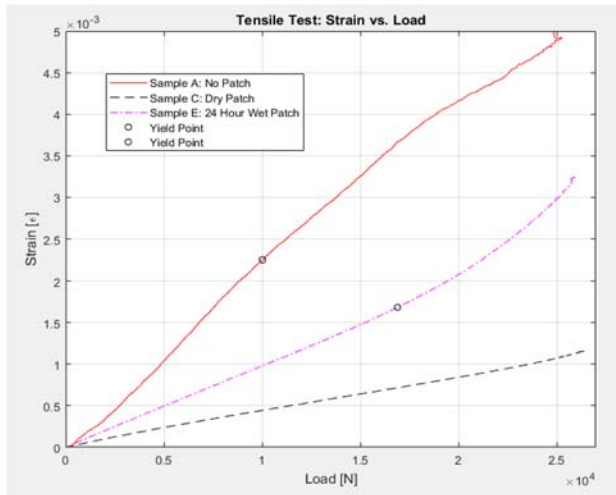
**Fig. 6** Plots of load-strain for no patch, dry patch, and wet patch samples

Because two samples out of the same group behaved consistently, one of the two samples was selected to represent the group in the following discussion. Figure 6 compares the strain versus load curves for samples A, C, and E. The strain was measured at the edge of each hole in the aluminum plate. As seen in the figure, the samples with a patch had a significant decrease in the strain over the same loading conditions. The load to reach yielding at the hole also increased with a patch. Sample A, the no patch case,

reaches its yield point at approximately 10,000 N, whereas Sample E, the 24 h wet patch, reaches its yield point 16,900 N.

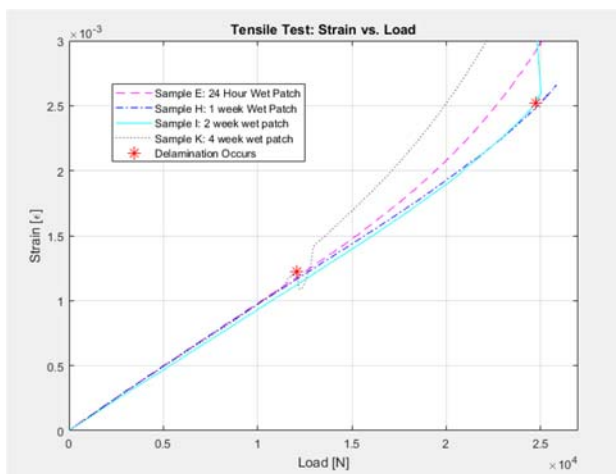
**Fig. 7** Comparison of load-strain plots among wet patched samples with a variable amount of curing time in water

The samples that were patched in the underwater environment and left in to cure for a variable amount of time are the samples E–L. One sample from each time period is shown in a comparative graph of strain versus load as shown in Fig. 7. As seen in the figure, the samples that have been patched underwater and allowed to cure in the water for different amounts of time perform very similar in the tensile test. There were two samples that experienced failure in the mode of delamination. These points are displayed by star symbols in Fig. 7.

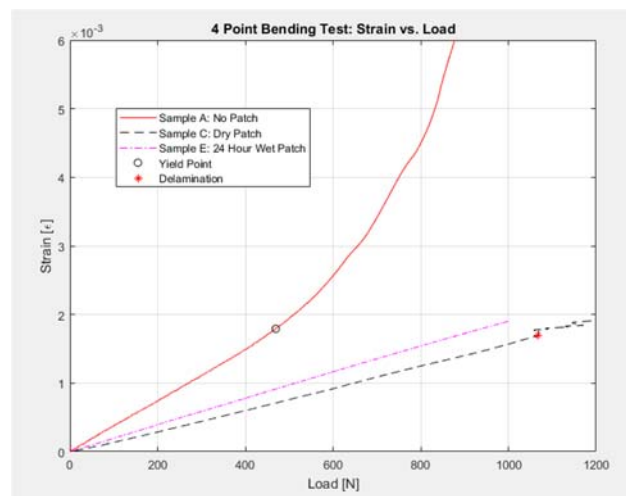
**Fig. 8** Load-strain curve for Samples A, C, and E under bending load

Figure 8 compares the load versus strain curves for the first three categories of samples: no patch, dry patch, and 24 h wet patch samples. Examining the test results suggests that a composite repair patch applied to an underwater structure can significantly improve the structural integrity. The strain experienced at the hole, which is directly related to stress, is significantly decreased when a repair patch is applied. The solid line in Fig. 8 is Sample A, with no repair patch applied. This aluminum sample reaches its yield point at 470 N and begins to enter the plastic region. Sample C, the sample with a dry repair patch, did not reach a yield point, but failure mode of delamination occurred at 1070 N. Sample E, the sample with a wet repair patch, did reach neither a yield point nor delamination of patch until the predetermined applied load was reached.

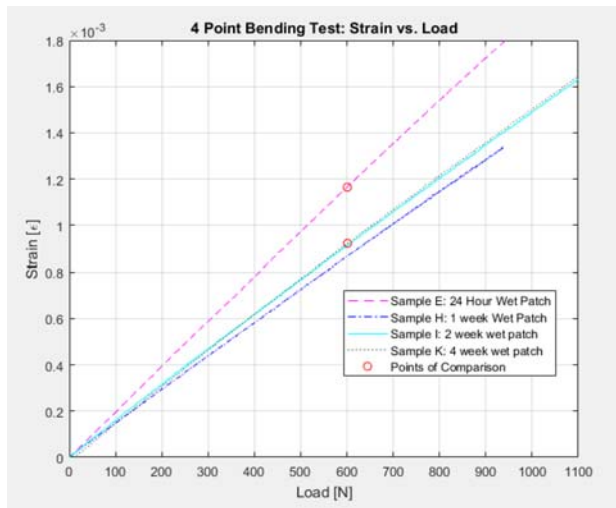
**Fig. 9 Comparison of load-strain curves for wet patched samples under bending loads**

Samples E and H have a similar shear stress when compared with sample C, but the experiment showed no failure due to delamination. This has shown that the interface strength between the patch and the aluminum sample is stronger when the patch is left in the water to cure. All samples that were patched in the water are compared in Fig. 9. This graph shows that except for Sample E, all other samples have very close load-strain curves. In order to validate the computer models under bending loads, the experimental and numerical strains near the hole were compared at the given loads. Table 5 summarizes the comparison. Overall, the comparison was reasonable to support the numerical model.
