# Accepted Practice for Recognizing Artifacts in Air Plasma Spray Thermal Barrier Coating Microstructures

*ASM Thermal Spray Society, Accepted Practices Committee*

## ABSTRACT

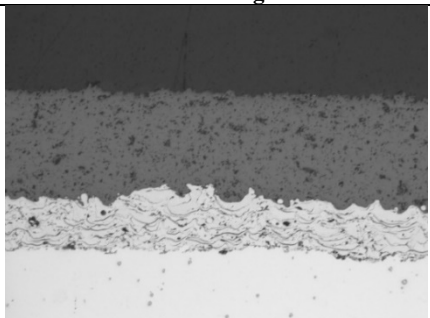
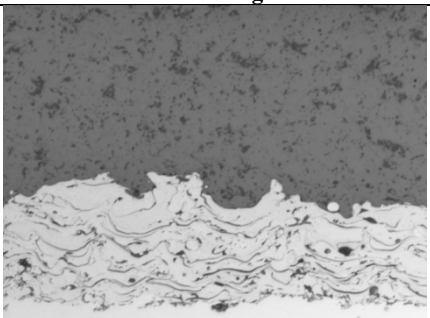
8.5
B

Sample A had reduced polishing times from Method-II for all polishing steps; the result was a higher pore fraction in the TC compared to the other samples, demonstrating that a false-high pore fraction is an artifact of planar grinding and insufficient fine grinding time.

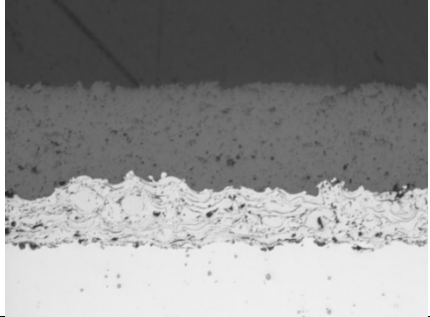
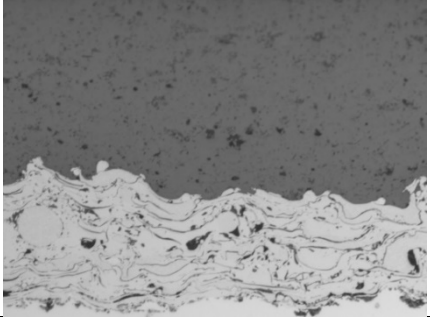
5.6
C

Sample B had a reduced fine grinding time but normal subsequent polishing times, resulting in significantly lower pore fraction from Sample A. Sample B demonstrates that a reduced fine grinding time can be compensated by longer subsequent polishing times, but localized planar grinding marks and artifacts may remain.

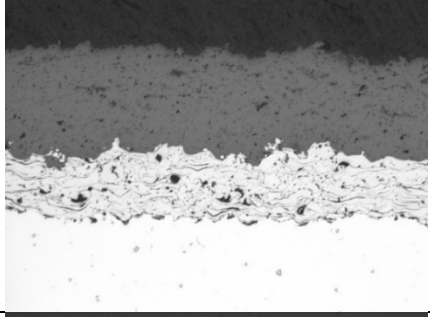
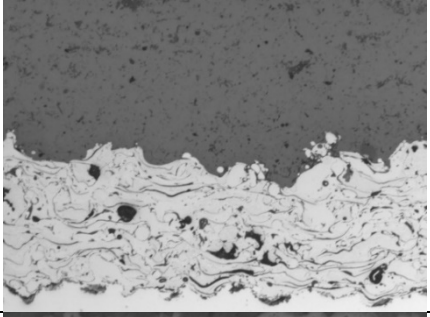
5.0
D

Sample C had normal fine grinding time but longer polishing times, resulting in slightly lower TC porosity than Sample B. Sample C demonstrates that pore fraction stabilizes (no longer decreases) when all artifacts are removed.

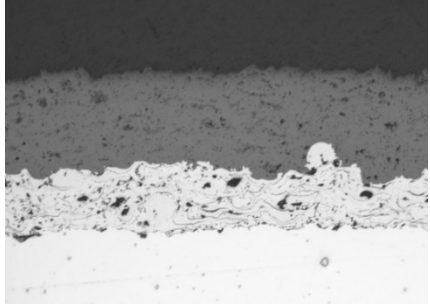
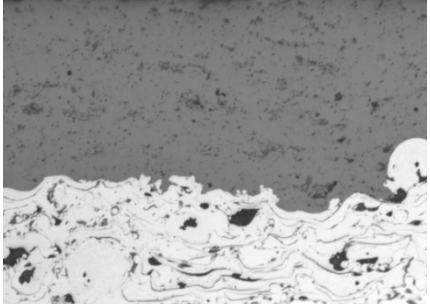
5.3

Sample D had extended times for all steps and demonstrates that true microstructure can be verified by extended polishing times where additional polishing causes no change in pore fraction.
