Defective Disposable Oxygen Face Masks

DAVID H. SPRAGUE, M.D.*

THIS COMMUNICATION reports three incidents in which manufacturing defects or poor design of disposable oxygen face masks led to potentially lethal problems when humidified,

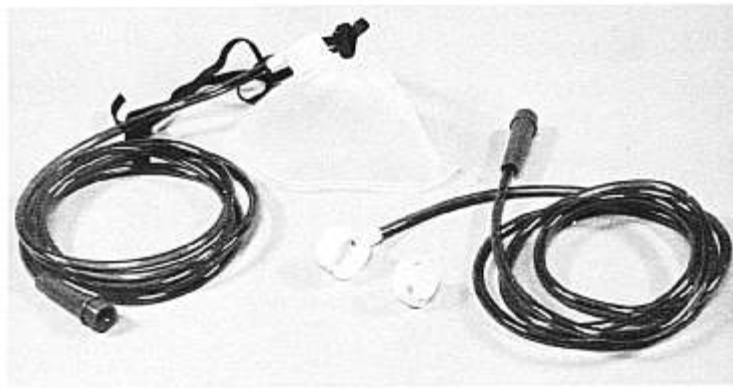
FIG. 1. The assembled Lif-O-Gen mask and the two parts of the swivel connector. The inner part projects through an opening in the mask from the patient's side; the outer part with the attached oxygen tubing slips over the projecting inner part.

oronasal oxygen mask† (fig. 1) with a swivel connector was attached to the patient. Thirty minutes after admission to the recovery room, the patient was found choking. As the patient was turned onto his side, he coughed out of his pharynx the inner part of the swivel connector. This inner part of the connector had fallen into his mouth

as the connector spontaneously disassembled. It was later found that application of a slight force to the oxygen tubing dislodged the inner part of the connector from the outer part attached to the tubing.

Inspection of the stock of Lif-O-Gen face masks at our hospital revealed that many of the swivel connectors disassembled easily when a slight force was exerted on the oxygen tubing. In addition to the complication documented in the first case, this defect has caused disconnections of the oxygen tubing from the face mask on other patients during oxygen therapy. Because of the serious nature of this defect, I feel that the design of the connector should be modified by the manufacturer in order to prevent accidental disassembling.

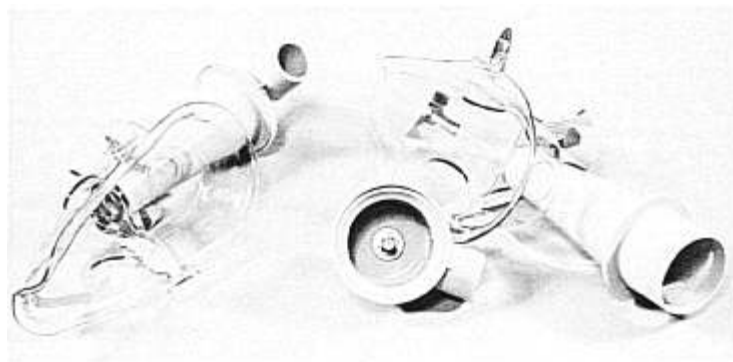
FIG. 2. The assembled and disassembled Vari-O-Mask. The disassembled mask is oriented to show the centrally located, oxygen orifice within the plastic body.

and pH 7.35. Due to a history of carbon dioxide retention, non-ventilatory therapy was employed initially. A disposable, variable-oxygen-concentration mask¹ (fig. 2) was connected to the patient, and the dial cap was set to deliver 35 per cent humidified oxygen. Thirty minutes later, arterial blood-gas values were P_{O_2} 30.6 torr, P_{CO_2} 79.3 torr, and pH 7.33. Because of the failure of the blood-gas values to change with oxygen therapy, the oxygen concentration under the mask was measured and found to be 20 per cent. Disassembling the mask disclosed that the oxygen orifice of the Venturi mechanism was occluded by a layer of clear plastic.

Patient 3. A 68-year-old man with chronic pulmonary disease was admitted to the hospital in acute respiratory failure. The patient's condition initially responded to therapy that included 30 per cent humidified oxygen delivered by a variable-oxygen-concentration mask¹ (fig. 2); arterial blood-gas values were P_{O_2} 46 torr, P_{CO_2} 55 torr, and pH 7.37. However, on the second night after admission, approximately 60 minutes after the mask had been replaced by a sterile one, the patient was confused. Measurement of the oxygen concentration under the face mask revealed an $F_{I_{O_2}}$ of 100 per cent rather than 30 per cent. Inspection of the mask revealed that the indicator for the oxygen concentration dial was not marked clearly. This shortcoming in the design of the mask had led to the mistaken identification of a seam in the plastic body as the indicator and thereby to the error in administered concentration.

Inspection of our stock of Vari-O-Masks revealed 15 masks with a plastic layer obstructing the oxygen orifice as in the second case; all the Vari-O-Masks in stock had oxygen concentration dials similar to that in the third case. This mask should be inspected before use to verify the patency of the oxygen orifice and to insure that the indicator for the oxygen concentration dial can be correctly identified.
