## CASE REPORTS

Anesthesiology

### Transesophageal Echocardiographic Diagnosis of Pulmonary Artery Catheter Entrapment and Coiling

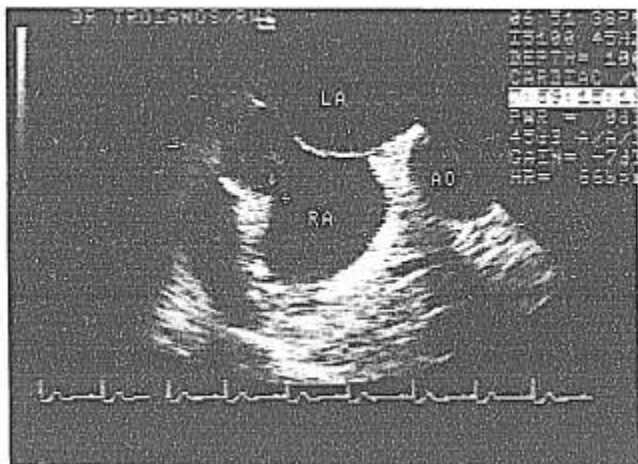
**Fig. 1.** Two-dimensional echocardiogram demonstrating invagination of the right atrial wall as the pulmonary artery catheter is withdrawn. RA = right atrium; LA = left atrium; AO = aortic root. Arrows indicate invagination of right atrial free wall. Top is posterior.

Transesophageal echocardiography was employed in the first case presented to determine the site of PA catheter entrapment and to direct surgical correction. Invagination of the right atrium while withdrawing the PA catheter confirmed its attachment to the lateral free wall of the right atrium. The implication of this finding

was that institution of cardiopulmonary bypass for direct examination inside the right atrium was not required. More importantly, the TEE examination determined that release of mitral annular sutures and, possibly, resuturing the prosthetic mitral valve were not necessary.
