Anesthesiology
80:1402, 1994
© 1994 American Society of Anesthesiologists, Inc.
J. B. Lippincott Company, Philadelphia

Severe Air Embolism Caused by a Pulmonary Artery Introducer Sheath

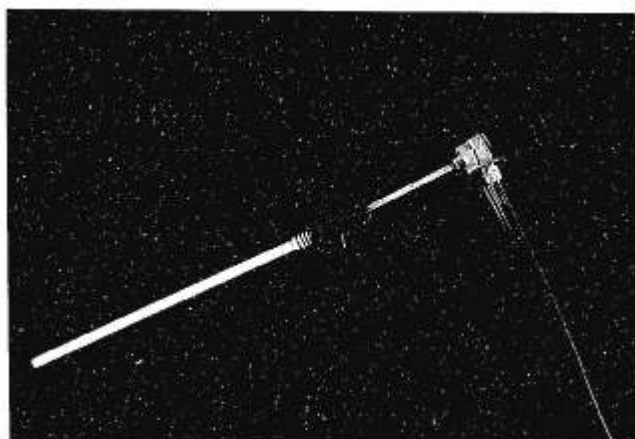
Fig. 1. Arrow 8.5-French introducer sheath with the unscrewed hemostatic valve and the obturator pulled out at half of its length. This situation was observed in the first case. In the second case, the hemostatic valve with the obturator was disconnected completely.

operative course in the intensive care unit was uneventful, and the pulmonary artery catheter was removed. An obturator was inserted through the hemostatic valve. The patient, somewhat disoriented 6 days after successful transplantation, unscrewed the hemostatic valve (fig. 1), and although the valve was immediately reconnected, the patient lost consciousness.

Air embolism is a rare complication of invasive monitoring of the right heart and of central venous cannulation, especially when large-bore catheters are used.² In the two cases described, embolism was facilitated by disassembly of the two-part introducer sheath and side port-hemostatic valve mechanism. The Luer lock screw-top attachment for the introducer to the side port and hemostatic valve has no safety lock to prevent unauthorized use. We believe that the development of a safety lock cap is the only way to allow the use of the two-part system in awake patients. Safe hemostatic valves and a tight or safe junction between the catheters (*e.g.*, introducer sheaths) and the valves are recommended.
