# Composite Resin Core Buildups With and Without Post for the Restoration of Endodontically Treated Molars Without Ferrule

P Magne • J Goldberg • D Edelhoff  
J-F Güth

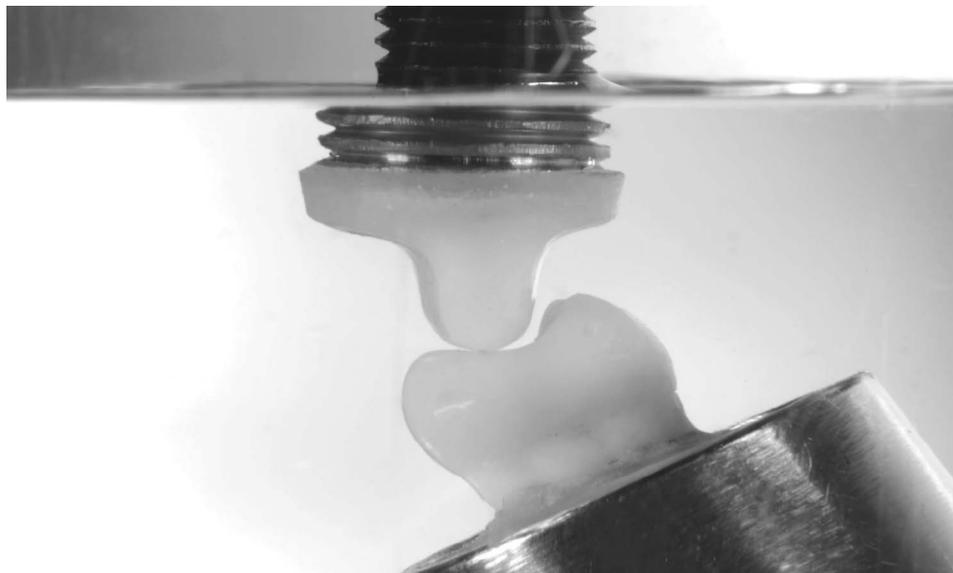
Figure 3. Specimen in load chamber, filled with distilled water to submerge specimen during testing.

Masticatory forces were simulated using closed-loop servohydraulics (Mini Bionix II, MTS Systems, Eden Prairie, MN, USA). The masticatory cycle was simulated by an isometric contraction (load control) applied through an artificial composite resin cusp (Z100, 3M ESPE) in the shape of a semicylinder (2.5-mm radius). The low stiffness and tooth-like wear of the composite resin cylinder allows realistic simulation of tooth contacts through wear facets distributing the load without reaching the compressive limit of the tissues or restorative materials. All specimens were placed in the load chamber at 30-degree angulation and situated with a positioning device (sliding table) to create a single contact between the semicylinder and the palatal cusp. The loading point was equidistant to the cusp tip and central groove (Figure 3). The load chamber was filled with distilled water to submerge the specimens during testing. Cyclic load was applied at a frequency of 5 Hz, starting with a warm-up load of 200 N for 5000 cycles (preconditioning stage), followed by stages of 400, 600, 800, 1000, 1200 and 1400 N at a maximum of 30,000 cycles each. Specimens were loaded until fracture or to a maximum of 185,000 cycles.

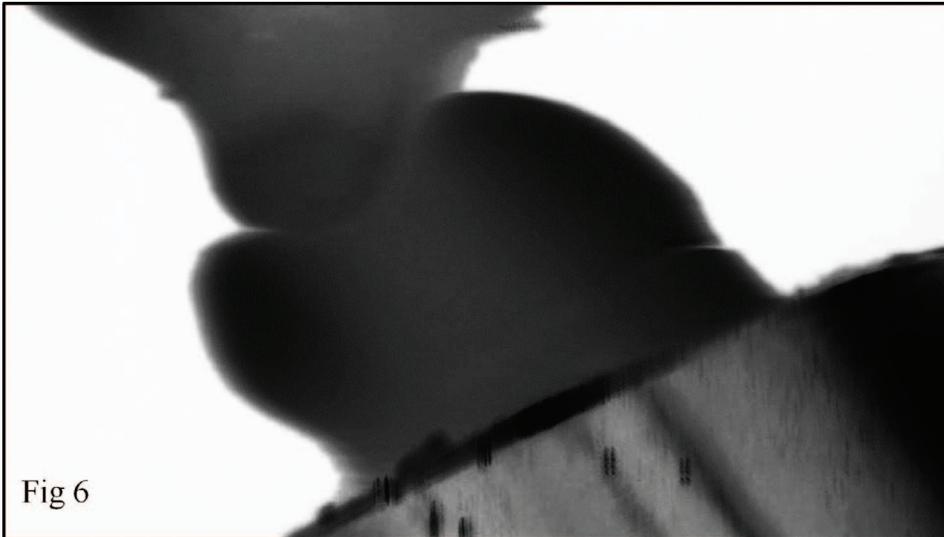
Fig 6

Figure 6. Initial failure of the specimen was preceded by the cyclic opening of a wide gap at the margin between the buildup/crown assembly and the root. The gap was always located at the opposing side of the post. Such occurrence was never found in the groups without post. Because clinical detection of such failures appears to be questionable, the analysis of survival was conducted for the “total failure.” Image motion blur is due to loading dynamics and water immersion.

During cyclic loading, initial failures (MFPi) were detected in 20% (3/15) of specimens of group MFP. Failure of the specimen was preceded by the cyclic opening of a wide gap at the margin between the buildup/crown assembly and the root. The gap was always located at the opposing side of the post. Such occurrence was never found in the other groups. In group MHB, no initial failures could be detected. The life table survival graphs for groups MHB, MFP, and MFPi are displayed in Figure 5. Log-rank test showed no statistically significant differences in the survival of group MHB compared to group MFP ( $p=0.613$ ) or group MFPi ( $p=0.221$ ).

During cyclic loading, initial failures were detected in 26.7% of specimens of group TECP (TECPi) and 20% of specimens of group MFP (MFPi) (Figure 6). Because clinical detection of such failures appears to be questionable, the analysis of survival was conducted for the “total failure” (TECP, MFP) and for the “initial failure” (TECPi, MFPi). For total failure, HPP showed, even after Bonferroni correction, significantly higher survival than TEC ( $p=0.001$ ) and TECP ( $p=0.001$ ). Differences between all other groups were not significant. When considering initial failure, however, HPP proved also to survive significantly better than TECPi and MFPi. The life table survival graphs for groups HPP, TEC, TECP, and TECPi are displayed in Figure 7. Table 2 gives the *p*-values for groupwise comparisons.

facilitating bacterial infiltration and possibly causing secondary decay. A possible explanation for this phenomenon is that the post acts as a lever (rotation center) and causes the opening of a gap opposite to the load side during oblique loading (30 degrees). In addition, post systems are usually supplied with their own self-etching and/or self-adhesive dentin bonding system. Because initial failures did not occur when the total etch-and-rinse three-step dentin adhesive was used (HPP, TEC, MHB), the efficiency of the simplified adhesives may be questioned. Further studies are needed to evaluate whether initial failures would also occur when limiting the application of the post adhesive system to the root canal itself and using a classic adhesive on the remaining dentin surface to which the core material is bonded. This would further complicate the already time-consuming, material-intensive, and technique-sensitive procedure of post insertion and buildup.
