A Conservative Technique for Repairing Class IV Composite Restorations

VC Ruschel • SC Stolf • S Shibata • LN Baratieri

Clinical Relevance

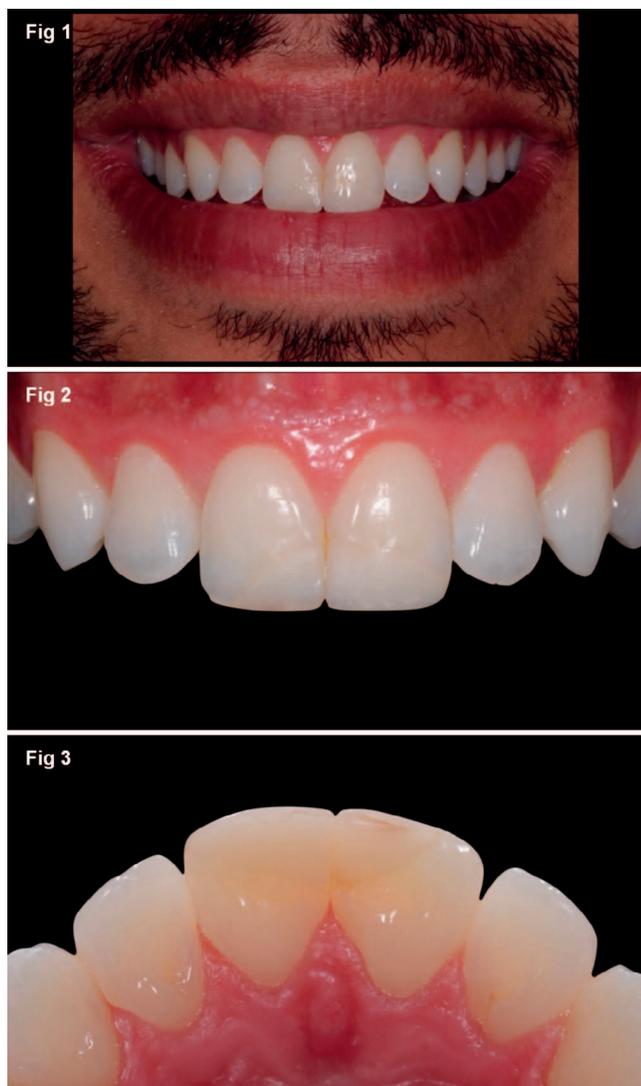
Figure 1. Initial aspects of the patient's smile. Note the unsatisfactory color of the class IV restorations in the two maxillary central incisors.

Figure 2. Intraoral view of maxillary anterior teeth.

Figure 3. Palatal view of maxillary anterior teeth. Observe that the palatal surface of the restoration in tooth No. 9 has adequate marginal adaptation, unlike the restoration in tooth No. 8.

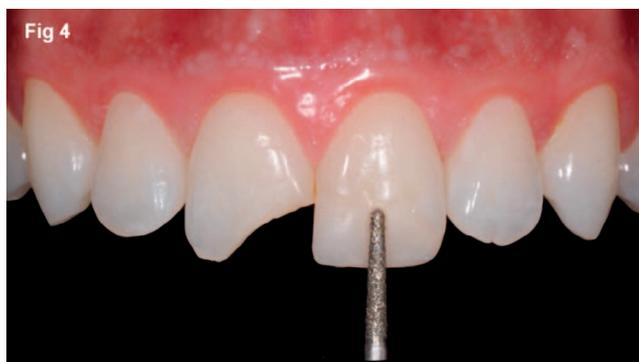
Figure 4. Restoration in tooth No. 8 removed and preparation of the facial surface of the restoration in tooth No. 9 with a tapered diamond bur.

remove the restoration in tooth No. 8 and to prepare the facial surface of the restoration in tooth No. 9 (Figure 4). The preparation was conducted to provide space for the composite resin stratification, across the entire facial surface of the restoration, respecting the inclination of the mesial and incisal thirds. In addition, the mesial surface was prepared to create space for insertion of proximal artificial enamel (Figures 5 and 6). A design of the mamelons was made in the incisal region, using a sharp-ended diamond bur (2137F, KG Sorensen), to obtain space for the reproduction of an opaque and opalescent halo (Figure 7). Afterward, a mock-up was conducted to verify the correct composite resin color selection and was left for 1 week as a temporary restoration.

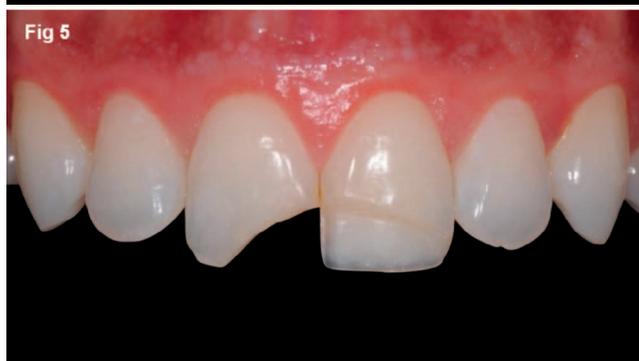
Figure 5. Aspect of the prepared facial surface of the restoration.

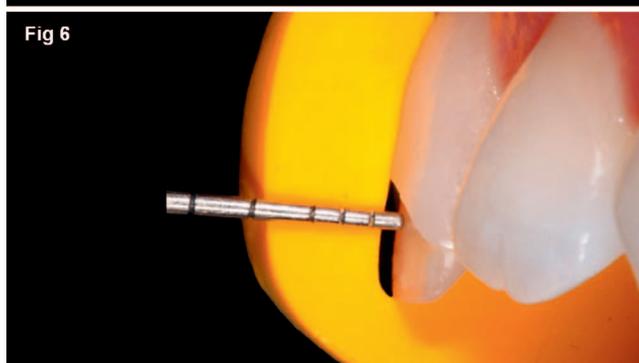
Figure 6. Lateral view of the silicone guide in position. Note that the space for insertion of the composite resin is 0.7 mm.

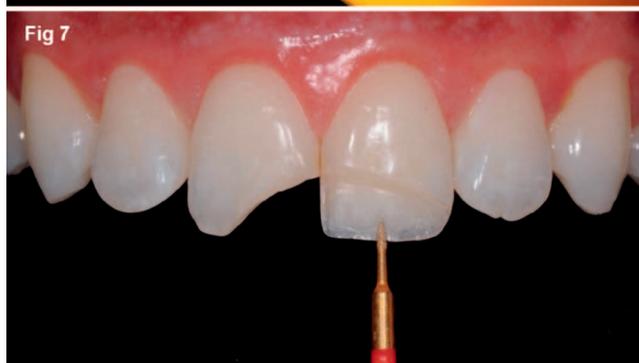
Figure 7. Design of the dentin mamelons with a sharp-ended diamond bur.

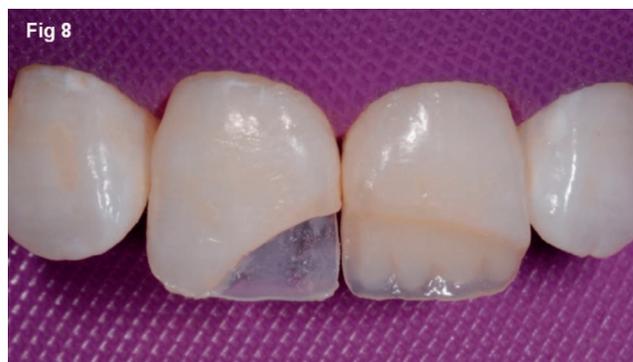
Figure 8. Intraoral view of the palatal enamel on tooth No. 8 and the preparation of tooth No. 9 after adhesive procedures.

The stratification of the composite resin on tooth No. 8 included high translucent resin EB1 (IPS Empress Direct, Ivoclar Vivadent) to reproduce the palatal enamel, using a silicone guide obtained from

the waxing (Figure 8). The incisal halo was reproduced with low translucent resin DB1 (IPS Empress Direct, Ivoclar Vivadent). Low translucent resin DA1 (IPS Empress Direct, Ivoclar Vivadent) was used to reproduce mesial thirds dentin, and low translucent resin DB1 (IPS Empress Direct, Ivoclar Vivadent) was used to reproduce incisal third dentin and dentin mamelons. A translucent resin was used (Trans 30, IPS Empress Direct, Ivoclar Vivadent) to reproduce the opalescent halo, which was lightly applied to the dentin mamelons. The facial enamel was finished with a thin layer of high translucent resin EB1 (IPS Empress Direct, Ivoclar Vivadent). The restoration in tooth No. 9 was performed with

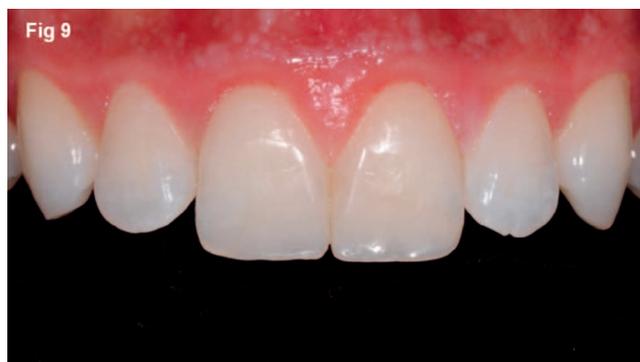
Figure 9. Aspect of the upper arch after the restoration is finished and polished.

In the next session, the finishing and polishing procedure was initiated with abrasive strips (3M ESPE) on the proximal surfaces. The facial surfaces were finished with sequential polishing discs of decreasing grit size (Sof-Lex Pop On, 3M ESPE). A carbide bur (FG 7664F, KG Sorensen) was used to remove excess resin from the preparation margin and to reproduce vertical texture. A felt disc (Diamond Felt Disc, FGM, Joinville, SC, Brazil) with diamond polishing paste (Diamond Excel, FGM; Figures 9-11) was used to perform the final polishing.

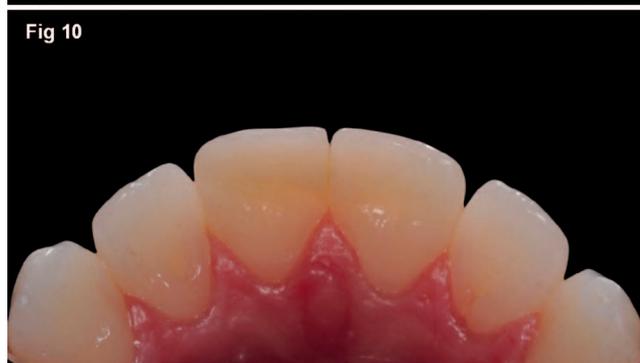
Figure 10. Palatal view of the finalized restorations.

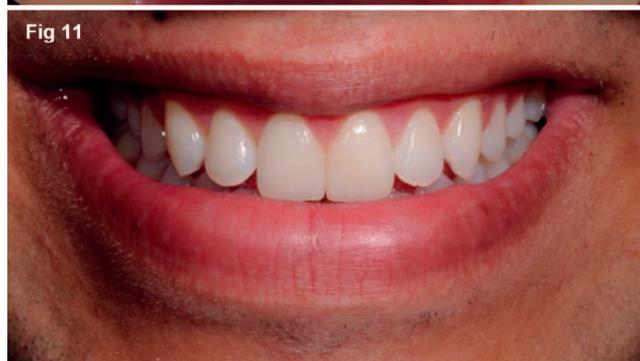
Figure 11. Patient's smile after restorative treatment.
