REPORT FROM ISRAEL

Niki Josefovici, DMD

Multimodal practice is alive and well here in Tel Aviv. This communication describes a 14-year treatment period for a patient who was under my care.

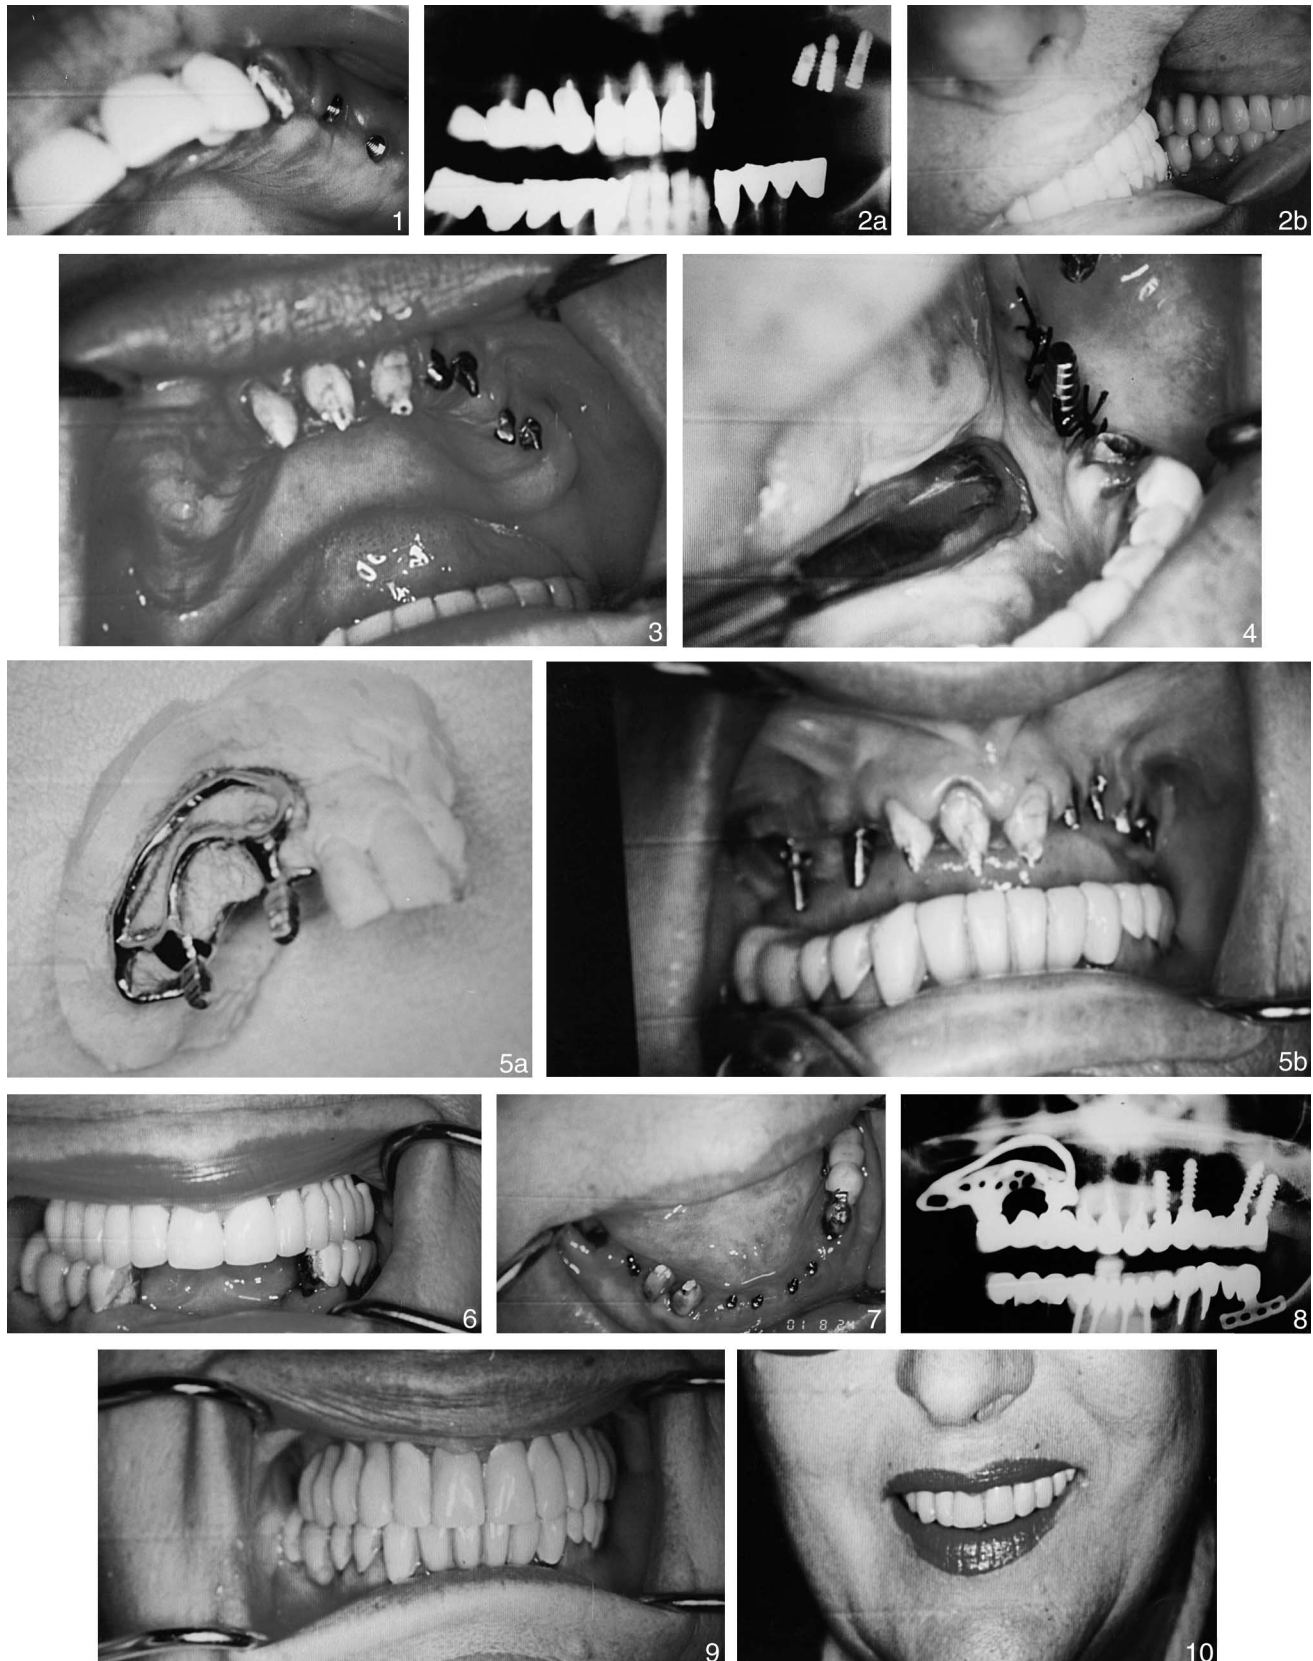
FIGURES 1–10. FIGURE 1. The maxillary left quadrant was provided with 2 root-form threaded implants. FIGURE 2. (a and b) This completed ceramometal fixed prosthesis was supported by 2 root-form implants and the restored canine tooth. FIGURE 3. The lateral incisor has now been added as a means of maintaining a newly fabricated bridge. FIGURE 4. This blade implant was selected for the left posterior mandible because the bone morphology required it. FIGURE 5. (a and b). The subperiosteal implant casting was placed and within 6 weeks, with the assistance of the remaining dentition and implants, served as abutments for a full-arch fixed bridge. (See FIGURES 7, 8, 9). FIGURE 6. The lower incisors were lost because of neglect. FIGURE 7. Mini-implants were placed strategically in the anterior and right mandible. The blade from previous years was still serving reliably. FIGURES 8, 9, 10. The most recent panoramic radiograph, close-up, and full-face photographs of this persevering woman show her current state of oral health.

The earliest encounter with this healthy female patient was in 1985; she presented for treatment of the left maxilla, which was edentulous, distal to the canine. The canine was restored with a cast post and core, 2 root-form implants placed, and the quadrant restored with a ceramometal fixed bridge (Figures 1 and 2). Within 6 months the restoration failed secondary to the fracture of the canine root. New root-form implants were inserted (bringing the total to 3), and the lateral incisor was prepared to serve as an abutment for a new fixed prosthesis. (Figure 3). At the same time the left posterior mandible required treatment. Due to a narrow ridge, a single-headed blade implant was placed and a 4-unit bridge completed the procedure (Figure 4).

plained of problems in the right maxilla. With the loss of this support, the left posterior prosthesis became unstable. The final solution for the maxillae was developed with the assistance of 2 new, 1-stage, threaded root-form implants on the left side and a unilateral, double-abutted subperiosteal implant on the right side (Figure 4a and b). With the support of 3 remaining natural incisors, a full-arch, fixed prosthesis was fabricated and cemented.

Seven years later, after long periods of neglect, the patient returned with significant mandibular anterior deterioration (Figure 5). Treatment consisted of removal of the right posterior bridge, placement of 5 mini-implants, and replacement with a full-arch fixed prosthesis (Figures 6 and 7).

It has been almost 5 years since the patient's implants have been restored and her course during this period has been free of problems. The final photographs demonstrate her oral appearance and excellent state of gingival health (Figures 8, 9 and 10).
