Ferrule-Effect Dominates Over Use of a Fiber Post When Restoring Endodontically Treated Incisors: An *In Vitro* Study

P Magne • PC Lazari • MA Carvalho • T Johnson • AA Del Bel Cury

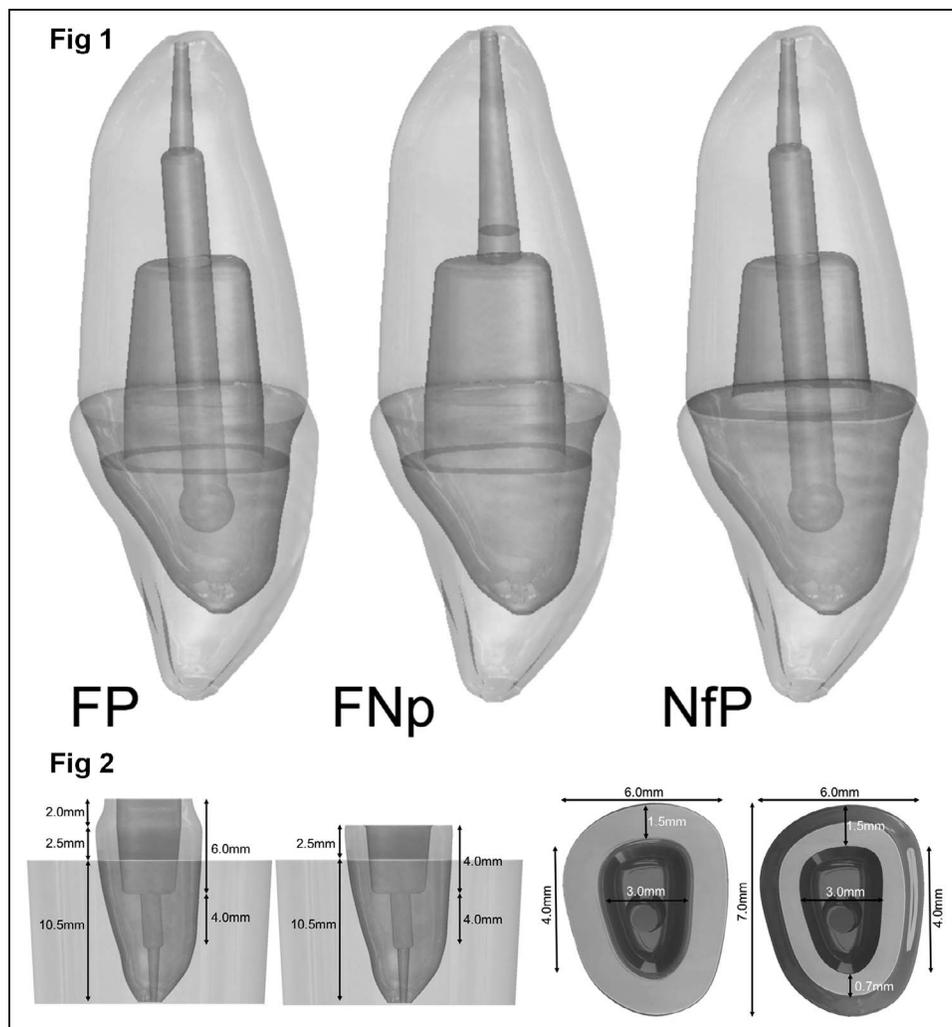
Figure 1. Schematic views of restored endodontically treated incisors. (A): Group FP. (B): Group FNp. (C): Group NfP. Figure 2. Schematic view of root dimensions before restoration.

post and resin core buildup, FNp = ferrule and direct resin core buildup, or NfP = no ferrule with GFR post and resin core buildup (Figures 1 and 2). The specimens were mounted in a special positioning device with acrylic resin (Palapress Vario, Heraeus Kulzer, Armonk, NY, USA) embedding 11.5 mm of the root. For the ferrule groups, the specimens were prepared with a tapered round-ended diamond bur (Brasseler, Savannah, GA, USA), creating a 2-mm-high/1-mm-thick circular ferrule and a 0.8-mm horizontal circular chamfer (cervical limit). Table 1 presents the brand, company and qualitative composition information of materials used in the present study.

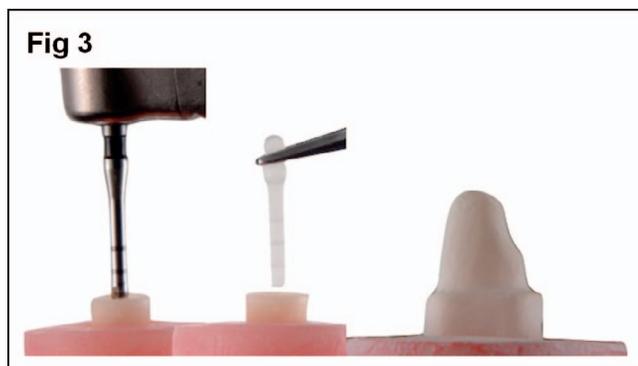
Figure 3. Post insertion and buildup.

Lux (no. 6, 1.5-mm diameter, Coltène Whaledent, Altstätten, Switzerland) (Figure 3). Using a cutting disc, the apical portion of the posts was removed to obtain a length of 11 mm (8 mm below and 3 mm above the cervical limit of the crown preparation). Prior to the luting procedure, the posts were cleaned with alcohol and air-dried. The post space walls were lightly coated with cement (RelyX Unicem 2 Automix, 3M ESPE, Seefeld, Germany), and the post was inserted. Cement excesses were cleaned, leaving 4 mm of post height in the cement. The cement system was light cured for 40 seconds (VALO Curing Light, Ultradent Products, Inc, South Jordan, UT, USA). After post cementation, the exposed dentin walls and the post were sandblasted with 30- μm silicated Al_2O_3 powder (Rocatec Soft, 3M ESPE). Silane (Ceramic Primer, 3M ESPE) was applied to the post head and air-dried. For dentin bonding purposes, 35% phosphoric acid (Ultra-Etch, Ultradent Products) was used for etching for 10 seconds, dentin walls and post rinsed and gently dried, followed by application of the adhesive system (Optibond FL Primer and Adhesive, Kerr, Orange, CA, USA) and light curing for 40 seconds (VALO Curing Light). All buildups were obtained with five to six 2-mm-thick increments of Miris 2 (Coltène Whaledent), each polymerized at 1000 mW/cm^2 (VALO Curing Light) for 40 seconds. An air-blocking barrier (KY Jelly, Johnson & Johnson Inc, Montreal, QC, Canada) was used to cover the preparation surface, and additional polymerization was carried out for 10 seconds per surface. Special care was taken to shape the Miris 2 buildup ideally in order to avoid any further corrections of the preparation surface and margins. All buildups were 11 mm high (4 mm internal and 7 mm above the cervical limit of the crown preparation).

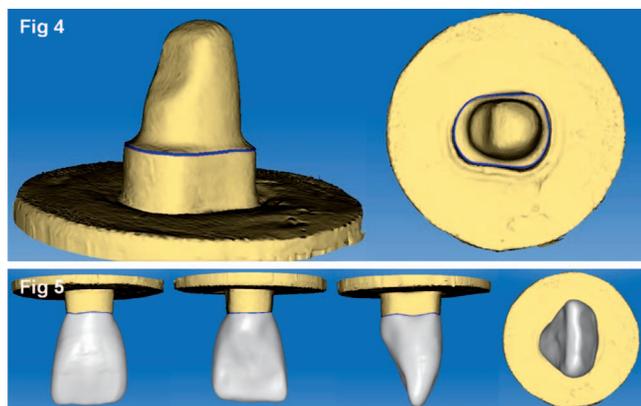
Figure 4. CAD data set of preparation with preparation line.

Figure 5. Standardization of crown design using Cerec software. All crowns were 11 mm high and 9 mm in mesial–distal width.

All bonded ceramic crowns were fabricated using the Cerec 3 CAD/CAM system (Sirona Dental Systems GmbH, Bensheim, Germany). Digital impressions of the prepared teeth were performed with Cerec Blue Cam, using a contrast powder (IPS Contrast Spray Chairside, Ivoclar Vivadent). The specimens were fitted with a crown of standardized thickness and anatomy with 11-mm incisio-cervical length and 9-mm mesio-distal width. All crowns were milled in lithium disilicate ceramic (IPS e.max CAD, Ivoclar Vivadent) using the “crown mode” with the sprue located at the lingual surface. After milling, lithium disilicate restorations were glazed, crystallized, and fired according to the manufacturer’s protocol (Programat CS, Ivoclar Vivadent) using IPS Object Fix Putty and IPS e.max CAD Crystall/Glaze Spray (Ivoclar Vivadent). The steps of digital design as well as the final restoration are presented in Figures 4 through 6.

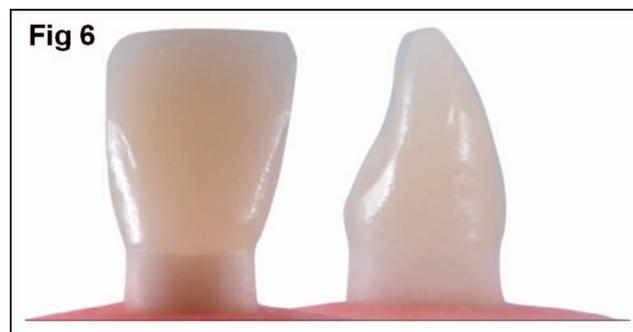
Figure 6. Final assembly after cementation.

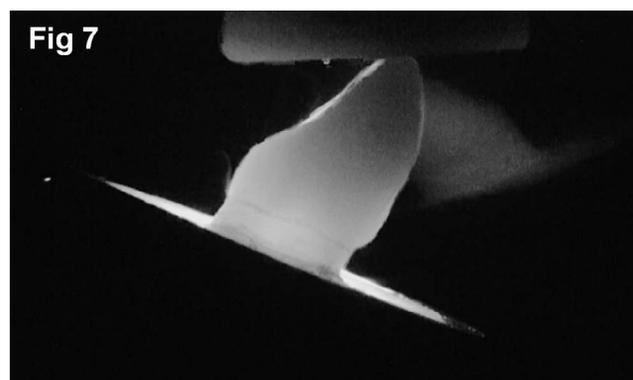
Figure 7. Specimen in the load chamber. Cyclic isometric loading was applied to the incisal edge at an angle of 30°.

Masticatory forces were simulated in an artificial mouth using a closed-loop electrodynamic system (Acumen 3, MTS Systems, Eden Prairie, MN, USA). The chewing cycle was simulated by an isometric contraction (load control) applied through a flat composite resin antagonist (Z100, 3M ESPE). The force was applied at a palatal angle of 30° with the flat surface contacting three-fourths of the incisal edge (Figure 7). The load chamber was filled with distilled water to submerge the sample during testing. A cyclic load was applied at a frequency of 5 Hz, starting with a load of 100 N (warm-up of 5000 cycles), followed by stages of 200, 300, 400, 500, 600, 700, 800, 900, and 1000 N at a maximum of 15,000 cycles for each force. Samples were loaded until fracture or to a maximum of 140,000 cycles.

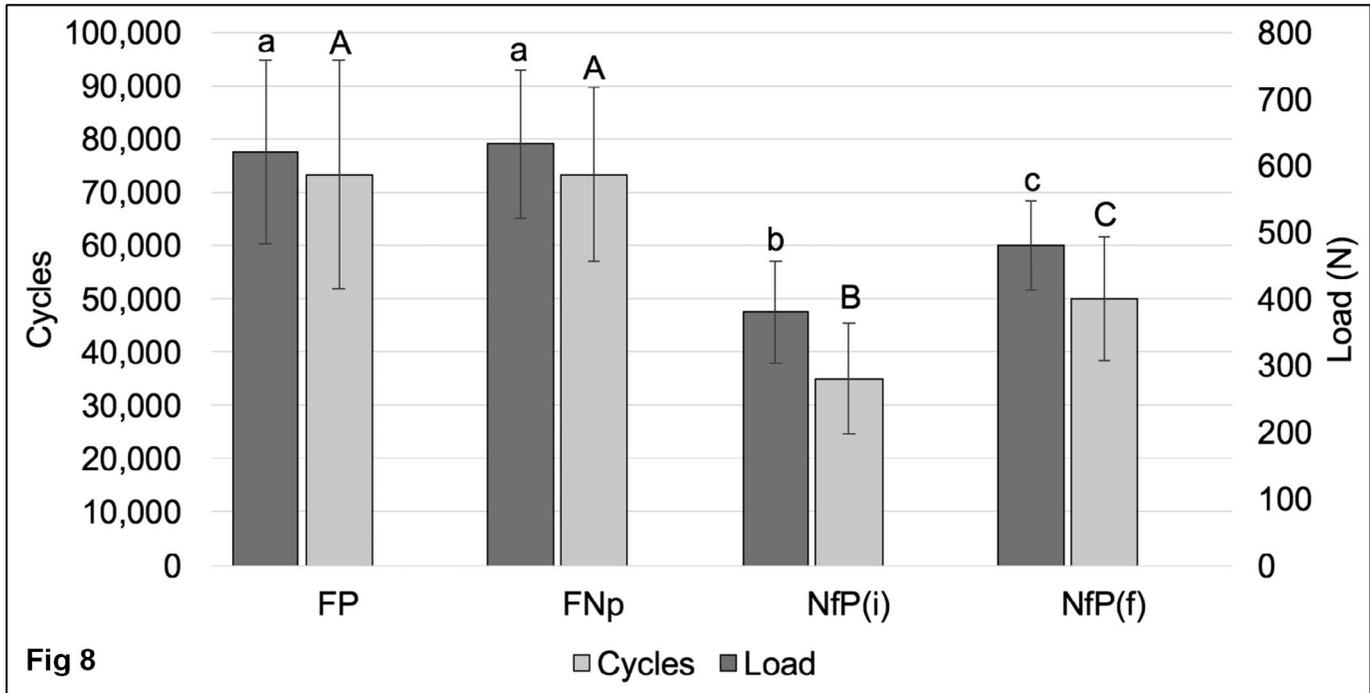
Figure 8. Mean fracture loads (dark gray) and average number of survived load cycles (light gray) and their standard deviations, respectively.

None of the specimens withstood all 140,000 load cycles. As all specimens fractured, the mean fracture load/cycles could be calculated (Figures 8 and 9). During cyclic loading, initial failures were detected in 81% (12/15) of the specimens in the no-ferrule group and 14% (2/15) and 7% (1/15) for a ferrule with a post and a ferrule without a post, respectively. The initial failure phenomenon can be described as the opening of a wide gap between the buildup/crown assembly and the root. The gap was always located at the lingual margin. Because clinical detection of such initial failures appears to be questionable, the analysis of survival was conducted for both the “final failure” (NfP[f]) and the “initial failure” (NfP[i]). The initial failure (i) values were recorded by reviewing the motion picture (high-definition macro mode) of the entire test for each specimen. Initial failure was easily detected by a significant high-pitched noise and simultaneous opening of a wide gap with emission of debris and air bubbles. The final failure (f) values were obtained by the testing machine when the sample completely fractured, causing the

One-way ANOVA and the Tukey test revealed that the mean fracture load for the FP group (620.00 ± 137.32 N; $p = 0.984$) showed no statistical difference when compared with the FNp group (633.33 ± 111.2697 N; $p = 0.984$). Ferrule groups were significantly higher than the NfP group (380.00 ± 77.4596 N [i], 480.00 ± 67.6123 N [f]) considering the initial and final failure ($p < 0.001$). The same results were found when the number of survived cycles was statistically compared (FP group to FNp group: $p = 1.000$; FP group to NfP group: $p < 0.01$; FNp group to NfP group: $p < 0.01$). Figure 8 shows the mean values of fracture loads and survived cycles and their standard deviations, respectively.

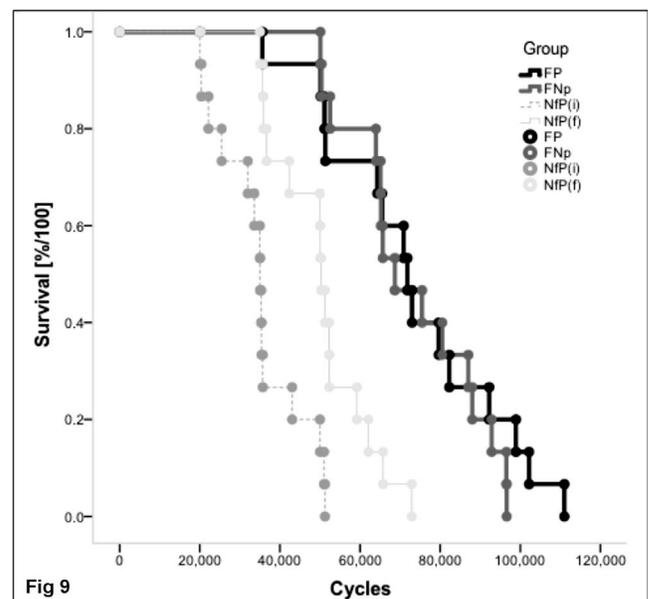
Figure 9. Kaplan-Meier survival graphs for groups FFp, FNp, and NfP. For better comparison, the survival graph of group NfP was divided into initial failure and final failure.

The Kaplan-Meier survival graphs for all groups are displayed in Figure 9. The log-rank test showed significantly higher survival of groups with a ferrule

compared to groups without a ferrule ($p < 0.001$). No difference could be found between groups with ferrule ($p = 0.488$). Also when considering the initial failure, the log-rank test showed the same results; that is, a significantly higher survival of the ferrule group compared to the no-ferrule group ($p \leq 0.001$) and no statistical difference between ferrule groups ($p = 0.508$).

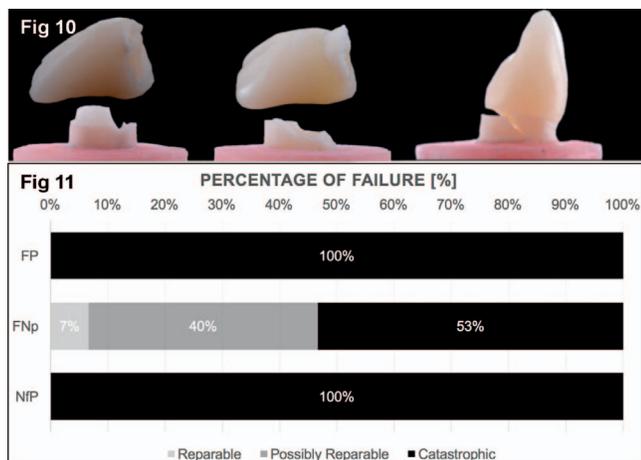
Figure 10. All specimens were analyzed and classified in one of the three failure modes: "reparable" fracture (cohesive or cohesive/adhesive fracture of restoration only), "possibly reparable" (cohesive/adhesive failure with fragment and minor damage, chip, or crack, of underlying tooth structure) or "catastrophic" (tooth/root fracture that would require tooth extraction).

Figure 11. Percentage of specimens per group for each fracture mode.

Groups with fiber post showed 100% catastrophic failures, while the no-post group presented 47% noncatastrophic failure. Possible fractures of the roots were made visible by transillumination in order to classify the specimen correctly (Figure 10). Figure 11

provides the number of specimens and percentage of each specific fracture mode for each group.
