First flush effect from vegetated roofs during simulated rain events

J. C. Berndtsson, L. Bengtsson and K. Jinno

Key words | first flush effect, green roof, stormwater quality, vegetated roof

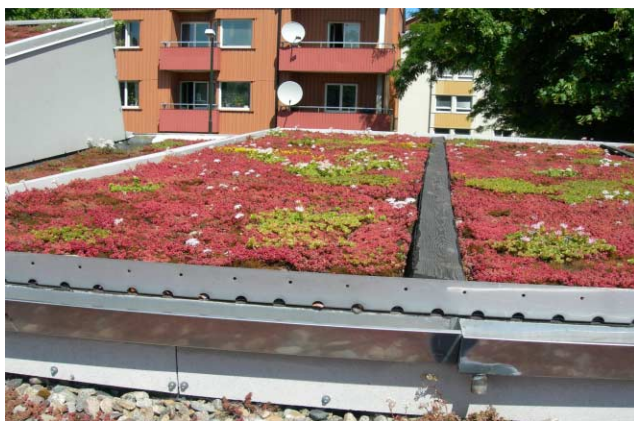
Figure 1 | Sections SD (from the left) and S0 of the extensive vegetated roof, Augustenborg, Malmö, Sweden.

The studied extensive vegetated roofs are located in the Augustenborg residential area, in the city of Malmö (270,000 inhabitants), Sweden. The vegetated roofs were established in 2001 on existing single-storey buildings. These vegetated roofs consist of a prefabricated sedum-moss vegetation layer grown in a 3 cm thick soil substrate, a geotextile filter layer and usually some kind of a drainage layer. The soil substrate is a commercially available mixture of crushed lava, natural calcareous soil, clay and shredded peat. A bitumen membrane reinforced with a polyester layer is situated beneath the vegetated roof to protect the original roof. The roof material is described in more detail in [Czemiel Berndtsson *et al.* \(2006\)](#). The studied extensive vegetated roof, situated on the municipal office buildings, is divided into sections with different drainage layers and different slopes. Two of the sections ([Figure 1](#)), which are 1.25 m wide and 4 m long, with

a slope of 1.5°, are used in this study. The first section is with an underlying 2 cm thick drainage layer made from crushed bricks, and the second is without a drainage layer. They are further referred to as SD and S0, respectively (S indicates study site Sweden, D – drainage layer and 0 – no drainage layer). The hydraulic field capacity of the soil, as investigated by [Bengtsson *et al.* \(2005\)](#) is 10 mm. The vegetated roofs were fertilized during spring 2001 and spring 2002 and there was no fertilizer added since 2003.

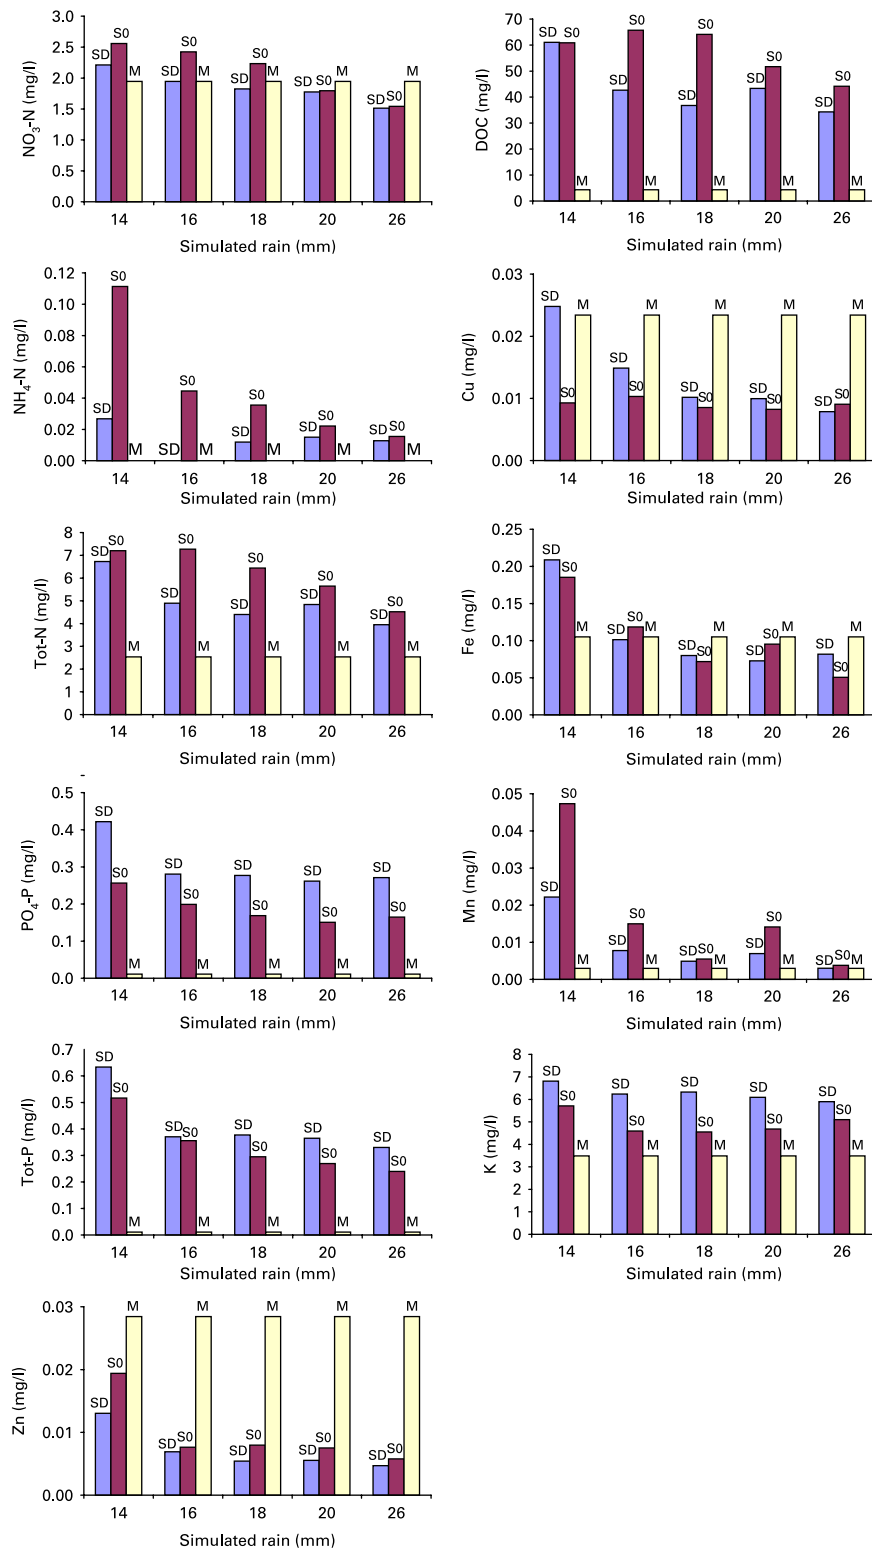
Figure 4 | Concentration of metals and nutrients in mains-supply water (M) and in runoff from extensive vegetated roofs (SD – with drainage layer, S0 – no drainage layer).

The results are presented in Figure 4 (study in Sweden) and Figure 5 (study in Japan). Pb, Cd and Cr are not included in Figure 4 and Pb, Cd, Cr, Mn, NH₄-N and PO₄-P are not included in Figure 5 because those compounds and elements were either not detected or detected in concentrations close to the detection limits. As changes of concentrations are discussed and not the loads the total pollutant load reduction due to runoff volume reduction within the vegetated roof is not accounted for.

The results show that, for nearly all compounds studied, on both sections of the extensive vegetated roof (SD and S0,

Figure 4) and the intensive vegetated roof (J, Figure 5), the first runoff sample collected at the beginning of runoff shows higher concentrations of the studied compounds than the samples taken at higher runoff depths. The exception is Cu in the runoff from S0, which almost does not change during the simulated event, and the concentration of DOC, which is lower in the first runoff sample than in those taken at higher runoff depths. The concentration changes follow different paths for different components and roofs (SD and S0 in Figure 4 and J in Figure 5).

function of normalized cumulative flow the values are above the diagonal line. This would indicate that proportionally more mass is washed off in the earlier runoff than in the later (i.e. the occurrence of first flush (*Kim et al. 2005*)). It is assumed that a leveling-off concentration is that of samples taken at the runoff depth of 12 mm for extensive roofs (SD and S0) and of 18 mm for the intensive roof (J). It is further assumed that, lacking quality data for runoff at 8 and 10 mm for extensive roofs (SD and S0) and at 14 mm for the intensive roof (J), it should be as that of the last taken runoff sample (*Figures 4 and 5*).

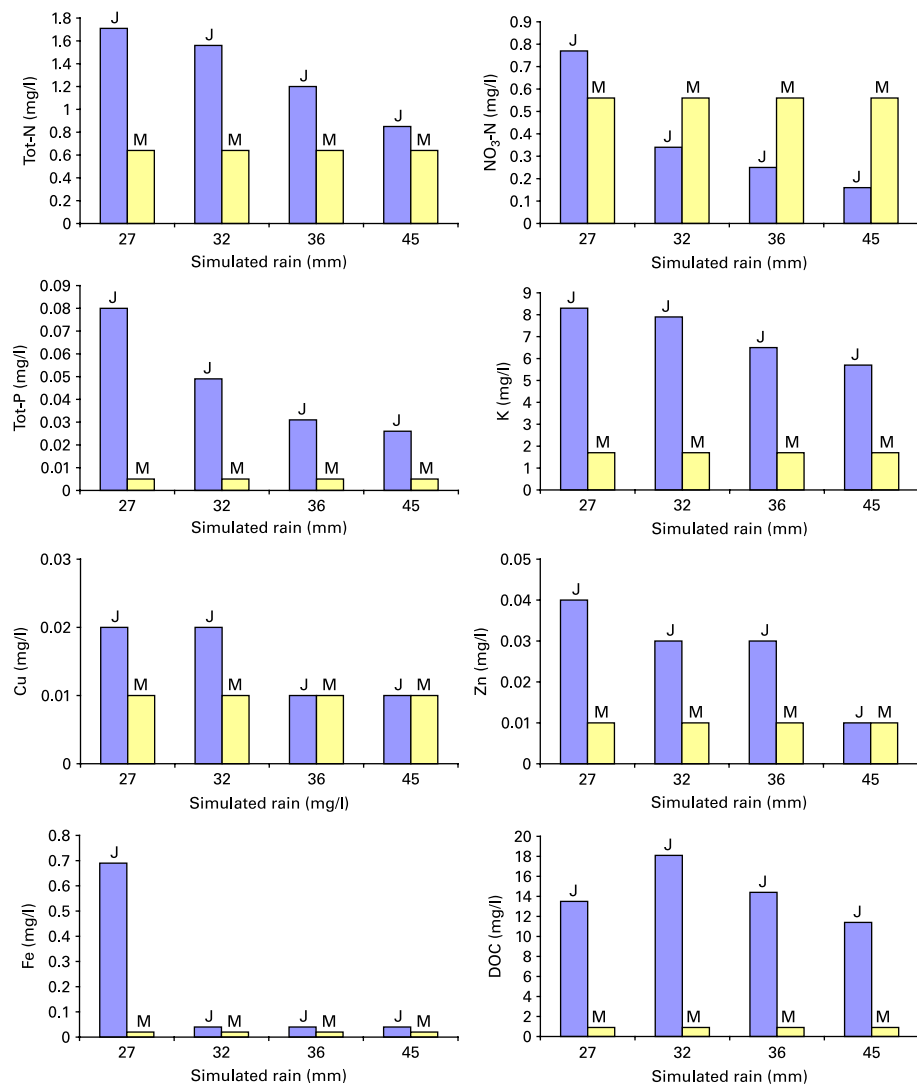
Figure 5 | Concentration of metals and nutrients in mains-supply water (M) and in runoff from the intensive vegetated roof (J).

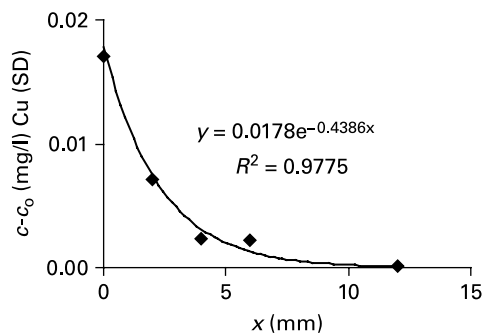
Figure 6 | Evolution of the copper concentration in the vegetated roof (SD) runoff during the simulated rain event.

It is found, for roof SD (extensive vegetated roof with a drainage layer), that the concentration changes of Cu, Zn and Tot-P in the runoff can be expressed as a first-order law as a function of runoff depth (with R^2 of the fit exceeding 0.9), thus showing a similar first flush effect as the runoff from hard surfaces. For roof S0 (extensive vegetated roof without drainage layer) the runoff concentrations of $\text{NH}_4\text{-N}$, Tot-P and Zn can be expressed in the same manner, thus depicting a first flush effect. For intensive vegetated roof (J), $\text{NO}_3\text{-N}$ and Tot-P depict a first flush effect. Concentrations of Tot-P in runoff during a simulated event from all studied roofs exhibits a first flush effect. The result of Cu concentration evolution in runoff from SD is presented in *Figure 6*.

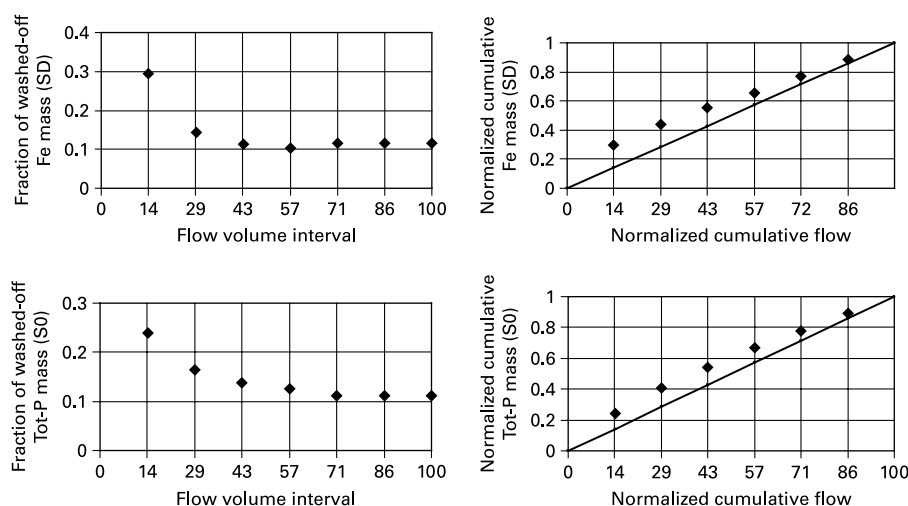
Figure 7 | Wash-off pollutant mass and volume (Fe, roof SD; Tot-P roof S0) indicating first flush effect.

The left-hand graphs in *Figure 7* show discharged mass in each volume interval (14.3% of total volume). The figure shows, for example, that 0.3 (30%) of the total Fe mass and 0.24 (24%) of Tot-P is washed off in the first 14% of the runoff volume. The right-hand graphs of *Figure 7* show the running total washed-off Fe and Tot-P, respectively, as a function of normalized flow. The values above the diagonal line indicate that there is proportionally more Fe and Tot-P mass washed off in the earlier runoff than in the later runoff, which indicates first flush. Such analyses performed for all studied runoff constituents indicated first flush occurring from both extensive vegetated roofs (SD and S0) for Fe, Mn, Zn, for Cu from SD and for $\text{NH}_4\text{-N}$ from S0. A less pronounced first flush effect was also indicated for Tot-P, $\text{PO}_4\text{-P}$, Tot-N, $\text{NO}_3\text{-N}$ and DOC from roofs SD and S0 and for $\text{NH}_4\text{-N}$ from SD. The first flush effect was not observed for K from roofs SD and S0 and for Cu from S0. Analysis of runoff from the intensive vegetated roof (J) indicated the occurrence of first flush effect for $\text{NO}_3\text{-N}$, Tot-N, Tot-P, Fe, Mn, Zn and Cu but not for K and DOC.
