# First flush effect from vegetated roofs during simulated rain events

J. C. Berndtsson, L. Bengtsson and K. Jinno

## ABSTRACT

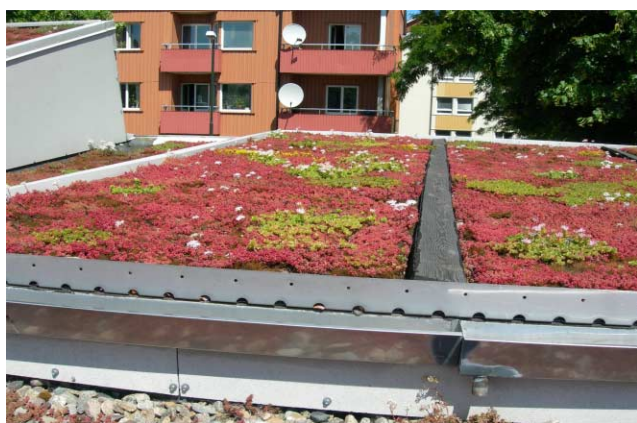
**Figure 1** | Sections SD (from the left) and S0 of the extensive vegetated roof, Augustenborg, Malmö, Sweden.

a slope of 1.5°, are used in this study. The first section is with an underlying 2 cm thick drainage layer made from crushed bricks, and the second is without a drainage layer. They are further referred to as SD and S0, respectively (S indicates study site Sweden, D – drainage layer and 0 – no drainage layer). The hydraulic field capacity of the soil, as investigated by [Bengtsson \*et al.\* \(2005\)](#) is 10 mm. The vegetated roofs were fertilized during spring 2001 and spring 2002 and there was no fertilizer added since 2003.

The studied extensive vegetated roofs are located in the Augustenborg residential area, in the city of Malmö (270,000 inhabitants), Sweden. The vegetated roofs were established in 2001 on existing single-storey buildings. These vegetated roofs consist of a prefabricated sedum-moss vegetation layer grown in a 3 cm thick soil substrate, a geotextile filter layer and usually some kind of a drainage layer. The soil substrate is a commercially available mixture of crushed lava, natural calcareous soil, clay and shredded peat. A bitumen membrane reinforced with a polyester layer is situated beneath the vegetated roof to protect the original roof. The roof material is described in more detail in [Czemiel Berndtsson \*et al.\* \(2006\)](#). The studied extensive vegetated roof, situated on the municipal office buildings, is divided into sections with different drainage layers and different slopes. Two of the sections ([Figure 1](#)), which are 1.25 m wide and 4 m long, with

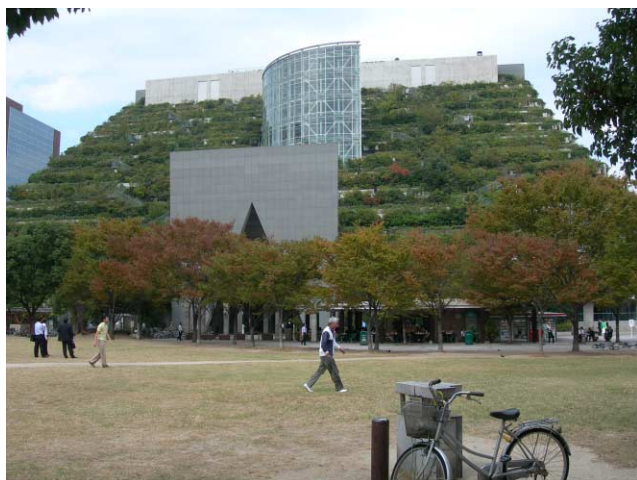
Figure 2 | Vegetated terraces at ACROS building (roof J), Fukuoka, Japan.

commercial building which houses shops, entertainment facilities, restaurants and offices. Terraces with vegetation were constructed on the south side of the building (Figure 2). More than 70 different plant species have been planted in this terrace garden but many new ones have appeared in the area due to seeds spread by wind and birds. The role of garden terraces, later in this paper referred to as the intensive vegetated roof, in stormwater management has not previously been studied.

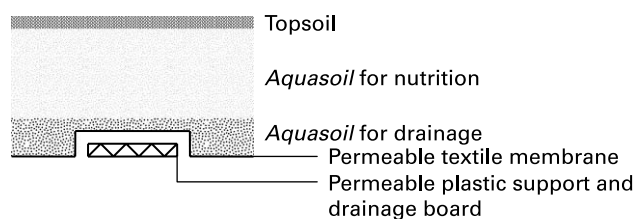
Figure 3 | Cross section of soil layer on the study site, ACROS Fukuoka, Japan.

On the floors, vegetation, including trees and bushes, is planted in a 50 cm deep artificial soil layer (Figure 3). At half the height on each floor, attached to the building's outside wall, there is a concrete overhang filled with artificial soil of 40 cm depth. It provides support for bushes and smaller plants. Overhanging between floors 12 and 13 on the west side of the building, the section closest to the middle of the building was used in this study. The choice was dictated by the accessibility of this site, the possibility to sample runoff and the relatively small size of separate sections with individual drainage. The section used in the simulation experiment is 0.8 m wide and 2.75 m long. It is further referred to as roof J (J indicates study site from Japan). Drainage is made of plastic.

A commercially available *Aquasoil* used on the terraces is made of perlite – naturally occurring siliceous rock which, after being crushed and heated, produces an inorganic lightweight soil. Since perlite is a form of natural glass (contain mainly Si, Al, K and Na), it is classified as

chemically inert and has a pH of approximately 7. Specific gravity of the *Aquasoil* used at the ACROS building is 0.65 (Takenaka Corporation 2005) and its saturated hydraulic conductivity is 5148 mm/h (AquaSoil Ikegami Inc. 2002). *Aquasoil* for nutrition and *Aquasoil* for drainage are commercially available types of modified *Aquasoil*. *Aquasoil* for nutrition is enriched in micronutrients, while *Aquasoil* for drainage is enhanced to work as an aeration and drainage layer, and both have large water retention ability and high drainage capacity when saturated.

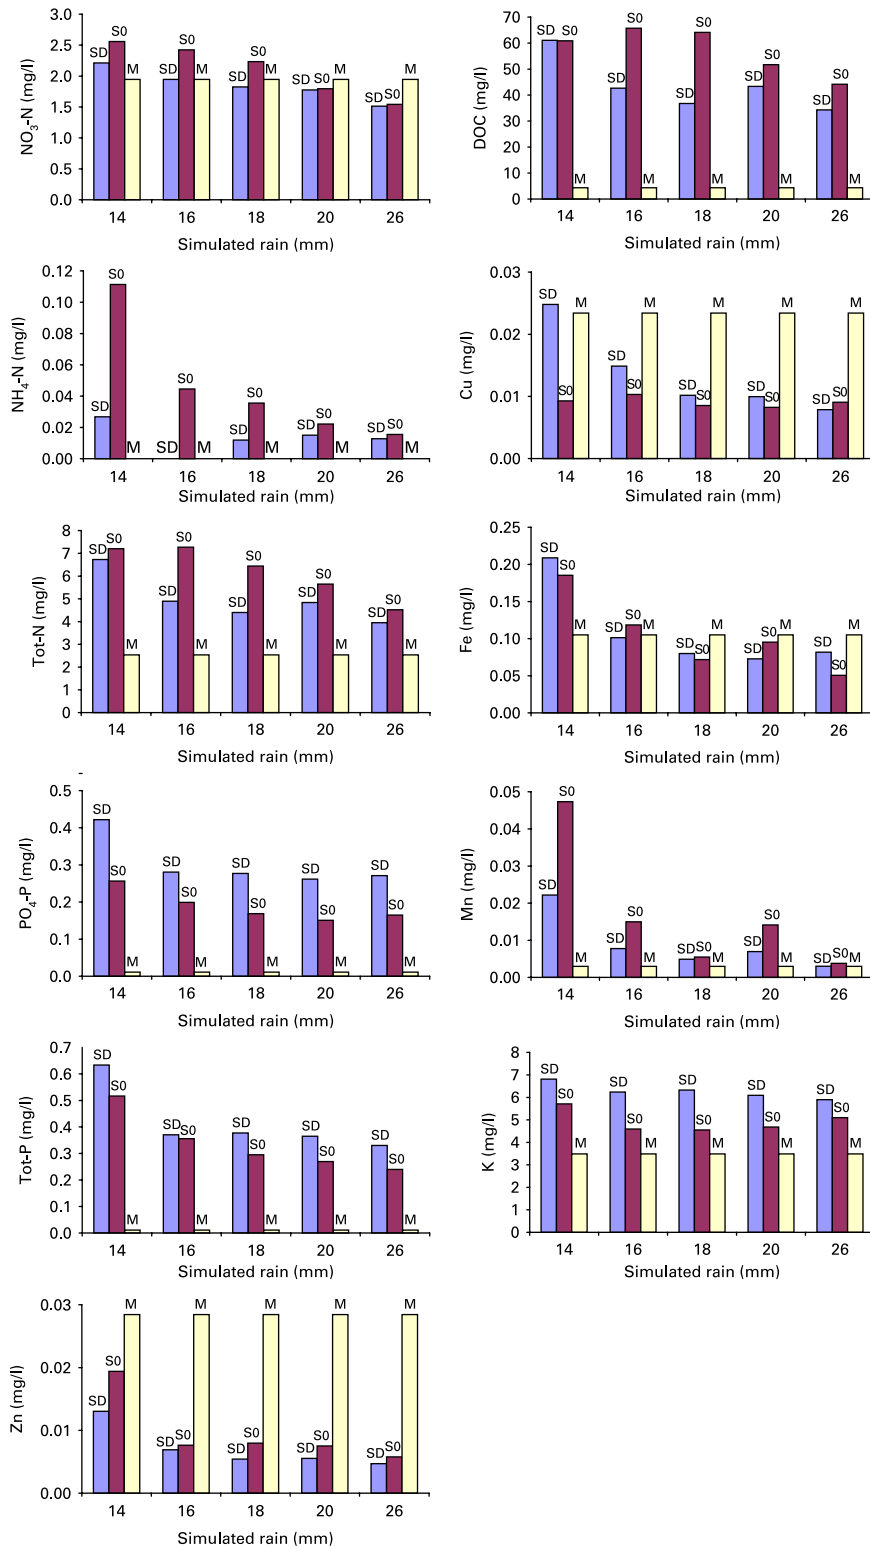
Figure 4 | Concentration of metals and nutrients in mains-supply water (M) and in runoff from extensive vegetated roofs (SD – with drainage layer, S0 – no drainage layer).

The results are presented in Figure 4 (study in Sweden) and Figure 5 (study in Japan). Pb, Cd and Cr are not included in Figure 4 and Pb, Cd, Cr, Mn, NH<sub>4</sub>-N and PO<sub>4</sub>-P are not included in Figure 5 because those compounds and elements were either not detected or detected in concentrations close to the detection limits. As changes of concentrations are discussed and not the loads the total pollutant load reduction due to runoff volume reduction within the vegetated roof is not accounted for.

Figure 4) and the intensive vegetated roof (J, Figure 5), the first runoff sample collected at the beginning of runoff shows higher concentrations of the studied compounds than the samples taken at higher runoff depths. The exception is Cu in the runoff from S0, which almost does not change during the simulated event, and the concentration of DOC, which is lower in the first runoff sample than in those taken at higher runoff depths. The concentration changes follow different paths for different components and roofs (SD and S0 in Figure 4 and J in Figure 5).

function of normalized cumulative flow the values are above the diagonal line. This would indicate that proportionally more mass is washed off in the earlier runoff than in the later (i.e. the occurrence of first flush (*Kim et al. 2005*)). It is assumed that a leveling-off concentration is that of samples taken at the runoff depth of 12 mm for extensive roofs (SD and S0) and of 18 mm for the intensive roof (J). It is further assumed that, lacking quality data for runoff at 8 and 10 mm for extensive roofs (SD and S0) and at 14 mm for the intensive roof (J), it should be as that of the last taken runoff sample (*Figures 4 and 5*).

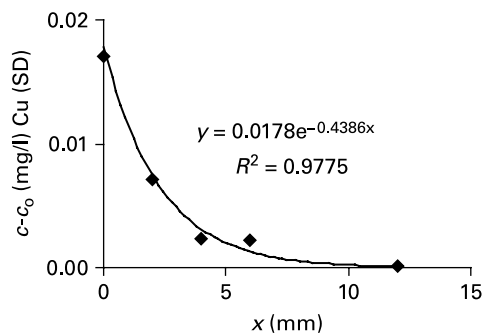
**Figure 6** | Evolution of the copper concentration in the vegetated roof (SD) runoff during the simulated rain event.

It is found, for roof SD (extensive vegetated roof with a drainage layer), that the concentration changes of Cu, Zn and Tot-P in the runoff can be expressed as a first-order law as a function of runoff depth (with  $R^2$  of the fit exceeding 0.9), thus showing a similar first flush effect as the runoff from hard surfaces. For roof S0 (extensive vegetated roof without drainage layer) the runoff concentrations of  $\text{NH}_4\text{-N}$ , Tot-P and Zn can be expressed in the same manner, thus depicting a first flush effect. For intensive vegetated roof (J),  $\text{NO}_3\text{-N}$  and Tot-P depict a first flush effect. Concentrations of Tot-P in runoff during a simulated event from all studied roofs exhibits a first flush effect. The result of Cu concentration evolution in runoff from SD is presented in *Figure 6*.

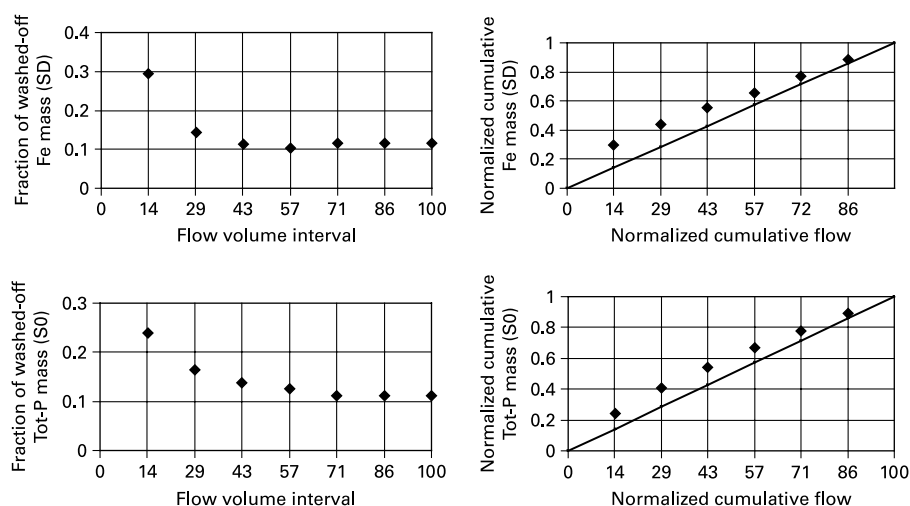
**Figure 7** | Wash-off pollutant mass and volume (Fe, roof SD; Tot-P roof S0) indicating first flush effect.

The left-hand graphs in *Figure 7* show discharged mass in each volume interval (14.3% of total volume). The figure shows, for example, that 0.3 (30%) of the total Fe mass and 0.24 (24%) of Tot-P is washed off in the first 14% of the runoff volume. The right-hand graphs of *Figure 7* show the running total washed-off Fe and Tot-P, respectively, as a function of normalized flow. The values above the diagonal line indicate that there is proportionally more Fe and Tot-P mass washed off in the earlier runoff than in the later runoff, which indicates first flush. Such analyses performed for all studied runoff constituents indicated first flush occurring from both extensive vegetated roofs (SD and S0) for Fe, Mn, Zn, for Cu from SD and for  $\text{NH}_4\text{-N}$  from S0. A less pronounced first flush effect was also indicated for Tot-P,  $\text{PO}_4\text{-P}$ , Tot-N,  $\text{NO}_3\text{-N}$  and DOC from roofs SD and S0 and for  $\text{NH}_4\text{-N}$  from SD. The first flush effect was not observed for K from roofs SD and S0 and for Cu from S0. Analysis of runoff from the intensive vegetated roof (J) indicated the occurrence of first flush effect for  $\text{NO}_3\text{-N}$ , Tot-N, Tot-P, Fe, Mn, Zn and Cu but not for K and DOC.
