## First flush effect from vegetated roofs during simulated rain events

J. C. Berndtsson, L. Bengtsson and K. Jinno

### ABSTRACT

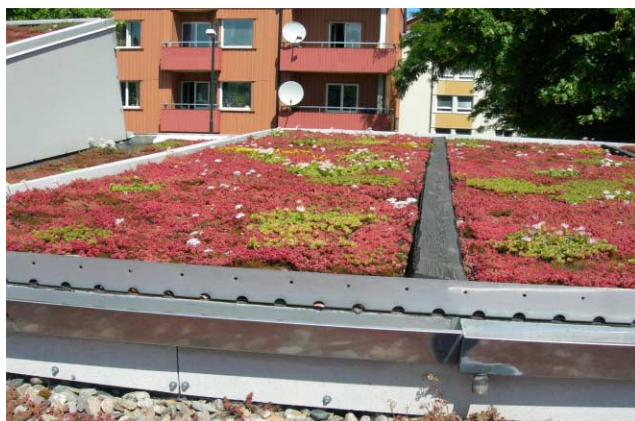
**Figure 1** | Sections SD (from the left) and S0 of the extensive vegetated roof, Augustenborg, Malmö, Sweden.

a slope of 1.5°, are used in this study. The first section is with an underlying 2 cm thick drainage layer made from crushed bricks, and the second is without a drainage layer. They are further referred to as SD and S0, respectively (S indicates study site Sweden, D – drainage layer and 0 – no drainage layer). The hydraulic field capacity of the soil, as investigated by *Bengtsson et al. (2005)* is 10 mm. The vegetated roofs were fertilized during spring 2001 and spring 2002 and there was no fertilizer added since 2003.

The studied extensive vegetated roofs are located in the Augustenborg residential area, in the city of Malmö (270,000 inhabitants), Sweden. The vegetated roofs were established in 2001 on existing single-storey buildings. These vegetated roofs consist of a prefabricated sedum-moss vegetation layer grown in a 3 cm thick soil substrate, a geotextile filter layer and usually some kind of a drainage layer. The soil substrate is a commercially available mixture of crushed lava, natural calcareous soil, clay and shredded peat. A bitumen membrane reinforced with a polyester layer is situated beneath the vegetated roof to protect the original roof. The roof material is described in more detail in *Czemiel Berndtsson et al. (2006)*. The studied extensive vegetated roof, situated on the municipal office buildings, is divided into sections with different drainage layers and different slopes. Two of the sections (*Figure 1*), which are 1.25 m wide and 4 m long, with

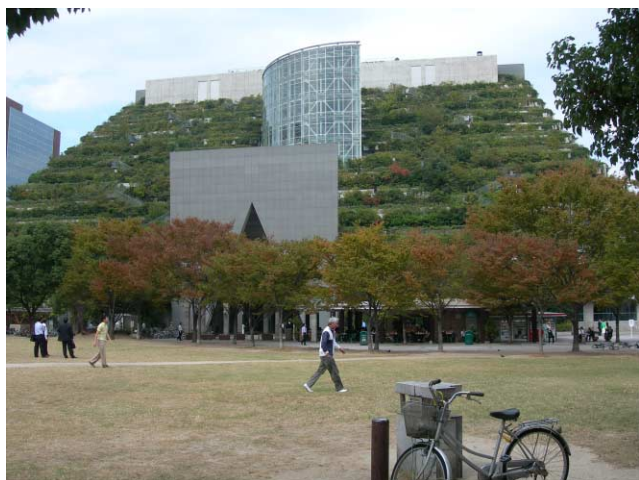
Figure 2 | Vegetated terraces at ACROS building (roof J), Fukuoka, Japan.

commercial building which houses shops, entertainment facilities, restaurants and offices. Terraces with vegetation were constructed on the south side of the building (Figure 2). More than 70 different plant species have been planted in this terrace garden but many new ones have appeared in the area due to seeds spread by wind and birds. The role of garden terraces, later in this paper referred to as the intensive vegetated roof, in stormwater management has not previously been studied.

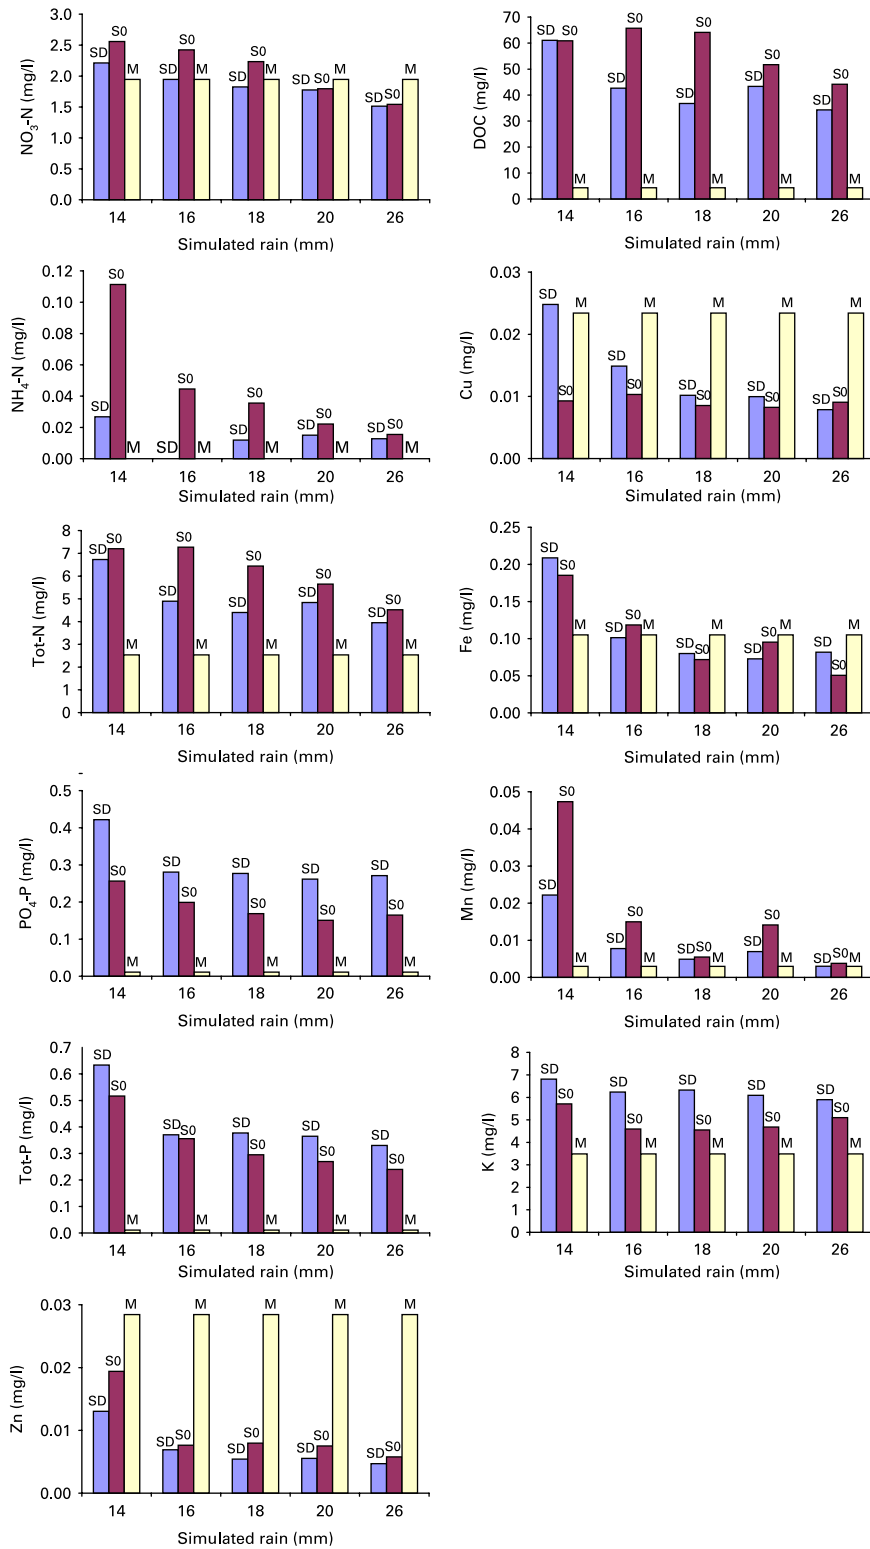
Figure 4 | Concentration of metals and nutrients in mains-supply water (M) and in runoff from extensive vegetated roofs (SD – with drainage layer, S0 – no drainage layer).

The results are presented in Figure 4 (study in Sweden) and Figure 5 (study in Japan). Pb, Cd and Cr are not included in Figure 4 and Pb, Cd, Cr, Mn, NH<sub>4</sub>-N and PO<sub>4</sub>-P are not included in Figure 5 because those compounds and elements were either not detected or detected in concentrations close to the detection limits. As changes of concentrations are discussed and not the loads the total pollutant load reduction due to runoff volume reduction within the vegetated roof is not accounted for.

The results show that, for nearly all compounds studied, on both sections of the extensive vegetated roof (SD and S0,

Figure 4) and the intensive vegetated roof (J, Figure 5), the first runoff sample collected at the beginning of runoff shows higher concentrations of the studied compounds than the samples taken at higher runoff depths. The exception is Cu in the runoff from S0, which almost does not change during the simulated event, and the concentration of DOC, which is lower in the first runoff sample than in those taken at higher runoff depths. The concentration changes follow different paths for different components and roofs (SD and S0 in Figure 4 and J in Figure 5).

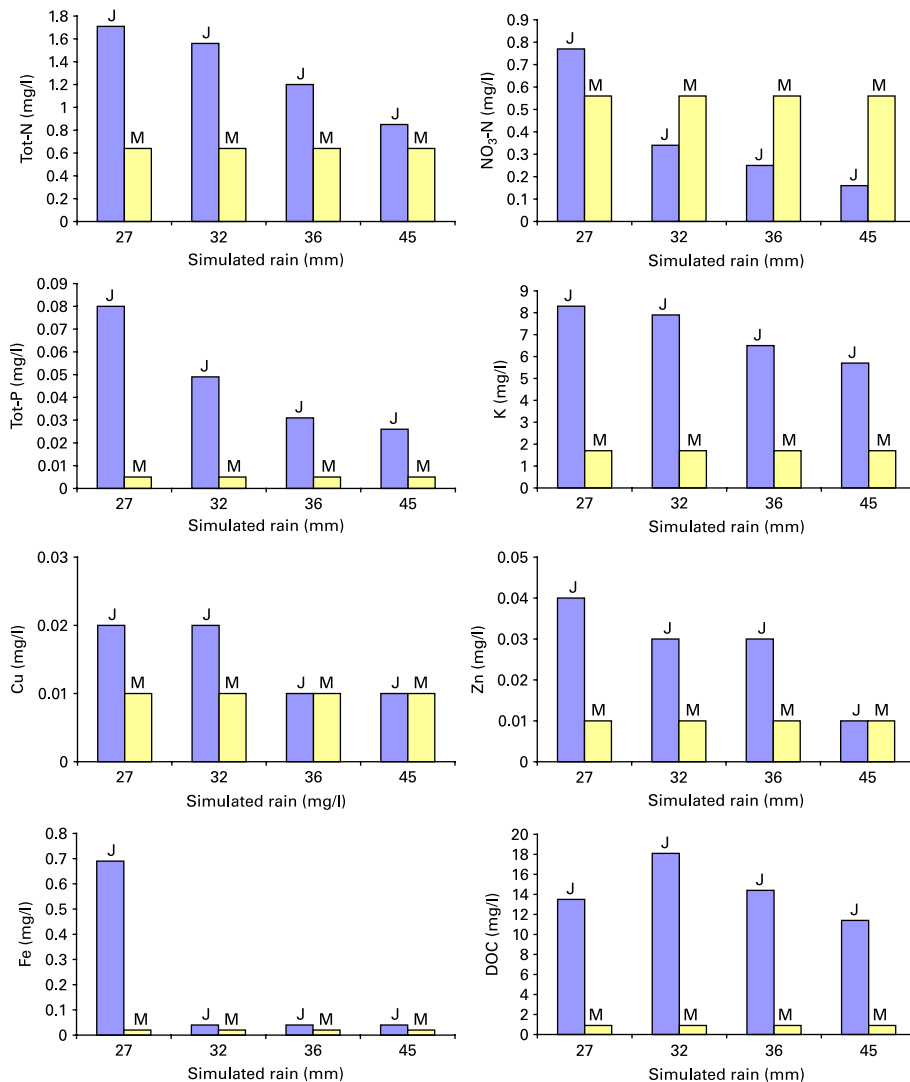
Figure 5 | Concentration of metals and nutrients in mains-supply water (M) and in runoff from the intensive vegetated roof (J).

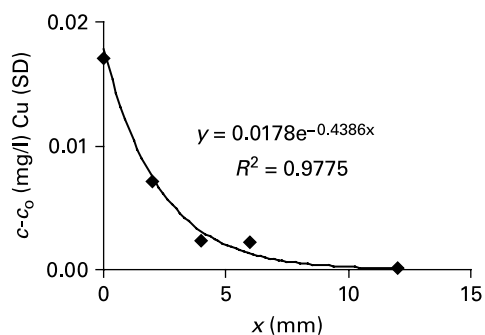
**Figure 6** | Evolution of the copper concentration in the vegetated roof (SD) runoff during the simulated rain event.

It is found, for roof SD (extensive vegetated roof with a drainage layer), that the concentration changes of Cu, Zn and Tot-P in the runoff can be expressed as a first-order law as a function of runoff depth (with  $R^2$  of the fit exceeding 0.9), thus showing a similar first flush effect as the runoff from hard surfaces. For roof S0 (extensive vegetated roof without drainage layer) the runoff concentrations of  $\text{NH}_4\text{-N}$ , Tot-P and Zn can be expressed in the same manner, thus depicting a first flush effect. For intensive vegetated roof (J),  $\text{NO}_3\text{-N}$  and Tot-P depict a first flush effect. Concentrations of Tot-P in runoff during a simulated event from all studied roofs exhibits a first flush effect. The result of Cu concentration evolution in runoff from SD is presented in *Figure 6*.

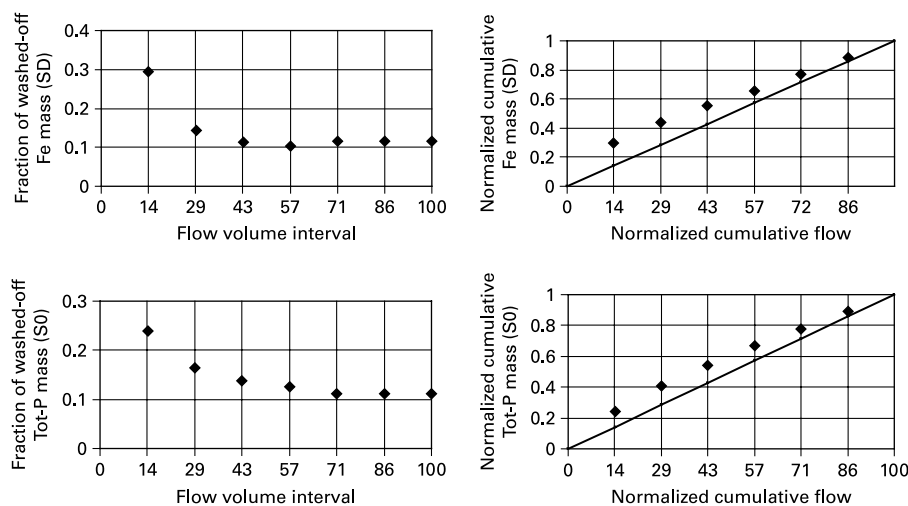
The left-hand graphs in *Figure 7* show discharged mass in each volume interval (14.3% of total volume). The figure shows, for example, that 0.3 (30%) of the total Fe mass and 0.24 (24%) of Tot-P is washed off in the first 14% of the runoff volume. The right-hand graphs of *Figure 7* show the running total washed-off Fe and Tot-P, respectively, as a function of normalized flow. The values above the diagonal line indicate that there is proportionally more Fe and Tot-P mass washed off in the earlier runoff than in the later runoff, which indicates first flush. Such analyses performed for all studied runoff constituents indicated first flush occurring from both extensive vegetated roofs (SD and S0) for Fe, Mn, Zn, for Cu from SD and for  $\text{NH}_4\text{-N}$  from S0. A less pronounced first flush effect was also indicated for Tot-P,  $\text{PO}_4\text{-P}$ , Tot-N,  $\text{NO}_3\text{-N}$  and DOC from roofs SD and S0 and for  $\text{NH}_4\text{-N}$  from SD. The first flush effect was not observed for K from roofs SD and S0 and for Cu from S0. Analysis of runoff from the intensive vegetated roof (J) indicated the occurrence of first flush effect for  $\text{NO}_3\text{-N}$ , Tot-N, Tot-P, Fe, Mn, Zn and Cu but not for K and DOC.

**Figure 7** | Wash-off pollutant mass and volume (Fe, roof SD; Tot-P roof S0) indicating first flush effect.
