The Evolution of a Dispersant Spraying Platform from Turboprop to Jet Engine Aircraft

March 10th , 2017

Abstract 2017-370.

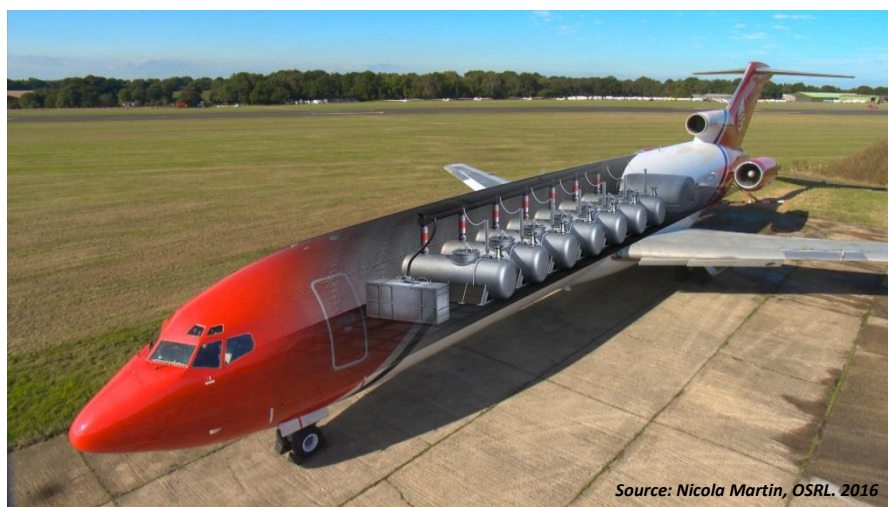
TERSUS is a modular system that comprises of 7 storage tanks with the capacity of 15,000 litres in total; a pump pallet that holds 2 centrifugal pumps and subsequent circulation circuit; a service pallet containing a flow meter that monitors fluid as it is pumped out of the pump pallet; a ventilation system that maintains constant air pressure in the TERSUS system and ventilates any vapours from the tanks; an air compressor and 2 spraying boom arms with 15 nozzles each as well as ancillary equipment and ground loading dispersant equipment, to describe it simply. TERSUS has been built with secondary containment capability, which means that should primary containment fail, this fail-safe feature will ensure dispersant is not released outside the TERSUS system and spilled inside the aircraft.

Figure 1 - Graphic Representation of the TERSUS System installed in the Boeing 727-2S2F (RE).

From an operational point of view, previous systems had system control panels that were located at the aft of the aircraft and required system operators to wear harnesses so as to be able to work near the aft door while this is open during spraying operations. The TERSUS design completely eliminates this practice, by integrating the system control within the flight

engineer's panel within the cockpit. These are operated by the aircraft crew safely without the need to leave the cockpit.

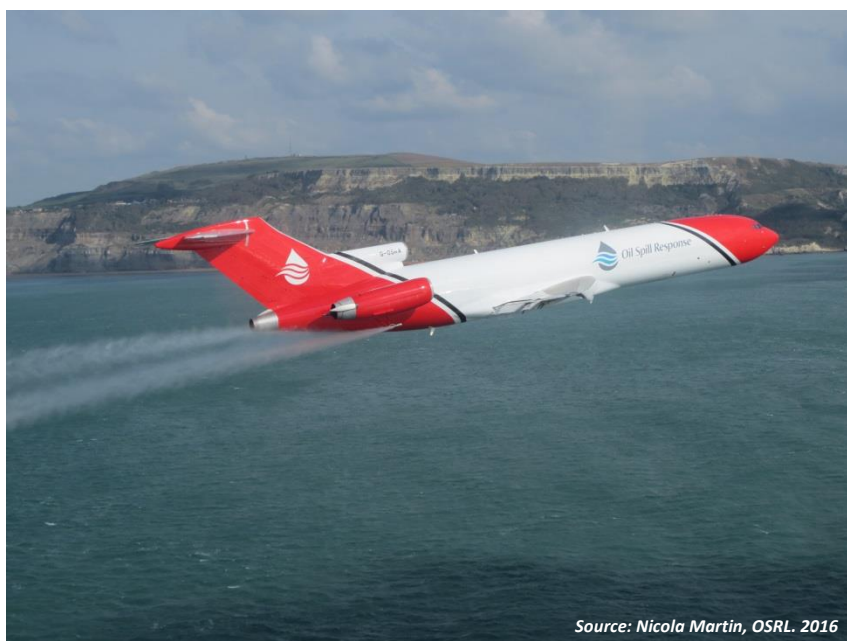
Figure 2 - G-OSRA during a spraying exercise (water spraying, in this instance).

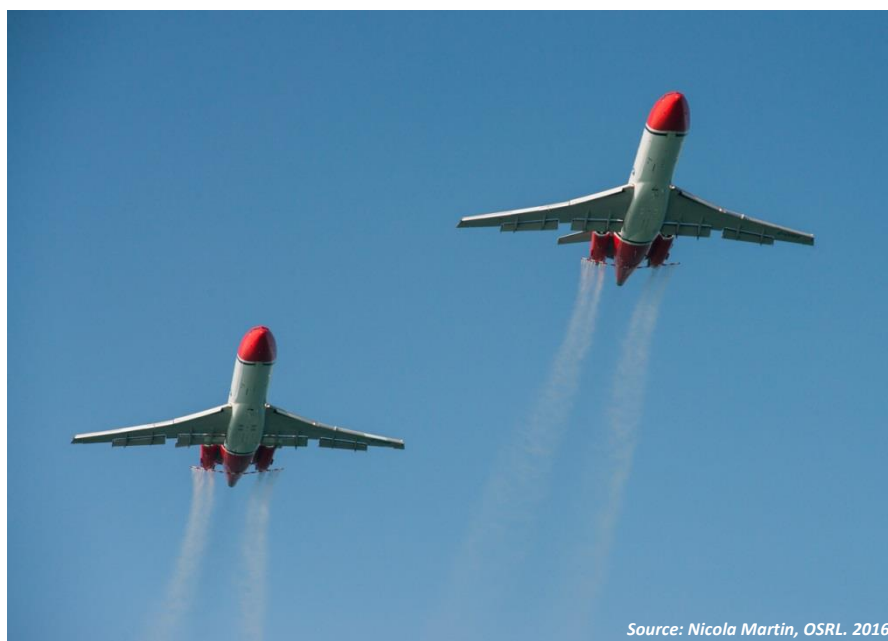
The system has only recently been made operational, and further system testing is scheduled for 2017. However, spray runs carried out in September 2016 have demonstrated

that the aircraft performs steadily during spraying speeds of 150 knots at an altitude of 150 feet.

Figure 3 - G-OSRA and G-OSRB during a spraying exercise (water spraying, in this instance)
