## Evaluation of pot-chlorination of wells during a cholera outbreak, Bissau, Guinea-Bissau, 2008

### ABSTRACT

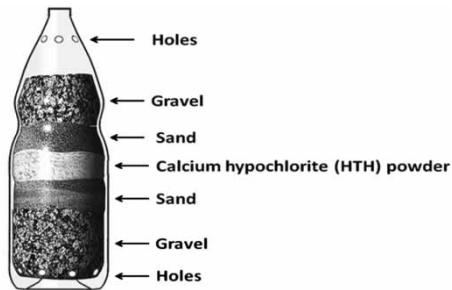
### Plastic Bottle Chlorinator

Figure 1 | Example of plastic bottle chlorinator.

In an effort to curb the spread of the cholera outbreak, the Bissau Department of Water and Sanitation (BDWS), in collaboration with UNICEF, began a project in mid-August 2008 to disinfect municipal wells in affected Bissau neighbourhoods using hand-made pot-chlorinators. Pot-chlorinators made from 1.5 L plastic bottles were suspended in approximately 600 wells in 10 Bissau neighbourhoods. A monitoring plan had been developed, but data were inconsistently collected and unsuitable for analysis.

The protocol used for the UNICEF/BDWS well-chlorination project was followed for constructing the pot-chlorinators. A 1.5-L plastic bottle was rinsed with water.

Since most teams in the UNICEF/BDWS well-chlorination project used 20 holes per bottle (five in the bottom, two rows of seven circling the lower portion of the bottle, and one 'air hole' near the bottle neck), this was chosen as the standard for the evaluation. Holes were made using a nail, for a hole size of approximately 3–4 mm. The bottom third of the bottle was filled with washed gravel and the second third with washed sand.

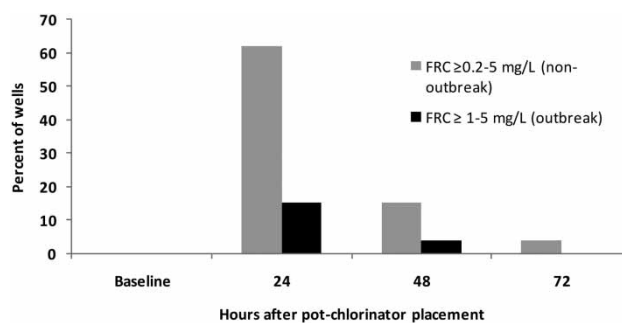
**Figure 2** | Summary of free residual chlorine (FRC) levels by days after pot-chlorinator placement.

6.0 mg L<sup>-1</sup> (mean =  $0.67 \pm 1.18$  mg L<sup>-1</sup>). Sixteen (62%) of 26 wells had FRC levels between 0.2 and 5.0 mg L<sup>-1</sup>; the FRC level was <0.2 mg L<sup>-1</sup> in nine (35%) wells and >5.0 mg L<sup>-1</sup> in one well. Approximately 48 h post-chlorination, FRC levels in wells ranged from BDL to 1.8 mg L<sup>-1</sup> (mean =  $0.18 \pm 0.35$  mg L<sup>-1</sup>). Four (15%) wells had FRC levels between 0.2 and 5.0 mg L<sup>-1</sup> and the remaining FRC levels were <0.2 mg L<sup>-1</sup>. After approximately 72 h, FRC levels in wells ranged from BDL to 0.21 mg L<sup>-1</sup> (mean =  $0.07 \pm 0.05$  mg L<sup>-1</sup>). Only one (4%) well had an FRC level  $\geq 0.2$  mg L<sup>-1</sup> (Table 1, Figure 2).

Approximately 24 h post-chlorination, four (15%) wells had FRC levels  $\geq 1.0 \text{ mg L}^{-1}$ ; one of these wells had an FRC level that exceeded  $5.0 \text{ mg L}^{-1}$ . Only this well (4%) had an FRC level  $\geq 1.0 \text{ mg L}^{-1}$  at 48 h post-chlorination. At 72 h post-chlorination, no wells had FRC levels  $\geq 1.0 \text{ mg L}^{-1}$  (Table 1, Figure 2).
