## Evaluation of pot-chlorination of wells during a cholera outbreak, Bissau, Guinea-Bissau, 2008

We evaluated the ability of UNICEF-designed pot-chlorinators to achieve recommended free residual chlorine (FRC) levels in well water in Bissau, Guinea-Bissau, during a cholera outbreak. Thirty wells were randomly selected from six neighbourhoods. Pot-chlorinators – perforated plastic bottles filled with gravel, sand and calcium hypochlorite granules – were placed in each well. FRC was measured before and 24, 48 and 72 h after placement and compared with World Health Organization (WHO)-recommended levels of  $\geq 1$  mg L<sup>-1</sup> for well water during cholera outbreaks and 0.2–5 mg L<sup>-1</sup> in non-outbreak settings. Presence of well covers, distance from wells to latrines, and rainfall were noted. Complete post-chlorination data were collected from 26 wells. At baseline, no wells had FRC  $> 0.09$  mg L<sup>-1</sup>. At 24, 48 and 72 h post-chlorination, 4 (15%), 1 (4%) and 0 wells had FRC  $\geq 1$  mg L<sup>-1</sup> and 16 (62%), 4 (15%) and 1 (4%) wells had FRC between 0.2 and 5 mg L<sup>-1</sup>, respectively. Several families reported discontinuing household water chl

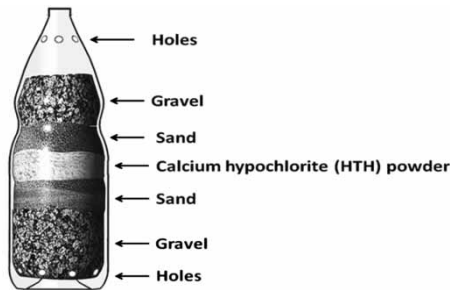
Figure 1 | Example of plastic bottle chlorinator.

### Plastic Bottle Chlorinator

Pot-chlorination, another widely used well-disinfection method, is designed to provide a more constant FRC level over a longer period of time. Pot-chlorinators are pierced containers (clay pots, plastic bottles or jerry cans) filled with layers of calcium high test hypochlorite (HTH) powder, gravel and sand, and suspended in a well (Figure 1). The intention of the pot-chlorinator is to provide a slow diffusion of chlorine into the water in order to maintain a consistent FRC concentration sufficient to inactivate *V. cholerae*. Many resources describe the construction and use of pot-chlorinators for well disinfection (Cairncross & Feachem 1993; Feachem *et al.* 1977; Garandeanu 2004), but few studies have evaluated their effectiveness.

In an effort to curb the spread of the cholera outbreak, the Bissau Department of Water and Sanitation (BDWS), in collaboration with UNICEF, began a project in mid-August 2008 to disinfect municipal wells in affected Bissau neighbourhoods using hand-made pot-chlorinators. Pot-chlorinators made from 1.5 L plastic bottles were suspended in approximately 600 wells in 10 Bissau neighbourhoods. A monitoring plan had been developed, but data were inconsistently collected and unsuitable for analysis.

The protocol used for the UNICEF/BDWS well-chlorination project was followed for constructing the pot-chlorinators. A 1.5-L plastic bottle was rinsed with water.

Since most teams in the UNICEF/BDWS well-chlorination project used 20 holes per bottle (five in the bottom, two rows of seven circling the lower portion of the bottle, and one 'air hole' near the bottle neck), this was chosen as the standard for the evaluation. Holes were made using a nail, for a hole size of approximately 3–4 mm. The bottom third of the bottle was filled with washed gravel and the second third with washed sand.

The calcium hypochlorite dosage used in the UNICEF/BDWS project was followed: 15 g of Niclon 70-G granular calcium hypochlorite (Tohoku Tosoh Chemical Co., Ltd) per 1 m<sup>3</sup> (1,000 L) of well water. Since a scale was not available in the field, it was estimated that 1 mL of calcium hypochlorite granules equalled 1 g of granules in weight; granules were measured using a graduated 20 mL measuring cup. The amount of calcium hypochlorite required for each well was calculated and added to the bottle on top of the layer of sand; the calcium hypochlorite was then covered with an additional layer of sand and the bottle was capped. A rope was tied around the bottle neck and the bottle was lowered upright into the well until it was submerged; the end of the rope was secured to the exterior of the well.
