## Environmental health aspects of drinking water-borne outbreak due to karst flooding: case study

Gyula Dura, Tamás Pándics, Mihály Kádár, Katalin Krisztalovics, Zoltánné Kiss, Judit Bodnár, Ágnes Asztalos and Erzsébet Papp

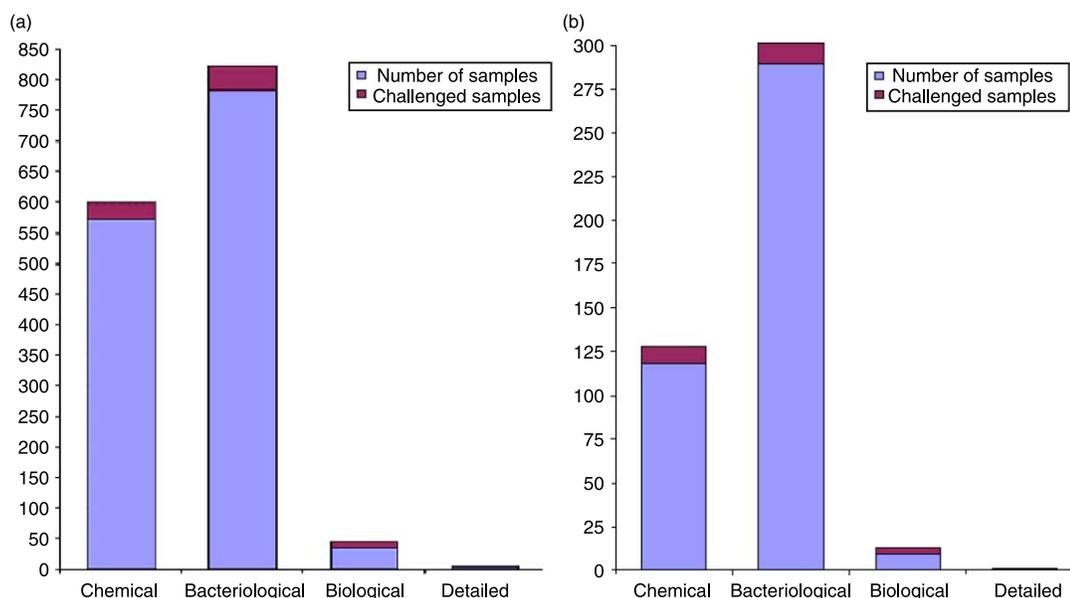
Figure 1 | Miskolc, 2006, samples taken and non-compliant samples from waterworks' own sampling (a) and public health authority sampling (b).

Non-compliance of samples taken from the Miskolc water mains have been extremely rare over a period of several decades. Bacteriological and chemical tests, carried out by the public health authority and by the waterworks, generally showed good water quality with a small number of exceptions (Figure 1). Currently, there are eight water-extraction facilities attached to the aquifers. Karstic water is extracted partly by gravitation from springs and partly from wells by means of pumping. The protective zone over the springs has an area of 291 km<sup>2</sup>, of which the surface profile of the primary protective area is 171 km<sup>2</sup>, while the secondary confined protective zone is 120 km<sup>2</sup>.

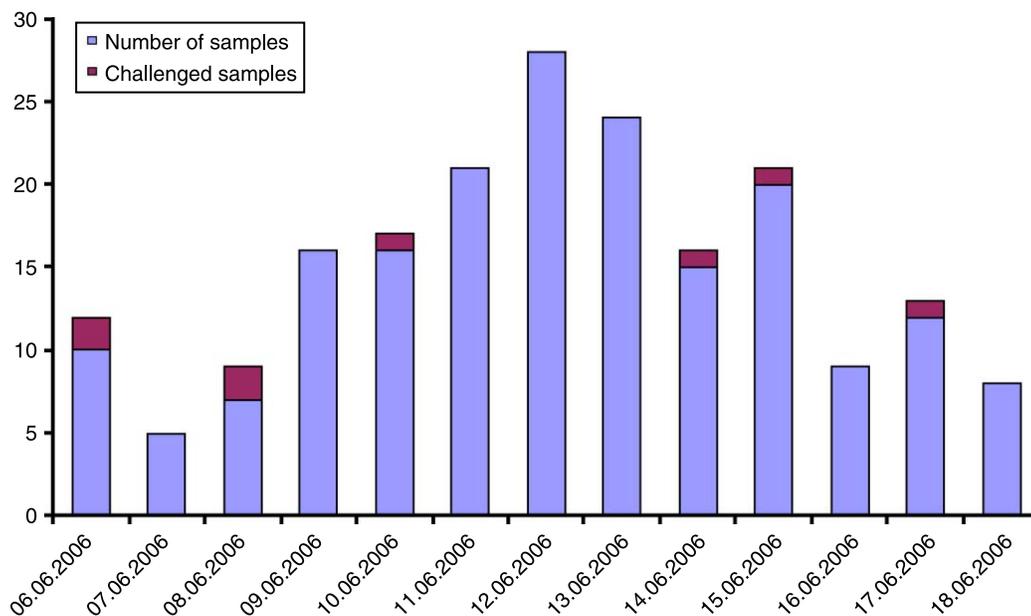
**Figure 2** | Bacteriological samples in mains and number of non-compliant samples, 6–18 June 2006.

According to the results of tests conducted by the Water Hygiene division of the National Institute of Environmental Health (OKI), samples taken five days after shutting down the well still contained significant bacterial contamination. OKI found both *Cryptosporidium* and *Giardia* (not viable) and there were unconfirmed positive results for several viruses. The immunochromographic preliminary test was positive for adenovirus and negative for rotavirus, IDEIA norovirus Elisa test was positive, while RT-PCR tests for norovirus GI and GII genotypes and hepatitis A were negative. In the period 6–18 June, a total of eight non-complying samples were found (Figure 2).

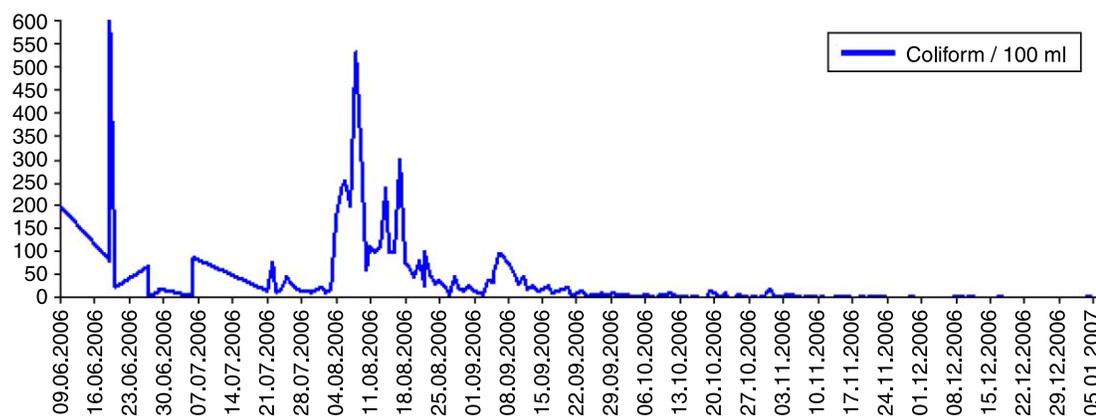
**Figure 3** | Trend of coliform bacteria numbers in the untreated water of the Miskolc-Tapolca waterworks, 9 June 2006 to 5 January 2007.

The samples taken from the non-chlorinated well water showed faecal contamination over a longer period (Figures 3 and 4). The chemical test results were satisfactory.

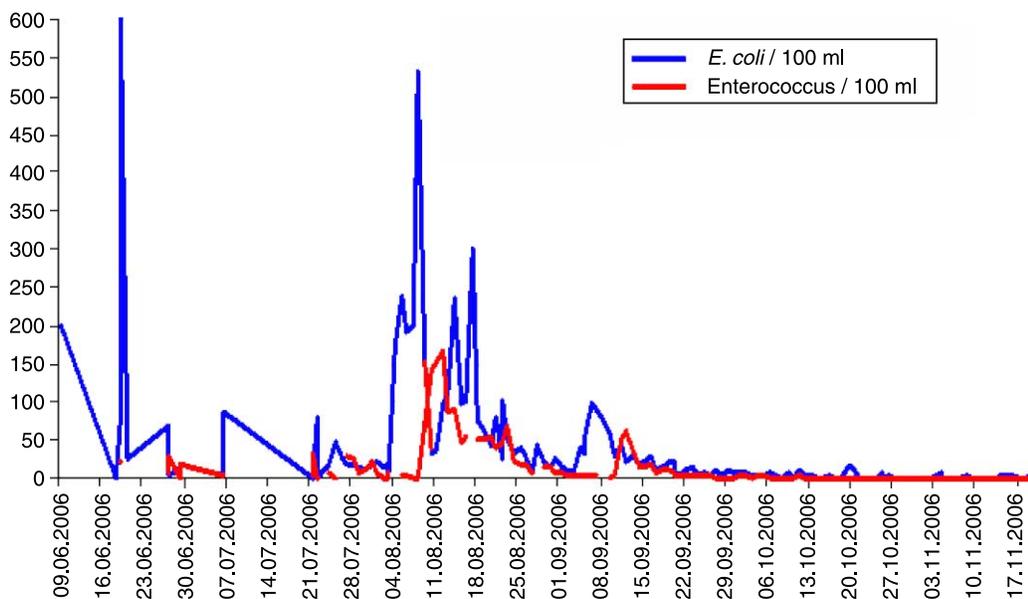
**Figure 4** | *E. coli* and *Enterococcus* numbers in the untreated water of the Miskolc-Tapolca waterworks, June–November 2006.
