## Evaluation of a silver-ion based purification system for rainwater harvesting at a small-scale community level

### ABSTRACT

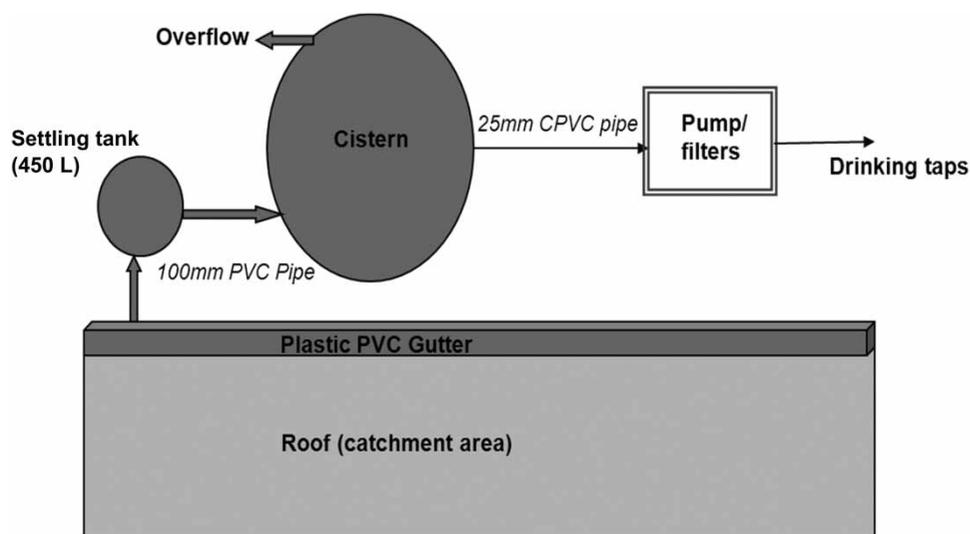
- rooftop and guttering;
- first-flush/settling tank;
- storage cistern (usually made of hard high-density polyethylene (HDPE) plastic or geomembrane);
- conventional filtration, including stainless steel mesh and activated carbon (GAC);
- silver ionising unit, described below, one of the key components of the system.

Figure 1 | System design showing main components (not to scale).

schools or clinics, between 2007 and 2009. The silver ionising devices were installed in 2009, towards the end of this period. The general system design is outlined in Figure 1 below.

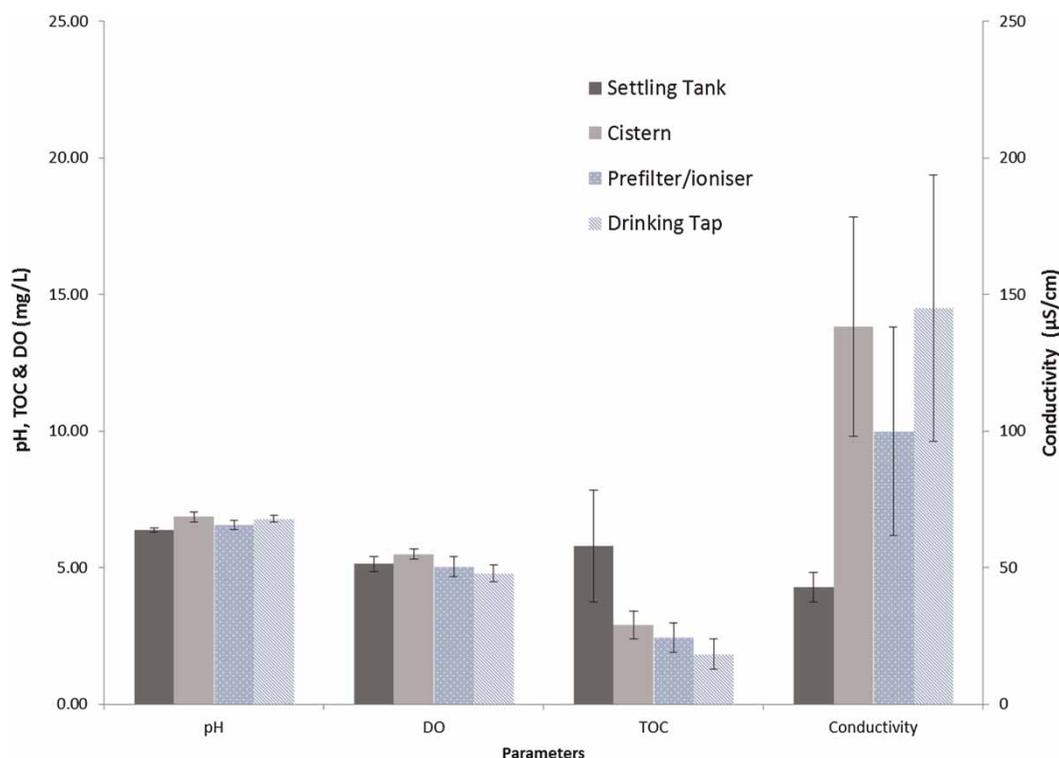
(COD) was found to be moderate in the settling tanks and cisterns (10–40 mg/L), but was practically eliminated after passing through the purification system. TOC followed a similar pattern (Figure 2). Alkalinity values, on the other hand,

**Figure 2** | Comparison of selected field parameter means at each of the sampling points (Table 4).

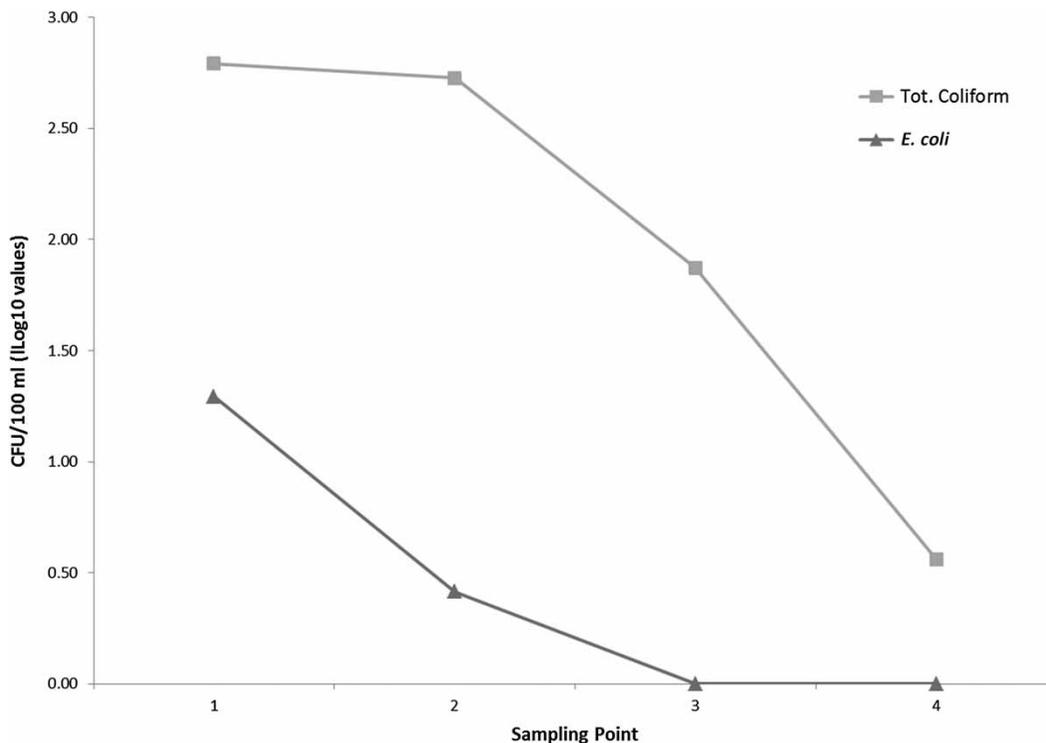
As expected, and according to our previous study (Adler *et al.* 2011), settling tanks tend to have a high coliform count, sometimes over 1000 CFU/100 mL for total counts, and corresponding lower counts for *E. coli* (maximum value detected was 275 CFU/mL). However, after passing through the entire filtration and silver ionising system, counts were consistently reduced to zero, making the water safe for human consumption. Settling in itself tended to reduce bacterial counts (Figure 3), which is in agreement with other studies performed on settling tanks and first flush systems,

Figure 3 | Reduction of average total coliforms and *E. coli* throughout the different sampling points (see Table 1). Microbiological indicators are expressed as Log10 values.
