A critical evaluation of two point-of-use water treatment technologies: can they provide water that meets WHO drinking water guidelines?

Heather M. Murphy, Edward A. McBean and Khosrow Farahbakhsh

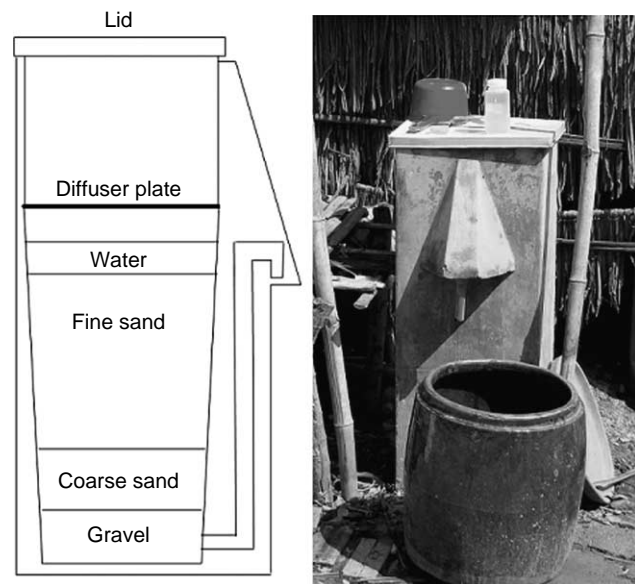
Figure 1 | BioSand filter.

In the early 1990s, Dr Manz at the University of Calgary adapted the design of a traditional slow sand filter so that it could be operated intermittently and called it the BSF (Buzunis 1995; Palmateer *et al.* 1999). The BSF is a household-operated slow sand filter (Figure 1). The Cambodian design of the BSF consists of a concrete frame and locally available crushed rock as the filter media.

The rock is crushed to two different sizes: a coarse layer and then a fine layer. The fine layer of crushed rock (sand) makes up the majority of the filter bed, approximately 46 cm, and has an effective size of between 0.15 and 0.35 mm and a uniformity coefficient of <3 (Samaritan's Purse Canada 2008). The design filtration rate for the BSF is between 600 and 800 ml min⁻¹ when the diffuser is full of water. In addition to the filter itself, the household must utilize a storage container to capture the treated water; the storage containers vary from household to household. The typical storage container included with the filter upon installation is an opaque plastic container with a medium-sized opening at the top, coupled with a lid.

collected from the untreated source water used for the filter and from the treated water leaving the filter spout (Figures 1 and 2). The questionnaire used in the study inquired about filter use, hygiene practices, household demographics and filter maintenance.

(Figures 1 and 2). In addition, water samples were collected from the treated water storage container for households using BioSand filters.

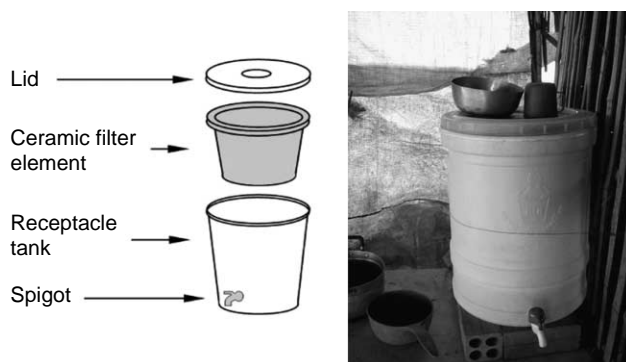
Figure 2 | Ceramic filter.

The design of the ceramic filter used in Cambodia originated from an organization called Potters for Peace (PFP) who developed ceramic filters in Nicaragua (Lantagne 2001a,b). The PFP design is a ceramic pot filter which resembles a flower pot (Figure 2). It consists of local clay, sand, sawdust and colloidal silver. The sawdust is used to increase the flow rate of the filter as it burns out in the firing process and allows for increased porosity. The colloidal silver is applied on the inner and outer surfaces of the clay filter after firing to act as a biocide. The pore size of the PFP filter ranges from 0.3 to 6 μm . A wide variety of research in a laboratory setting has shown between 97.8 and 99.99% *E. coli* removal and between 63.4 and 99.9% virus removal by ceramic filters (Lantagne 2001a,b; Brown 2007; Johnson 2007; Oyanedel-Craver & Smith 2008). In the field, Brown *et al.* (2007) observed on average 98% reduction of *E. coli*. This lower reduction was attributed to post-treatment contamination in the treated water storage containers (Brown *et al.* 2007; Murphy *et al.* 2009). Three epidemiology studies conducted in Bolivia and Cambodia found that a 40–70% reduction in diarrhoeal disease can be achieved through ceramic filter interventions (Clasen *et al.* 2004, 2006; Brown *et al.* 2007). Three NGOs implement ceramic filters across Cambodia: Resource Development International Cambodia (RDIC), International Development Enterprises and the Cambodian Red Cross. The current study examined filters implemented by RDIC in the field. To date, RDIC has produced approximately 90,000 ceramic filters which have been sold across Cambodia (Sampson, personal communication 2008).

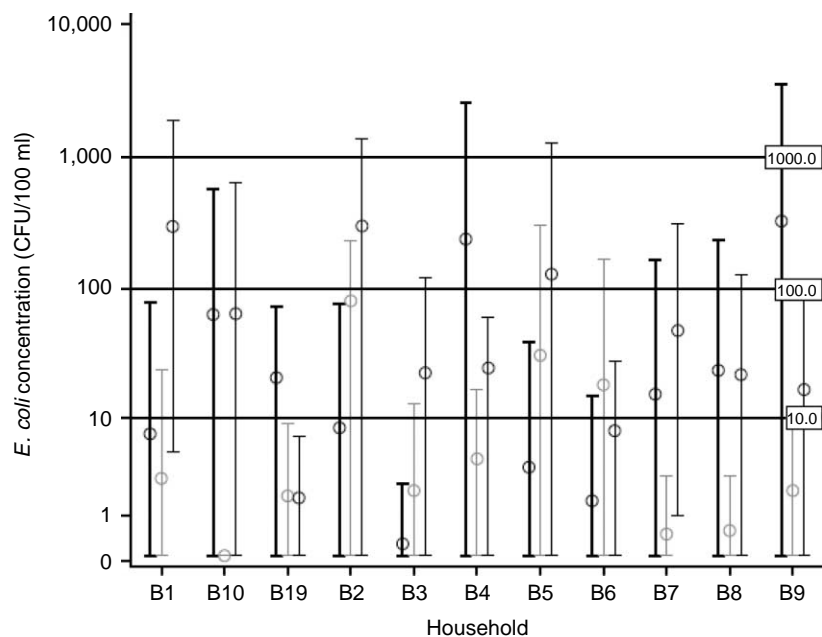
Figure 4 shows the *E. coli* concentrations for BSFs fed well water for the duration of the study. On average, these

filters provided a range of treatment for *E. coli*, from zero removal up to 2 log removal. Instances of the low removal could be attributed to the fact that the initial source water was often relatively low in microbial contamination. Eight of 11 filters, on average, produced treated water in the low risk range. In four cases: B2, B3, B5 and B6, an increase in *E. coli* concentration was observed from influent to effluent. As a result, these four filters were introducing bacteria into the treated water, possibly through contaminated spouts or other filter elements. Based on field observations, cleaning practices and flow rate measurements, it seems as though the households using filters B2, B3, B5 and B6 cleaned their BSFs frequently and as a result may have been using improper cleaning practices such as: sticking a finger or hand deep into the top layer of sand and stirring it around, scooping out sand and cleaning it and then replacing it back inside the filter. In some cases, the households reported removing sand from their filter. Consequently, filter maintenance is an important aspect for ensuring the provision of safe water from the BSF.

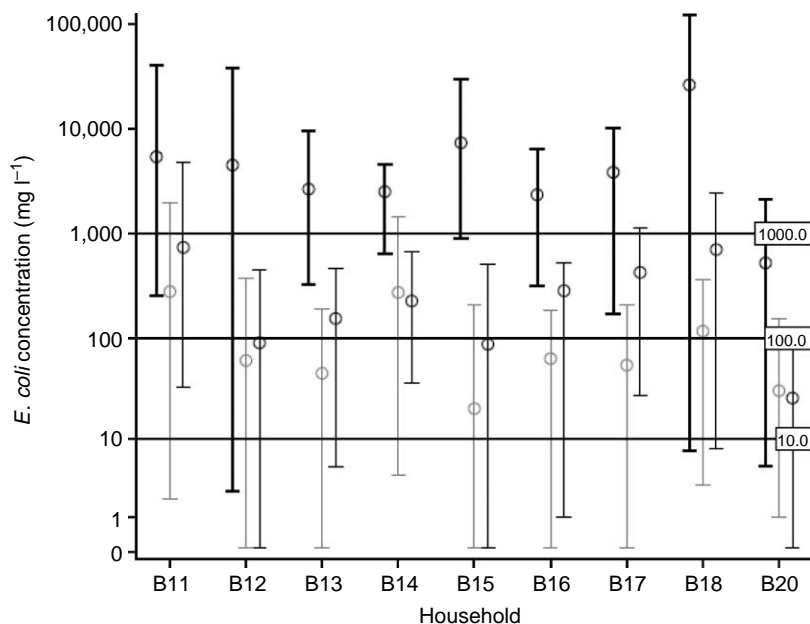
Figure 5 shows the *E. coli* concentrations for BSFs fed surface water sources for the duration of the study. None of the BSFs was consistently capable of providing treated water in the low risk range for *E. coli*. Given that the concentrations of *E. coli* in the raw surface water were extremely high, high

concentrations in treated water could be expected. On average, these filters were capable of achieving 1 to 2.5 log removal of *E. coli* when being fed surface water. In all cases, treated water was of better quality than the untreated water. Water produced from these filters ranged from medium risk up to extremely high risk (> 1,000 CFU/100 ml) on some occasions. Six and three filters, on average, produced water in the medium risk and high risk categories, respectively. For stored water, seven of nine households using surface water saw an increase in *E. coli* concentration from the treated water from the BSF to the treated water storage container. This demonstrates the importance of ensuring safe storage mechanisms are in place with the BSF.

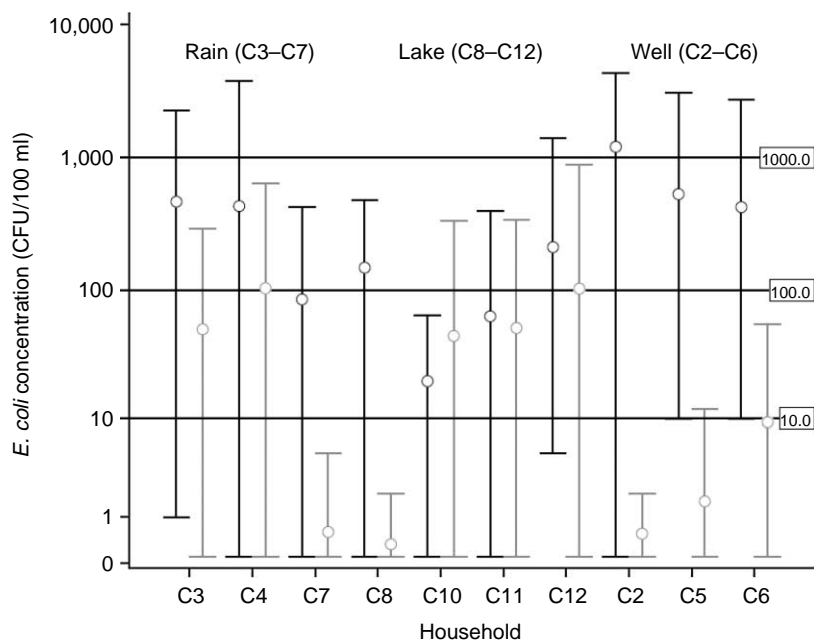
Escherichia coli concentrations in untreated and treated water from the ceramic filters that were fed rain, lake or well water are illustrated in Figure 6. Households C3, C4 and C7 used rainwater as their source water. C8, C10, C11 and C12 used lake water. C2, C5 and C6 used deep well water. Average bacterial removals for households using rainwater, lake or well water were between 0.75 and 1.0 log removal, 0 and 2.0 log removal and 1.75 and 3.0 log removal, respectively. Treated waters from ceramic filters using rainwater were in the low risk category for one filter and medium risk category for the other two filters. For well

water, all three filters produced treated water in the low risk category for exposure to *E. coli*. Treated lake waters were in the low and medium risk categories for one and three filters, correspondingly. In the case of C10, effluent *E. coli* concentrations exceeded influent lake water concentrations. One possible explanation for this is that the household frequently cleaned their filter, especially prior to our visit to their household. Although the filter element and plastic storage container never appeared visibly dirty, improper maintenance of the filter element (e.g. placing the filter on a dirty surface) and improper cleaning of the storage container (e.g. using a dirty cloth, dirty water, no soap) may have resulted in contamination of the stored treated water. This is consistent with findings from another study conducted by the senior author (Murphy *et al.* 2009). Filters were visually inspected at each household visit to see if there were any cracks in the ceramic filter elements. In addition, turbidity and colour were successfully reduced through the ceramic filter for C10; therefore, it is unlikely that there were any cracks in the filter element.

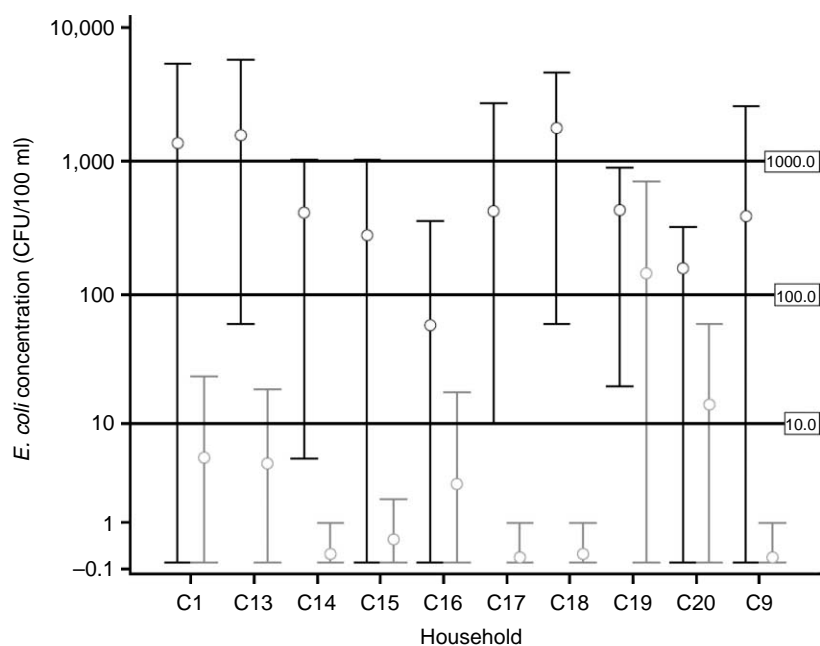
In Figure 7, *E. coli* concentrations are displayed for untreated and treated water from the ceramic filters fed Mekong River water. Average bacterial removals for *E. coli* ranged from 0.5 to 2.5 log. All filters reduced *E. coli* concentrations to between 0 and 10 CFU/100 ml with the exception of filters C19 and C20. Both C19 and C20 removed turbidity and colour; therefore it is unlikely that there were cracks in the filter elements. In the case of C19, the household cleaned their filter frequently, like household C10 discussed previously, and, as a result, it is likely that improper cleaning practices may have contributed to the poor treated water quality. For C20, the plastic container for the filter often looked dirty inside, the spout was dirty and was broken by a small child, indicating that children had ready access to the filter and could have been tampering with it. The filter was located on a small shelf very close to the floor and therefore accessible to domestic

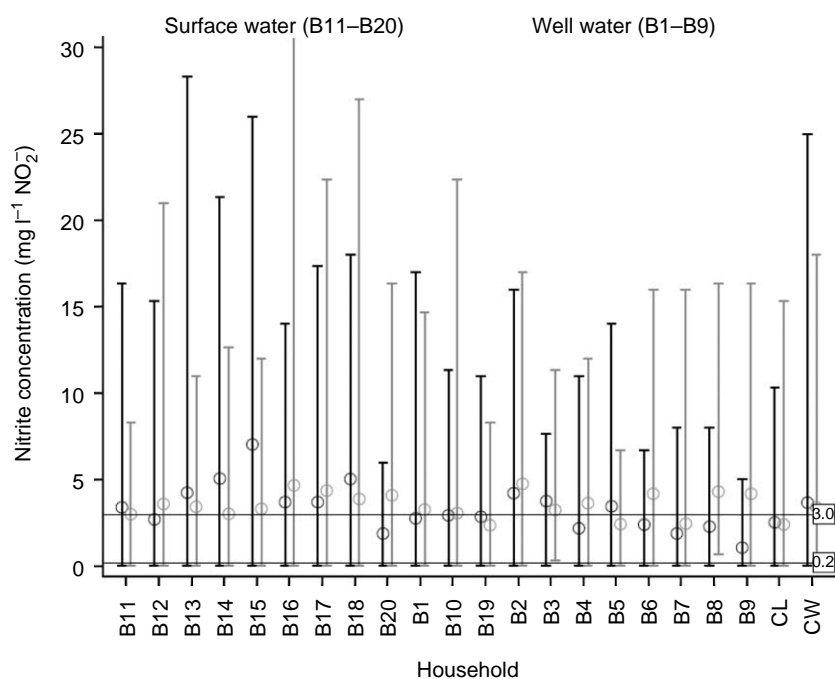
Figure 8 illustrates the nitrite concentrations for influent and effluent water for the BSFs in the current study. From the figure, one can see that 17 of 20 filters on

average exceed or equal the acute guideline value of 3.0mg l^{-1} for nitrite (NO_2^-) in the treated water. All 20 filters exceeded the chronic exposure guideline value of $0.2\text{mg l}^{-1}\text{NO}_2^-$ in the treated water. Twelve of 20 BSFs see an average increase in nitrite from influent to effluent water. In addition, a matched paired *t*-test was conducted and an average increase of 0.4 and $0.8\text{mg l}^{-1}\text{NO}_2^-$ was observed for BSFs fed well water and surface water, respectively. These results were significant at the 99.9% confidence interval level with *t* values of 11.51 and 8.98, respectively.

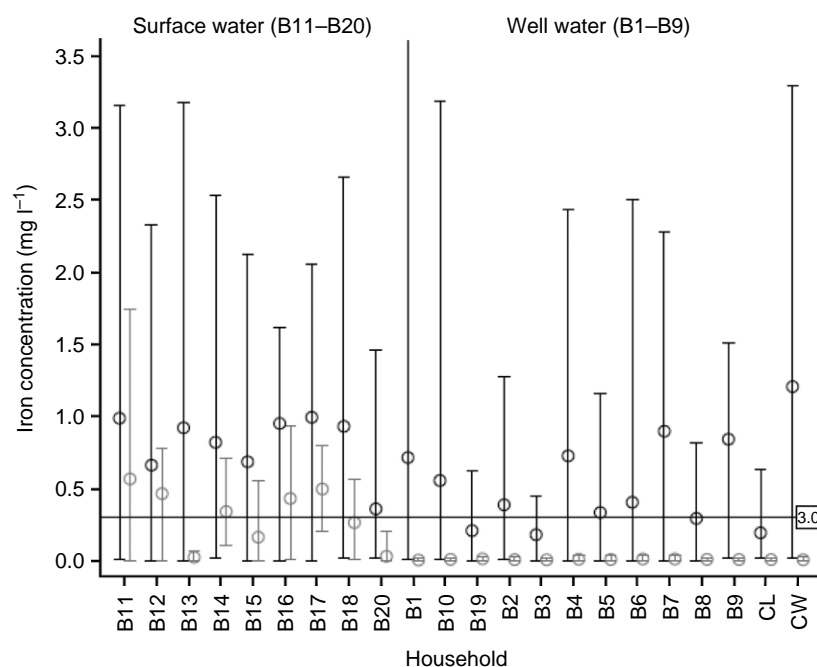
Although there is no significant health effects associated with iron in drinking water supplies, there are many aesthetic concerns such as taste and odour problems as well as the staining of laundry. The WHO aesthetic guideline for iron is 0.3 mg l^{-1} . In nearly all untreated water sources for the BSFs, total iron exceeded the 0.3 mg l^{-1} as shown in Figure 9.

Iron removal in sand filters occurs through two principal mechanisms: oxidation by aeration and adsorption of iron oxides onto the sand surfaces, or through microbial oxidation by iron-oxidizing bacteria followed by adsorption (Letterman 1999). For BSFs fed well water, >99% removal of iron was achieved by the BSFs and all filters produced water below the WHO guideline. For the BSFs fed surface water, iron removal varied from 40 to >99% removal. Four of nine filters fed surface water produced water below the WHO guideline. These results are somewhat surprising as they show that the iron is being removed more easily from well water sources than from surface water sources. The iron found in well waters is generally in the dissolved, more difficult to remove form (Fe^{2+}) and in surface waters it is in the insoluble form (Fe^{3+}). It is plausible that pumping of the well, transport to the BSF, and then pouring the water into the filter through the diffuser could aerate the well water enough to oxidize the iron to the more readily removed form, Fe^{3+} . At that point, the iron may have been adsorbed to the sand surface as it passes through the filter, thus explaining the high removal observed for the well water sources. Interestingly, this does not seem to be the case for all the surface water sources. Many households retrieved their

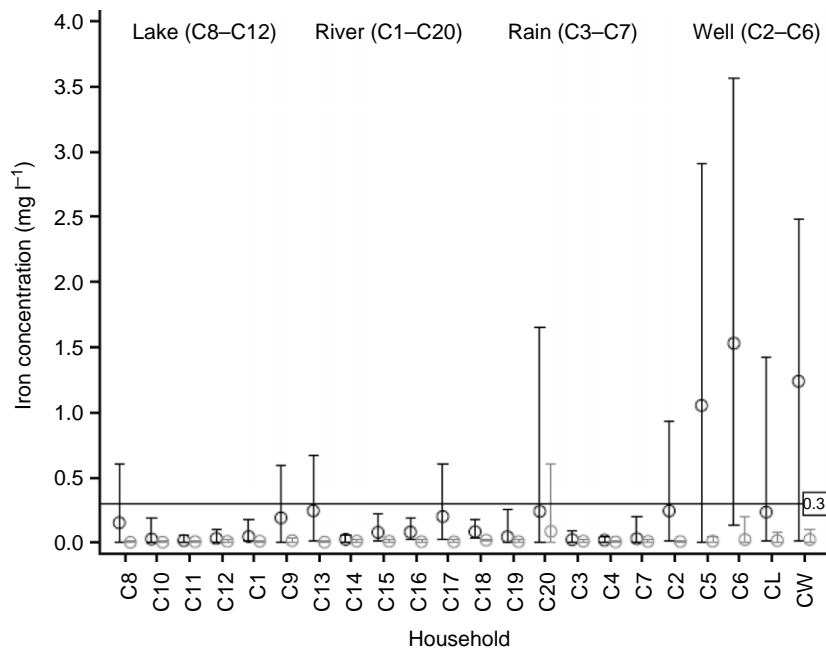
Figure 10 shows the iron concentrations observed in source water and treated water from ceramic filters. In general, the water sources were low in iron with the exception of the well waters. On average, all source waters except C5, C6 and the control well water (CW) were below the 0.3 mg l^{-1} guideline. For the three well water sources, the ceramic filters were consistently able to reduce the iron concentration to below the WHO guideline of 0.3 mg l^{-1} and achieved >99% removal of iron. These results are consistent with the results found by Low (2002) who reported greater than 90% removal of iron by ceramic filters. It is expected that the iron was oxidized from Fe^{2+} to Fe^{3+} during the pumping process and transport of water to the ceramic filters. The Fe^{3+} was subsequently removed by sedimentation in the ceramic filter as well as adsorption on the ceramic filter surface. Some biological

iron oxidation and subsequent removal may have also occurred at the ceramic filter surface, as a biofilm layer may exist if the ceramic filter is constantly filled with water and never left to dry out. Given that biofilms exist on all types of surface in contact with water, it is plausible that a biofilm exists inside the ceramic filter, especially since it has such a slow flow rate, and users often re-fill their filter before it has run dry (Marshall 1992). Further research would need to be conducted to confirm the nature of a biofilm within the ceramic filter.

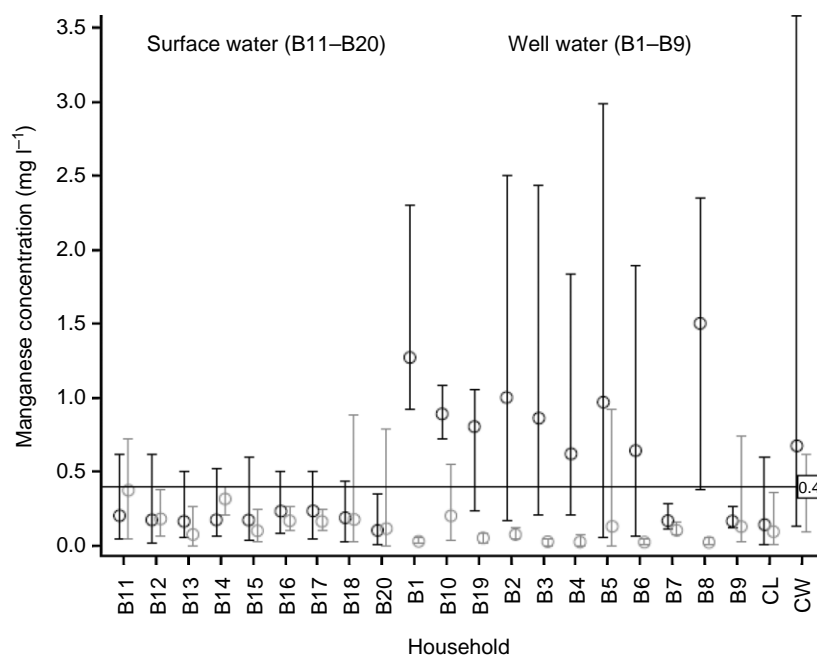
Figures 11 and 12 show the average influent and effluent concentrations of manganese observed for both

BSF and ceramic filters as well as high and low values observed during the sampling period. Manganese was below the WHO guideline for surface water sources used to feed the BSFs. Nine of 11 well waters exceeded the WHO guideline of 0.4 mg l^{-1} considerably. Manganese removal capabilities of the BSFs were $>97\%$ for those fed well water.

Similar to iron, manganese must be in the more oxidative state, Mn^{4+} , in order to be easily removed in the BSF through adsorption. The manganese was probably oxidized in the same way as the iron through aeration from pumping, transporting and pouring of the well water through the diffuser into the BSF or through manganese-oxidizing bacteria followed by adsorption on the sand surface. For filters B7, B9 and CW, all fed a well water source, Mn removal efficiencies were notably lower. Given the small initial concentrations of Mn for B7 and B9, it would be expected that treated water concentrations would be closer to zero. In all three filter cases, ammonia (NH_3) concentrations in effluent water samples ranged from 0.15 to 12.58 mg l^{-1} . Several authors have reported that manganese removal does not occur in sand filters until ammonia is
